Statistical Assessment of Damage to Churches Affected by the 2010-2011 Canterbury (New Zealand) Earthquake Sequence

The Canterbury Region of New Zealand experienced an extensive earthquake sequence during 2010-2011, with two particularly severe events being on 4 September 2010 and 22 February 2011. The presented work entails a statistical analysis of the data collected for 112 church buildings located in the affected region, including details of the *in situ* damage observed by the authors and the structural assessment classification assigned by the local authorities. The seismic performance of these churches is discussed and compared with both the structural classifications used in Italy, where a specific survey form for churches is used, and with the building damage classifications assigned by the local authorities.

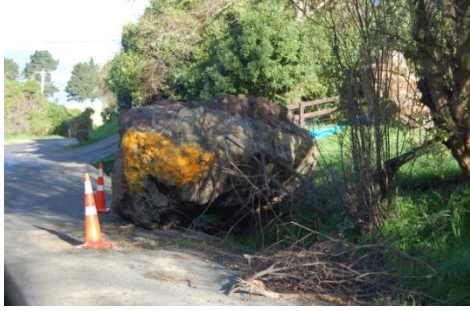
(a) example of a boulder that rolled downhill

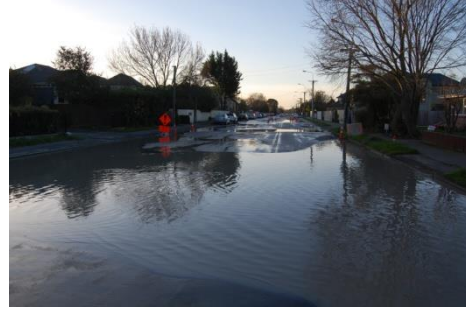
(b) liquefaction in the Christchurch City centre

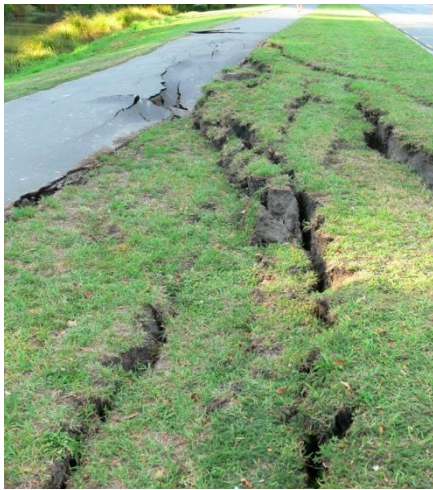
(c) lateral spreading along the Avon River

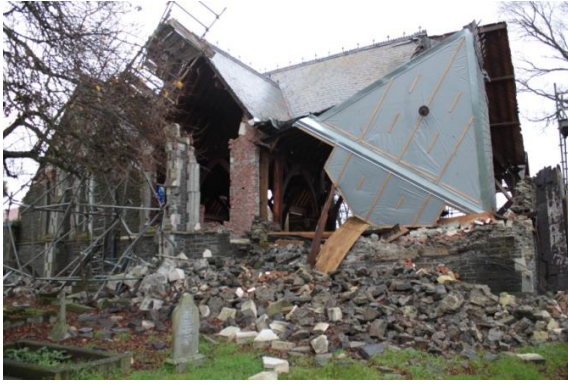
(a) exterior inspection only due to safety reasons (Holy Trinity, stone, Avonside)

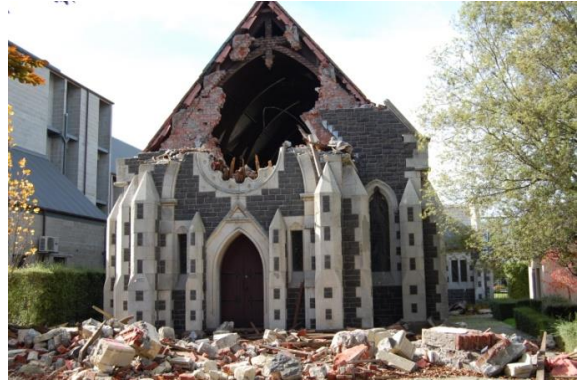
(b) exterior inspection only due to safety reasons (Rose Historic Chapel, stone, CBD)

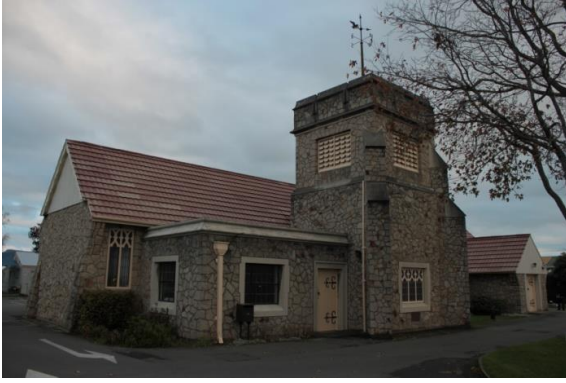
(a) *green* tagged (St. Martin's, stone, Middleton)

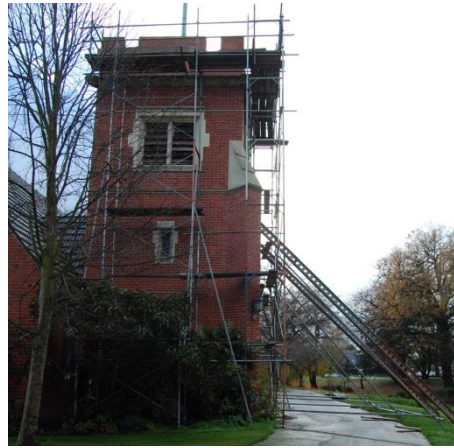
(b) *yellow* tagged (St. Andrew's College, brick, Papanui)

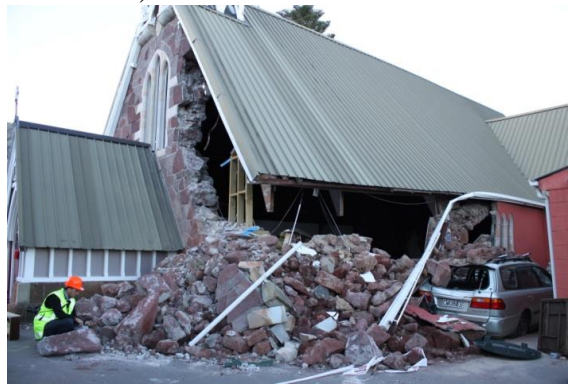
(c) *red* tagged (Holy Trinity, stone, Lyttleton)

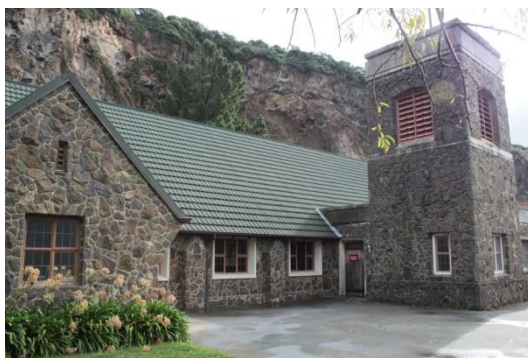
Figure 14 – Example of an undamaged church classified *red* due to instability of the slope shown in the background (All Saints, stone, Sumner).

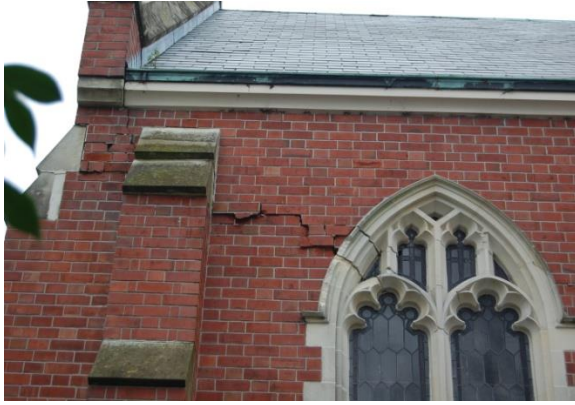
The most vulnerable collapse mechanisms found were shear damage in the longitudinal walls, hammering of the roof and overturning of the top of the facade.

(a) shear damage in the longitudinal walls (mechanism 6), outside (Nazareth's House church, brick, Sydenham)

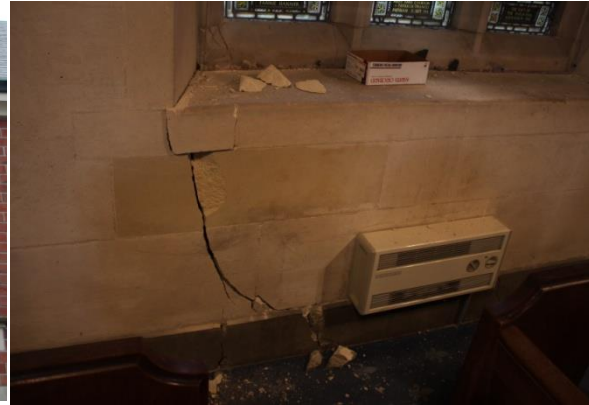
(b) shear damage in the longitudinal walls (mechanism 6), inside (St. Barnaba's, stone, Fendalton)

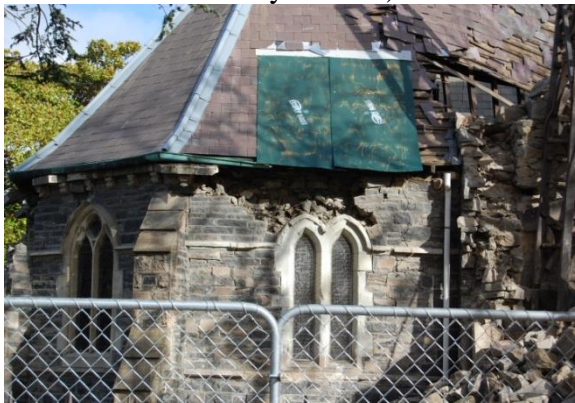
(c) hammering of the roof (mechanism 19), outside (St. John's, stone, Latimer Square)

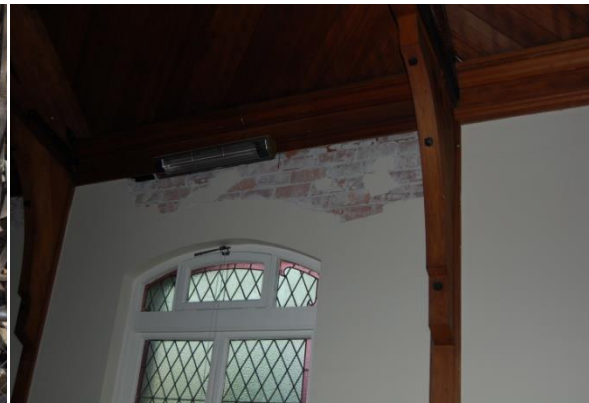
(d) hammering of the roof (mechanism 19), inside (Shirley Methodist, brick, Shirley)

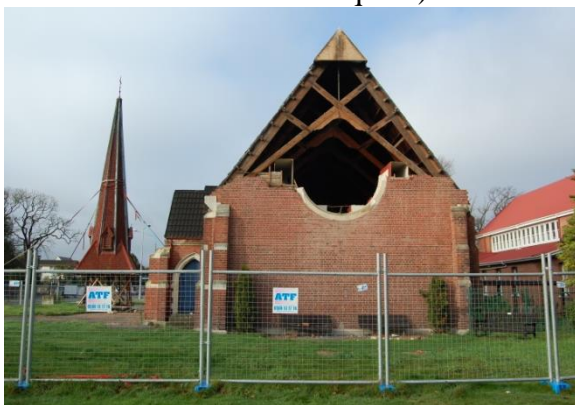
(e) overturning of the top of the facade (mechanism 2), outside (Chinese Methodist, brick, Papanui)

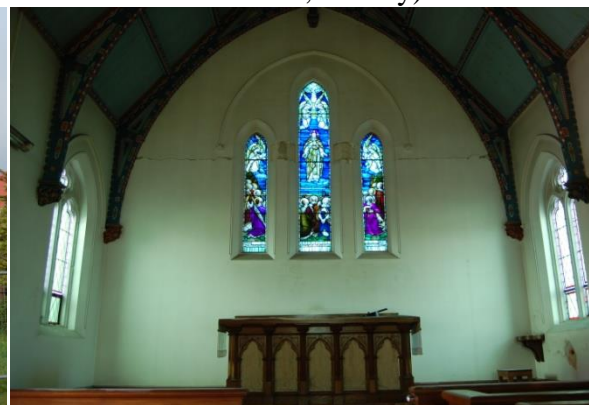
(f) overturning of the top of the facade (mechanism 2), inside (St. James, stone, Riccarton)
