# Damage Inspection in Churches – The Canterbury Earthquake (New Zealand) Experience

João Leite<sup>1</sup>, Jason M. Ingham<sup>2</sup>, Paulo B. Lourenco<sup>3</sup>

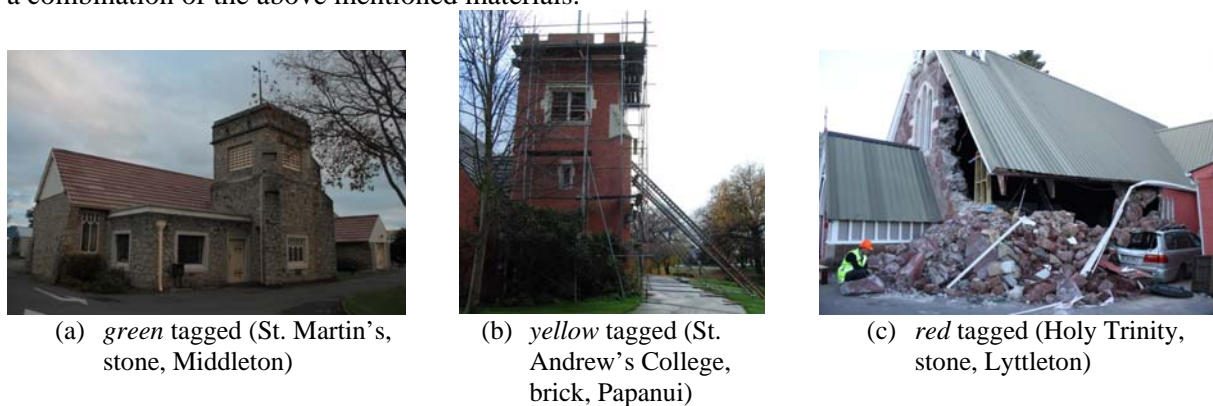
Figure 3. Examples of damaged churches.

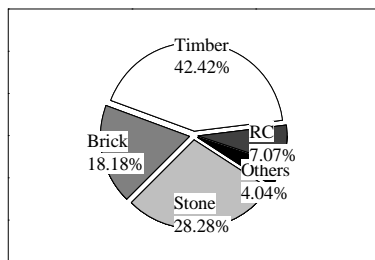
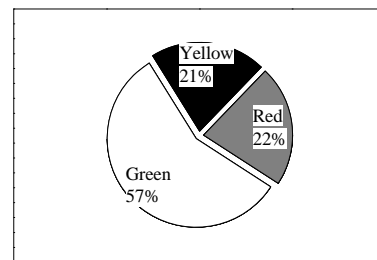
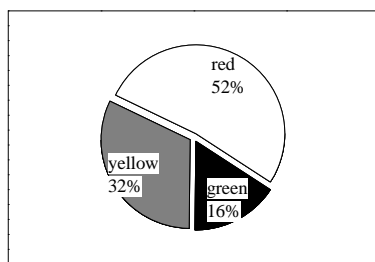
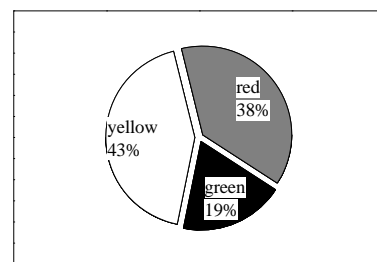
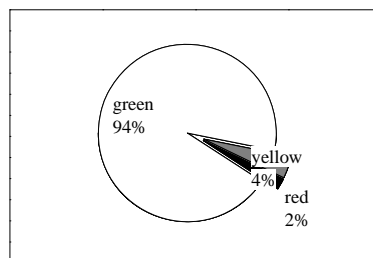
As shown in Figure 5 (a), the three major construction typologies for churches in the Canterbury region are timber, stone masonry and brick masonry, with about 10% of the buildings using other materials. More than half of the surveyed churches (57%) received a green placard from the structural inspectors (see Figure 5 (b)).

Figure 5. Damage statistics for the assessed churches.
