Damage Assessment of Unreinforced Stone Masonry Buildings After the 2010-2011 Canterbury Earthquakes

Ilaria Senaldi^a, Guido Magenes^b & Jason M. Ingham^c

DAMAGE ASSESSMENT OF UNREINFORCED STONE MASONRY BUILDINGS AFTER THE 2010- 2011 CANTERBURY EARTHQUAKES

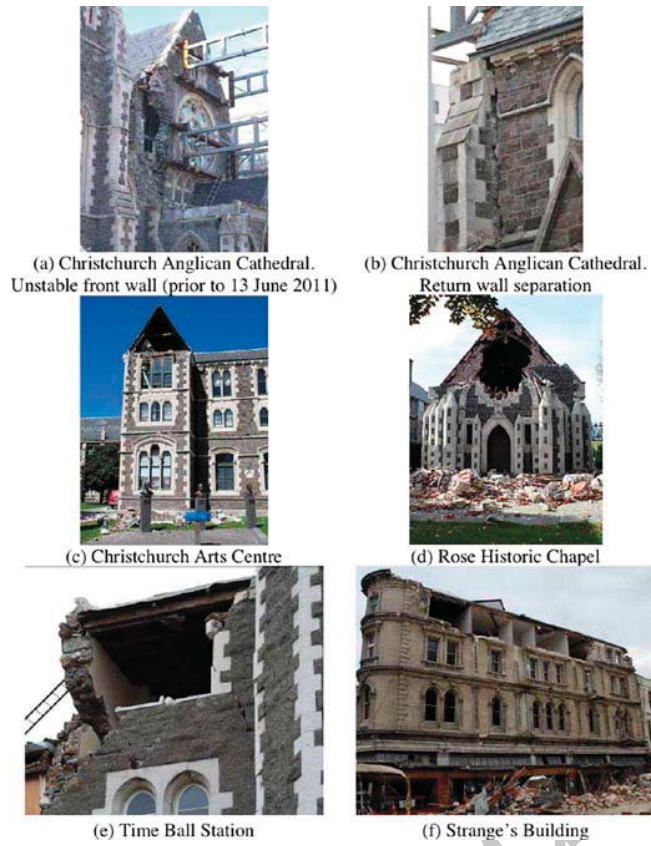
Figure 15. Examples of global and local out-of-plane overturning mechanisms of façades

for structures having these characteristics, it is not surprising that one of the most recurrent damage mechanisms reported for most of the structures inspected was the partial and global overturning of façades, with damage levels ranging from moderate to severe and in some cases reaching collapse, in both buildings and churches. The poor connections between the walls at their corners led to return wall separation and subsequent out-of-plane wall failure, either entirely as in the Anglican Cathedral or in the top portion of the façade as in the case of the Time Ball Station. Figure 15 (a, b) shows an example of an out-of-plane failure mechanism activated in the main façade of the Anglican Cathedral (partially collapsed after the 13 June 2011 earthquake and aftershocks).

The low level of vertical compression and inadequate connection between the gable and roof trusses are primary contributing factors to the occurrence of out-of-plane overturning of gable end walls, along with increased accelerations experienced at the top level of the structure. Many of the stone masonry buildings that were constructed in the Gothic Revival style sustained partial damage because of the activation of overturning mechanisms in the gable, with cases of local or complete collapse of the top portion of the façade, as shown in Figure 15 (c, d) in the Arts Centre and in the Rose Historic Chapel.

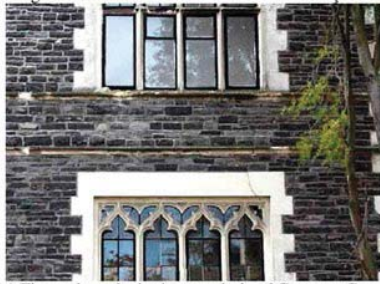
Evidence of in-plane wall damage in the east-west running walls of buildings was reported in conjunction with overturning of façades oriented in the orthogonal direction, because of the directivity effect of the February 2011 Christchurch earthquake caused by a fault rupture oriented in the same east-west direction. The damage patterns typical of failure due to shear or to flexure were frequently exhibited by masonry piers and spandrels. Examples of recurrent damage patterns are shown in Figure 16, where masonry piers of the Christchurch Anglican Cathedral exhibited a shear type of response (Figure 16a, b), evident by diagonal cracks that affected the buttress, as well as the piers of Strange's Building.

(b) Diagonal pier cracks in the Lichfield Street façade of Strange's Building

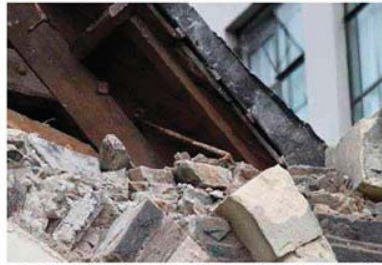
The higher percentage of strengthened buildings in which out-of-plane overturning mechanisms caused moderate to serious damage (60% of strengthened palaces were affected by the activation of mechanism 17 and more than 30% by mechanism 1), in comparison with the unstrengthened buildings requires clarification. Most of the strengthening interventions, particularly wall-to-diaphragm anchorages and steel bracings or trusses, were applied on buildings constructed following the principles of Neo-Gothic architecture, and hence these buildings were more prone to the activation of out-of-plane overturning mechanisms, rather than in dwelling or on buildings with simpler architecture and smaller dimensions. A close inspection of buildings that suffered out-of-plane wall failures indeed revealed that in many cases some anchors were present in the

walls that failed, or that inadequate securing of walls and diaphragms using wall-diaphragm anchors could not prevent portions of walls from overturning. In some cases anchors were either absent or were spaced too far apart to prevent bed joint shear failure of the masonry at the location of the anchorage. In buildings where anchoring had been seismically designed or where anchors were sufficiently closely spaced to resist lateral loads, the overturning of gables and other portions of walls was prevented. Figure 21a shows the damage resulting from overturning of the gable of the main façade of the former Trinity Church in the Christchurch CBD while the detail in Figure 21b illustrates how the anchoring was insufficient in size and spacing to secure the wall in place. Figure 21 also shows some examples of wall-to-roof anchoring respectively in the Christ's College (Figure 21c) and in the former Canterbury University Engineering Department (Figure 21d). As shown in Figure 21c, the use of a backing steel frame that connects both the masonry gable wall and the timber roof structure prevented complete collapse of the gable because of out-of-plane overturning, although collapse of portions of the wall did occur. A similar solution performed successfully in the former Malthouse, now the Canterbury Children's Theatre, where in addition to grout injection of the multi-leaf stone masonry walls, the diaphragms were stiffened by adding new steel trusses adjacent to the original timber ones at roof level and by replacing the plywood of floors as well as improving the wall-to-floor connections with steel anchors.

(a) Cramner Court.
Gable ended out-of-plane wall failure.

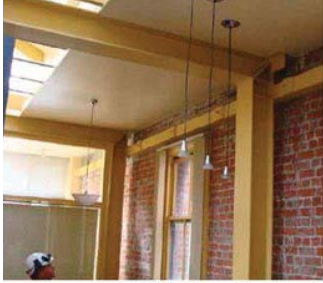
(c) Laurie and Wilsons Auctioneers building.
Presence of steel frame

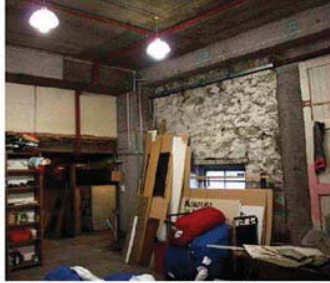
(d) Former Malthouse Building. Presence of reinforced concrete frame

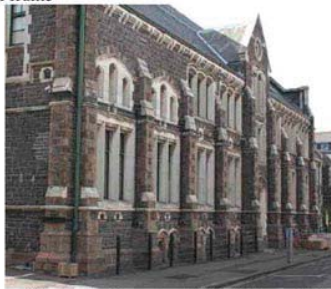
(e) Former Chemistry Department, Christchurch Arts Centre.
Use of post-tensioning.
