DAMAGE TO CONCRETE STRUCTURES FROM THE 2010 DARFIELD (CANTERBURY, NZ) EARTHQUAKE

Jason Ingham^{*}, Liam Wotherspoon^{**}, Lucas Hogan^{***} and Bilel Ragueed^{***}

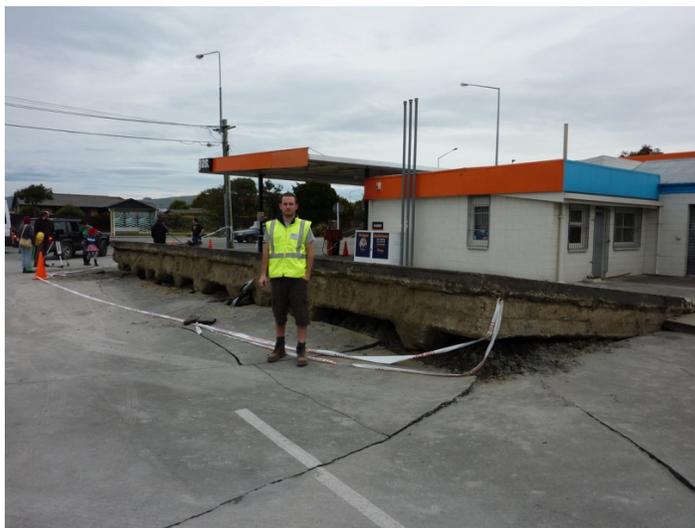
Figure 4. Floated petrol storage tanks in Bexley.

Widespread liquefaction and lateral spreading occurred in Christchurch City and the surrounding region. The most prevalent damage resulting from this liquefaction was to residential structures and water/wastewater networks. In Figure 4, petrol storage tanks floated due to liquefaction of the surrounding soil, with the soil no longer providing any resistance to the buoyancy of these tanks. Tanks were topped with concrete covered steel I beams, which gives the ridged base of the slab seen in the figure. In Kaiapoi, large lateral spread cracks up to 2 m deep and 1 m wide opened up in stopbanks adjacent to the river (see Fig. 5). These spread cracks developed along the stopbanks on

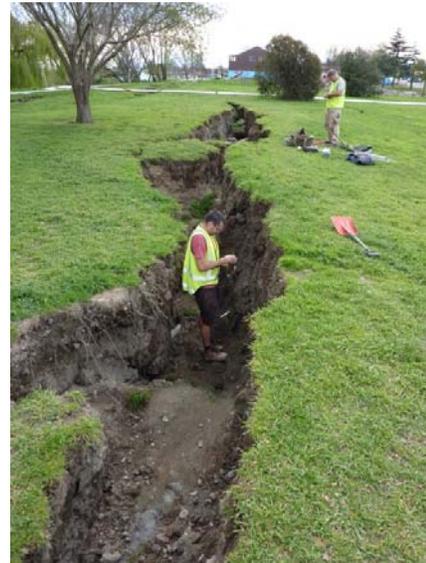
Figure 5. Lateral spreading of the northern stopbank of the Kaiapoi River

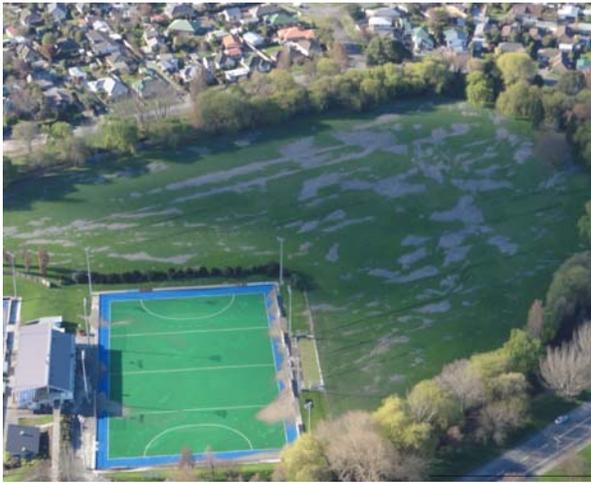
both sides of the river. Close to the river, no liquefaction ejecta was present in the cracks, while further from the river cracking had evidence of ejecta. Figure 6 shows an aerial view of the extensive liquefaction that occurred in Porritt Park in the suburb of Wainoni. This park is bordered on one side by the Avon River, with the remainder enclosed by a stream that follows the old path of the Avon. The large area of sand boils is clearly evident in the image, with the linear nature of some of these sand boils indicating the lateral spreading that also developed.

Figure 6. Aerial view of sand boils and lateral spreading in Porritt Park

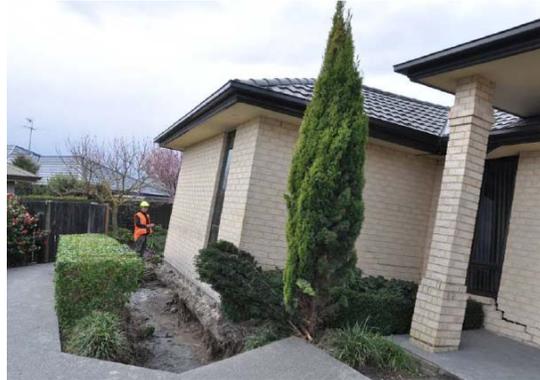
Figure 7. Effects of lateral spreading on residential structures in Kaiapoi

In south Kaiapoi a large number of residential properties in Courtenay Dr were damaged as a result of significant lateral spreading, such as

the structure shown in Figure 7. Large cracks up to 1.5 m wide ran through the area, cutting through the properties and the houses themselves. One and two storey structures were severely damaged because of this movement, resulting in tilting, foundation tension cracks and settlement. Even with this large movement and severe structural damage, none of the houses collapsed under their own gravity loads following the event. Figure 8 shows a long crack that developed in the floor slab of a single storey residential structure in Bexley as a result of lateral spreading. The slab was 100 mm thick and this crack was approximately 50 mm wide, developing parallel to the adjacent wetland area, with other cracks developing in external paving areas surrounding the structure. From inspection it was clear that no reinforcement was present in the slab of this structure. Figure 9 provides a close up view of ruptured floor slabs of structures in Spencerville. Lateral spreading of the ground parallel to the Styx River caused severe damage to multiple large single storey homes in the area. Long lateral spread features developed and extended across multiple properties and structures. The perimeter beam of the foundation was reinforced with two D16 reinforcing bars, while there appeared to be no reinforcement present in the slab. Cracking extended from the ground up into the walls and roof of the structure, however none of the structures collapsed.

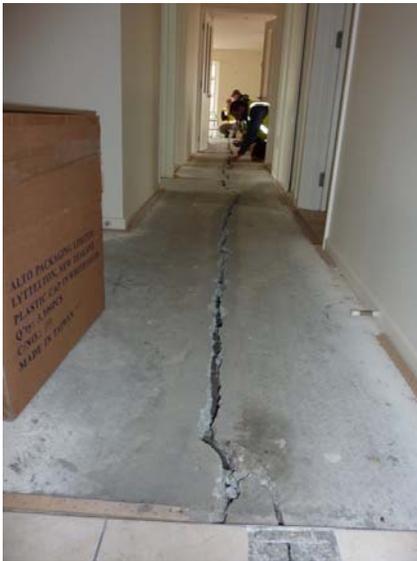
Figure 8. Cracking through floor slab of residential structure

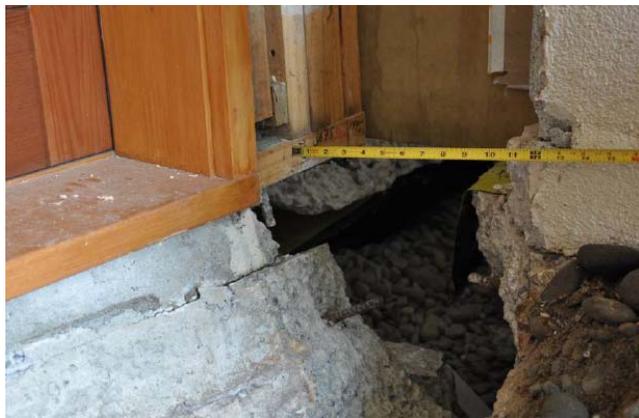
Figure 9. Separation of residential home due to lateral spreading

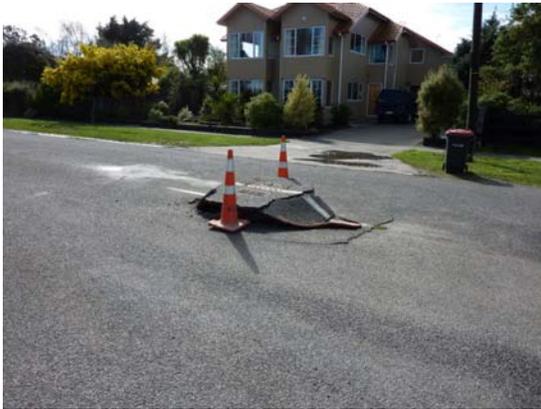
Damage to pipe networks as a result of liquefaction occurred extensively across the region as a result of ground movement and floating of manholes. Between Spencerville and Brooklands on Lower Styx Rd, liquefaction caused ground subsidence and uplifting of 25 manholes up to 450 mm above the road level. An example of this is shown in Figure 10.

Figure 10. Manhole uplift on Lower Styx Rd

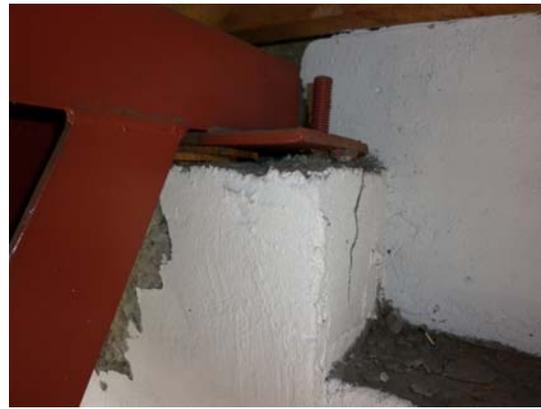
Figure 11. Damage to anchorage detail in low rise concrete building

In general, most concrete buildings performed well, with the majority of damage being associated with irregular or older non-ductile structures. Hairline cracking was observed in some reinforced concrete masonry buildings, and there was damage to bolted anchorage details between roofs and walls, as shown in Figure 11.

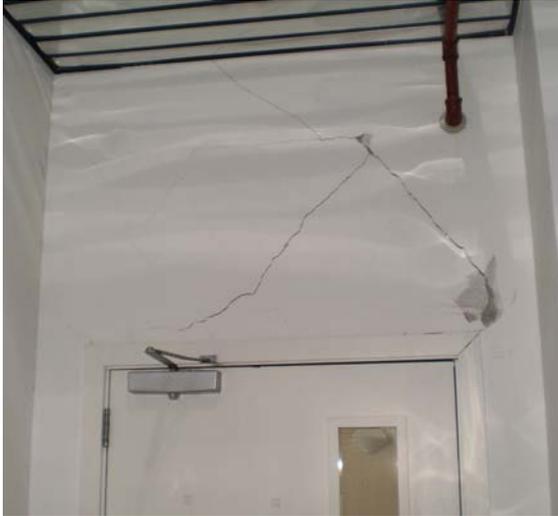
Damage to medium rise concrete buildings was attributable to poor load paths for the transmission of upper storey seismic loads to the ground (see Fig. 12), cracking in older non-ductile concrete buildings (see Fig. 13), and pounding damage between precast concrete panels (see Fig. 14). In taller buildings there was minor evidence of movement between structural elements, but perhaps the most significant damage was due to rupture of cold drawn wire mesh in precast floor toppings (see Fig. 15). The limited ductility of cold drawn wire mesh had been well documented previously (DBH 2005), but this was the first observed damage in a New Zealand earthquake that was attributable to the lack of ductility of cold drawn wire mesh.

Figure 12. Diagonal shear cracking due to reduced area of shear wall

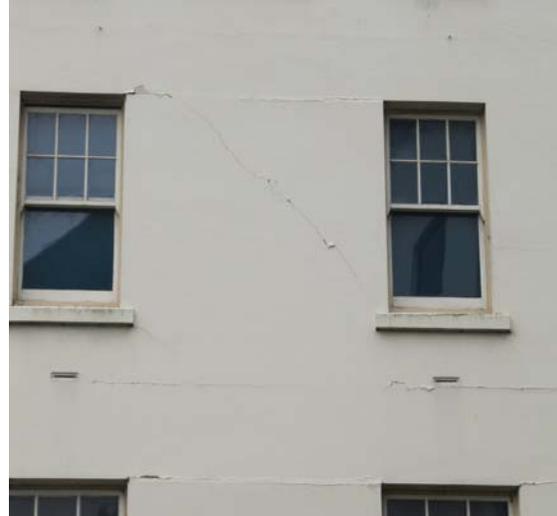
Figure 13. Diagonal cracking in older non-ductile concrete building

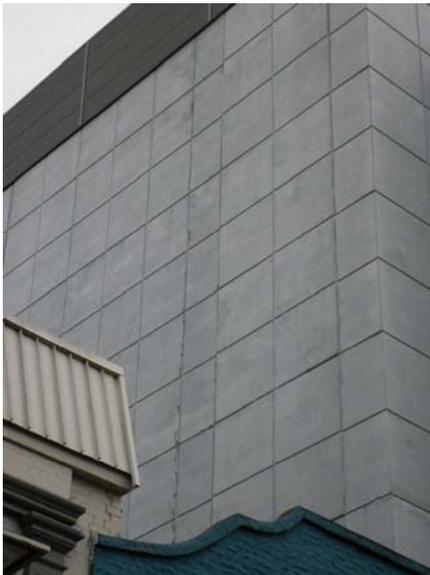
Figure 14. Pounding damage to exterior precast concrete panels

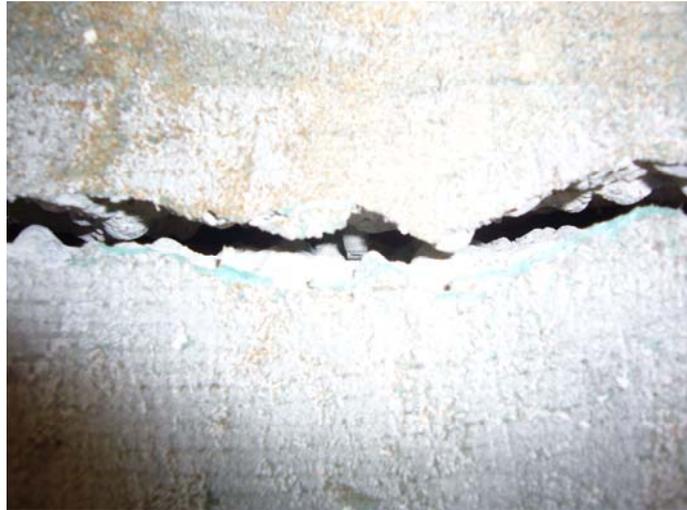
Figure 15. Fracture of cold drawn wire mesh in topping slab

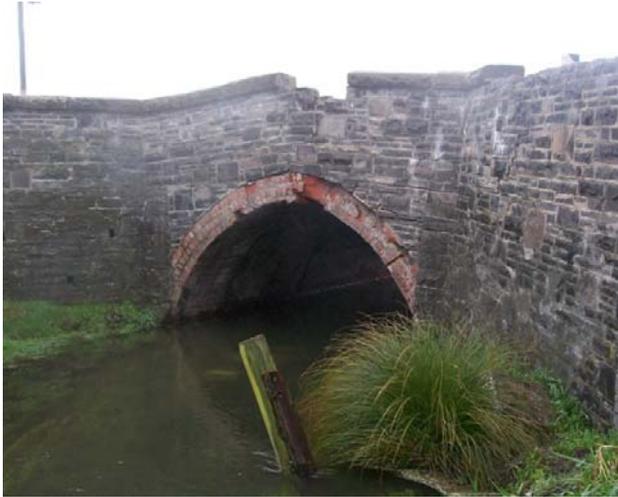
The only road bridge to sustain any significant damage to the superstructure was an unreinforced masonry arch bridge on Sabys Road (see Fig. 16(a)). The bridge crossed a small stream and during the earthquake both banks failed due to lateral spreading. The added compressive force from the bank movement caused the arch to crack and the road to buckle. The only other superstructure damage observed was pounding between the deck and abutment on the Bridge St. Bridge in South Brighton (see Fig. 16(b)).

(a) Failure of masonry arch bridge at Sabys Road

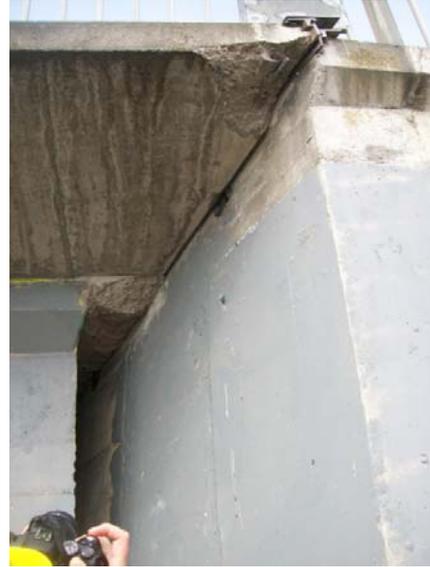
(b) Pounding of Bridge St. Bridge deck

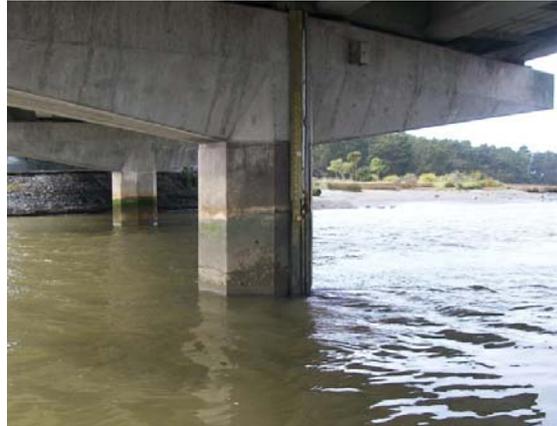
A small number of road bridges exhibited flexural cracking of the piers (see Fig. 17). While this cracking allows the bridge to perform satisfactorily structurally, it represents a potential threat to the lifespan of the bridge. Due to the proximity to the ocean and the salt content in the air, this cracking provides an accelerated pathway for chloride ingress. With the increased rate of chloride ingress, the reinforcement steel will corrode at a much faster rate, significantly reducing the serviceable life of the bridge.

Figure 17. Flexural cracking of piers on Bridge St. Bridge

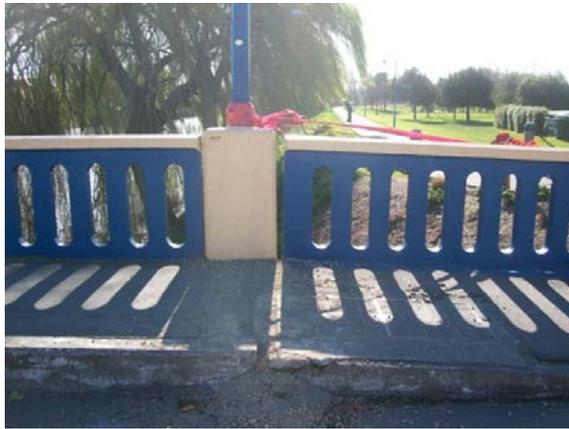
Abutment damage observed included cracking and/or the rotation of the entire abutment in two cases, these being Bridge St. Bridge in South Brighton and Williams St. Bridge in Kaiapoi. This abutment damage was caused by lateral spreading of the approach slopes in areas suffering from liquefaction. This effect was seen only on bridges with deep abutments, or closely spaced abutment piles. Cracking was observed on the river side of the piles and the bottom of the abutment rotated towards the river suggesting plastic hinging in the piles, as was previously observed in the 1987 Edgecome Earthquake (Berrill et al. 2001).

(a) Rotation of abutments due to lateral spreading:

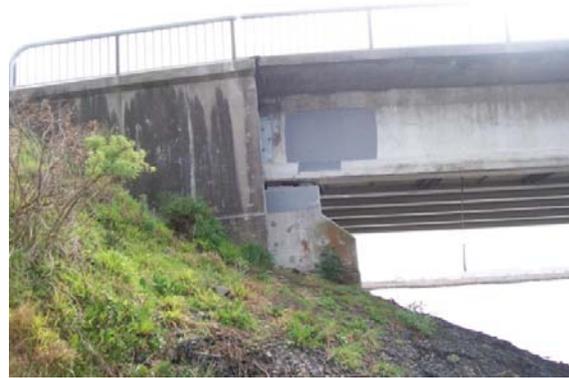
(b) Bridge St. South Brighton

Figure 18. Damage to bridge abutments

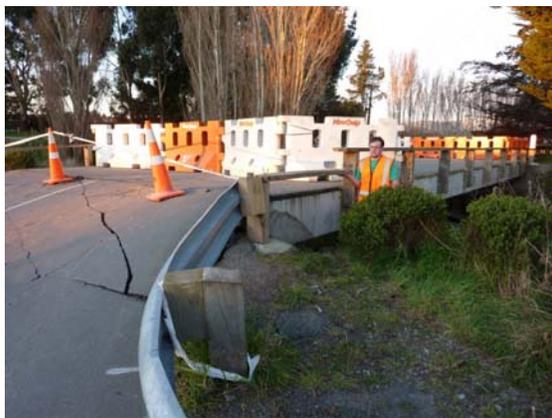
(a) River Road Bridge, South Lincoln

Seven of the eight closed road bridges were closed due to damage to the approach. In all cases closure was caused by lateral spreading of the approach towards the river. As the abutments were generally supported on piers, the bridge itself remained relatively unmoved. This phenomenon has been observed in previous earthquakes (Ashford and Kawmata 2006; Buckle et al. 2000). This differential movement led to the formation of vertical settlement between the bridge deck and the approach of up to 500 mm in River Road Bridge., causing settlement from its original perfectly horizontal alignment (see Fig. 19(a)). Cracks in the approaches parallel to the axis of the bridge provide evidence of the resistance against lateral spreading provided by this short monolithic span, as observed at the Gayhurst Road Bridge (see Fig. 19(b)).

Figure 19. Approach Settlement

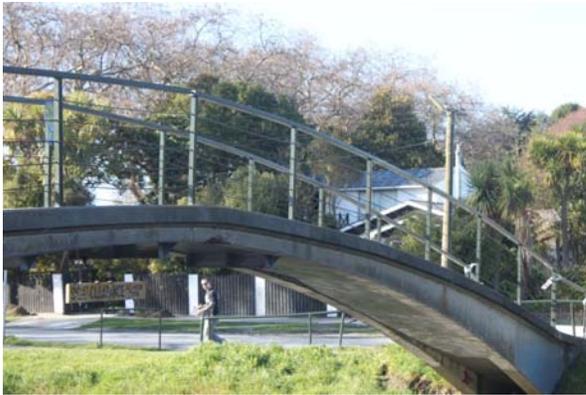
(a) Avon Park

Almost all pedestrian bridges that were closed due to the earthquake suffered extensive damage to the superstructure. The bridge failures occurred in regions that exhibited extensive liquefaction, and had associated lateral spreading of the riverbanks. While most road bridges with integral abutments had the necessary strength and stiffness to resist the added compression from the approach slopes, the pedestrian bridges did not. Therefore the bridges developed plastic mechanisms as observed at the Avon Park arch bridge (see Fig. 20(a)) where hinging formed at the apex of the arch. Plastic mechanisms were also observed at the Porritt Park footbridge where the prestressed beams were subjected to large compression loads and rotations (see Fig. 20(b)).

Figure 20. Plastic Mechanisms in concrete footbridges

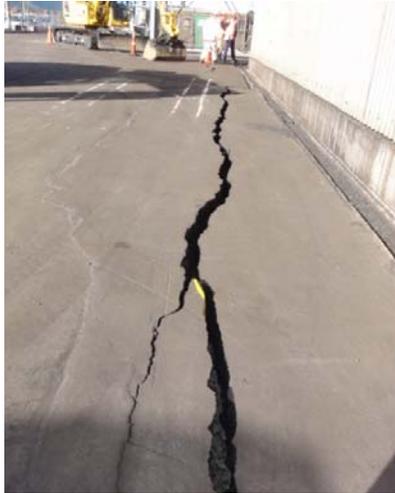
The overall port structure sufficiently resisted the forces induced by the earthquake, resulting in no structural collapses. However, ground deformations induced by the earthquake did cause serviceability damage, which is consistent with what has been observed in similar sized earthquakes in other countries (Mahoney, Francis and Kennard, 2008). The primary lateral resistance mechanism is a series of tie backs running underneath the large yard behind the wharfs and anchored in large concrete 'dead men' installed adjacent to the cliff face, which prevented the wharfs from completely detaching into the sea. However, the reclaimed land underneath the yard displaced towards the sea, which caused cracking in the concrete pavement as evident in Figure 22.

(a) Settlement induced cracks in quay

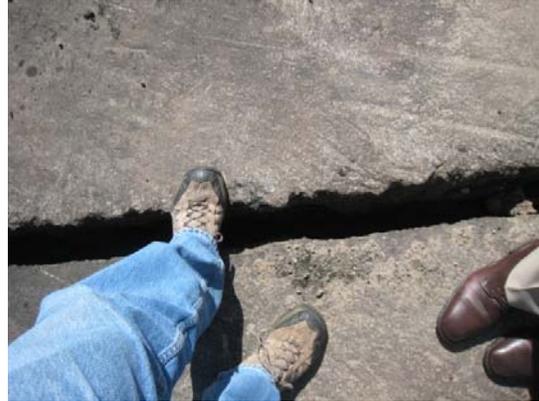
(b) Large crack in concrete wharf deck

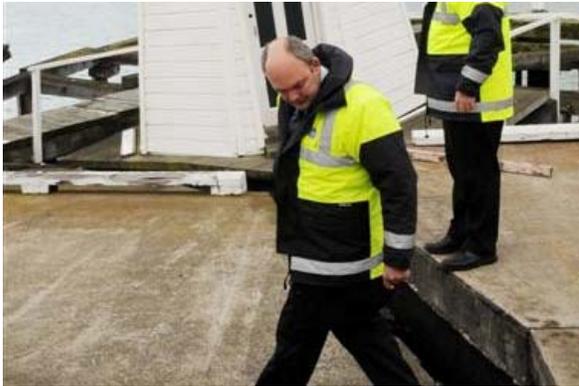
(c) Differential settlement (McNeilly, 2010)

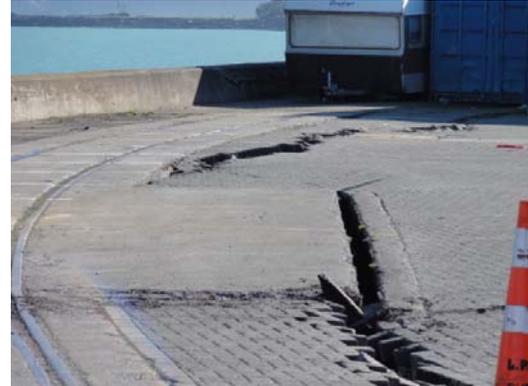
(d) Lateral spreading
