Implications of the 2010 Darfield (Christchurch, NZ) earthquake for Australia – are we ready?

Mike Griffith¹, Jason Ingham², Lisa Moon³

ABSTRACT

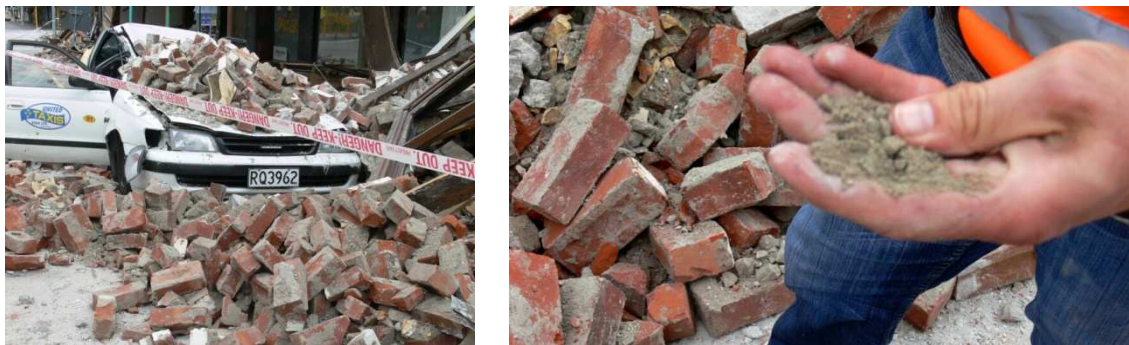
The general observation from the debris of collapsed URM walls was that the kiln fired clay bricks were generally of sound condition, but that the mortar was in poor condition. In most cases the fallen debris had collapsed into individual bricks, rather than as larger chunks of masonry debris and the mortar readily crumbled when subjected to finger pressure (refer Figure 5). However, it appears that superior mortar was often used in the ornate parapet above the centre of the wall facing the street, as this segment of the collapsed parapet often remained intact as it collapsed.

(a) relatively 'clean' bricks

(b) weak mortar crumbles between fingers

Figure 5. Masonry rubble from collapsed wall.

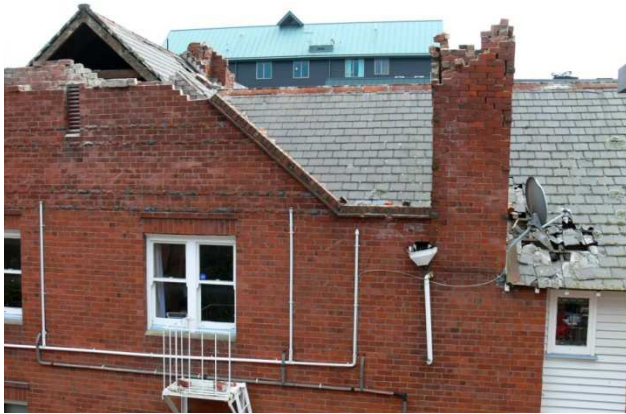
Unsupported or unreinforced brick chimneys performed poorly in the earthquake (Figure 6), with numerous chimney collapses occurring in domestic as well as small commercial buildings and churches. Many examples of badly damaged chimneys that were precariously balanced on rooftops were also seen (Figure 6b) and it was reported that one week after the earthquake, 14,000 insurance claims involving chimney damage had been received, from a total of 50,000 claims (NewstalkZB 2010). Removal of damaged chimneys to minimise further risk placed significant demand on emergency services personnel (Figure 6c). In contrast, Figure 6d shows an example of a braced chimney that performed well.

(a) Two damaged chimneys and gable wall.

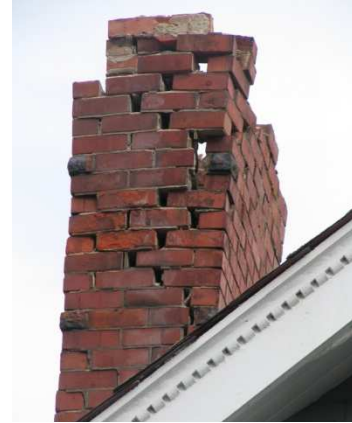
(b) Unstable damaged chimney

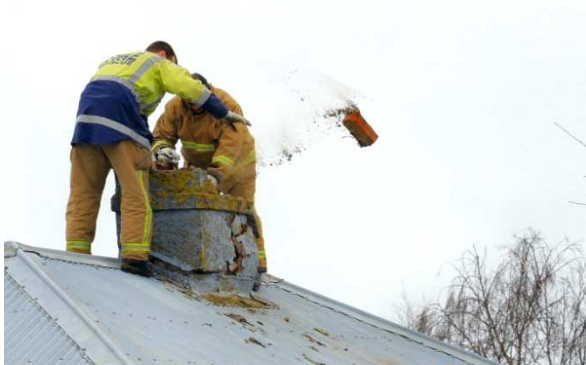
(c) Emergency services remove chimney.

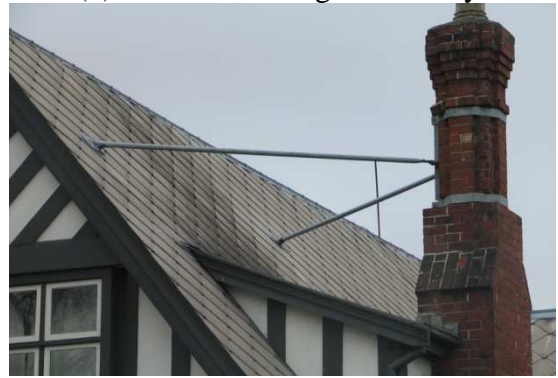
(d) Braced chimney performed well

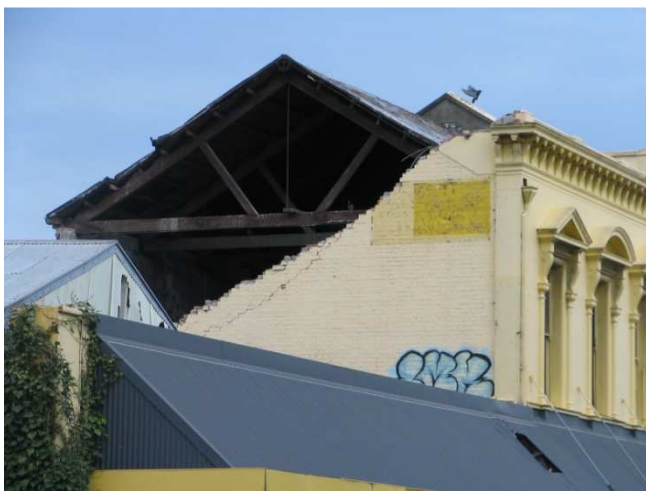
(a) 93 Manchester St

Many gable end failures were observed, often collapsing onto or through the roof of an adjacent building as seen in Figure 7. However, there were also many gable ends that survived; many more than might have been expected, with the majority having some form of visible restraints that tied back to the roof structure. These examples are shown and discussed later (refer Figures 15-17).

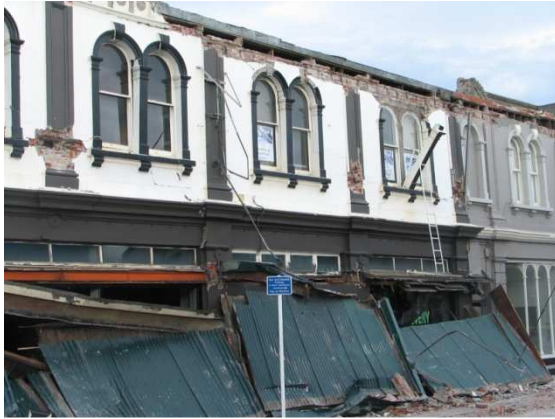
Numerous parapet failures were observed along building frontages and along their side walls, and for several URM buildings located on corners, the parapets collapsed on both perpendicular walls (refer Figure 8). Restraint of URM parapets against lateral loads has routinely been implemented in New Zealand since the 1940s, so whilst it is difficult to see these restraints unless roof access is available, it is believed that the majority of parapets that exhibited no damage in the earthquake were provided with suitable lateral restraint. In several cases, it appears that parapets were braced back to the perpendicular parapet, which proved unsuccessful.

(a) Multiple front wall parapet failures

Falling parapets typically landed on awnings which overloaded the awning tie rods causing collapse (Figure 8). Most awning supports comprised a tension rod tied back into the building through the front wall of the building. In most cases the force on the rod exceeded the capacity of the masonry wall anchorage, causing a punching shear failure in the masonry wall identified by a crater in the masonry (refer Figure 8a).

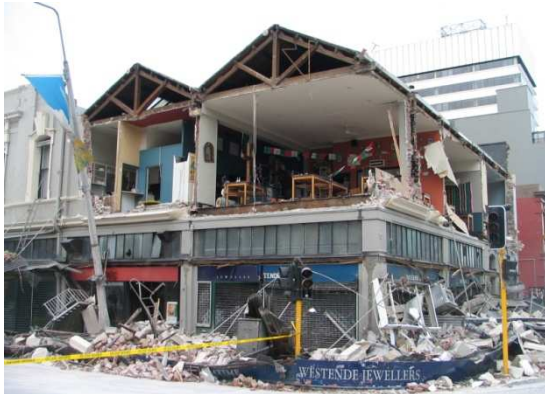
(a) Corner Worcester and Manchester St.

Out-of-plane wall failures were typically the result of poor or no anchorage of the wall to its supporting timber (floor or roof) diaphragm. Several examples of wall failure are shown below. Figure 9(a) shows a corner building that had walls fail in the out-of-plane direction along both directions. Figure 9(b) shows a 3-storey building where walls in the upper two stories suffered out-of-plane failures. In both of these instances, it appears that the walls were not carrying significant vertical gravity loads, other than their self weight, since the remaining roof structures appear to be largely undamaged.

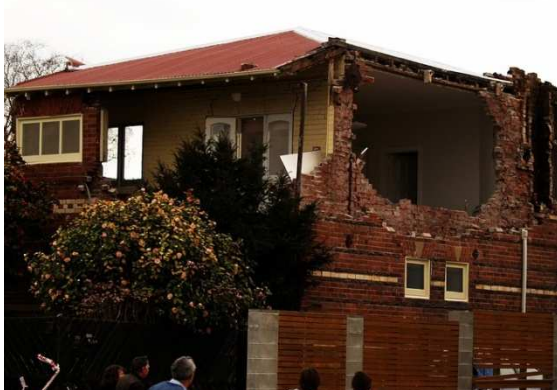
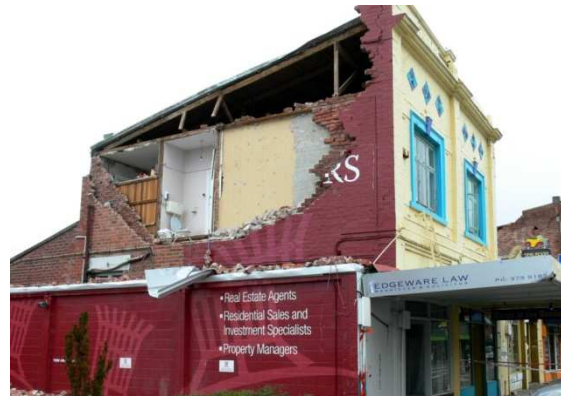
Cavity wall construction is generally believed to be much less common in New Zealand than is solid multi-leaf (or multi-wythe) construction. However, cavity wall construction can be extremely vulnerable to out of plane failure in earthquakes in situations where the cavity ties were poorly installed, or more commonly have corroded over time, as the wall is then comparatively slender and less stable than for solid construction. Figure 10 shows examples of cavity wall buildings that suffered out-of-plane wall failures. In most cases, cavity ties were present but were insufficient to prevent the outer leaf from failing.

Figure 10. Examples of out-of-plane failures in cavity walls.

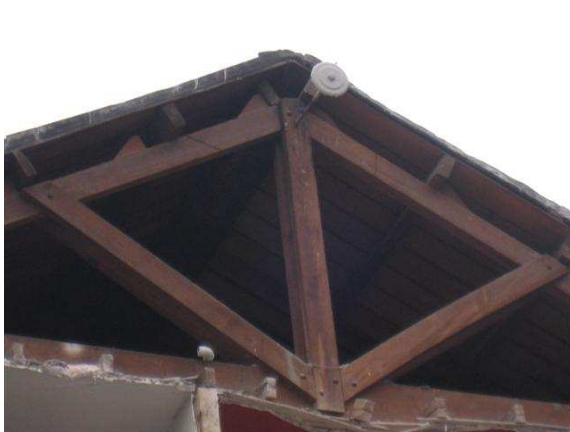
In some cases wall-diaphragm anchors remained visible in the diaphragm after the wall had failed, again indicating that failure had occurred due to bed joint shear in the masonry (refer Figure 11). Figure 11(b) shows a situation where a diaphragm anchor had been embedded within the wall. It can be seen that the anchor successfully prevented the restrained wall from failing, but was not able to prevent toppling of the masonry above the anchor.

(a) Gable wall failure despite anchor

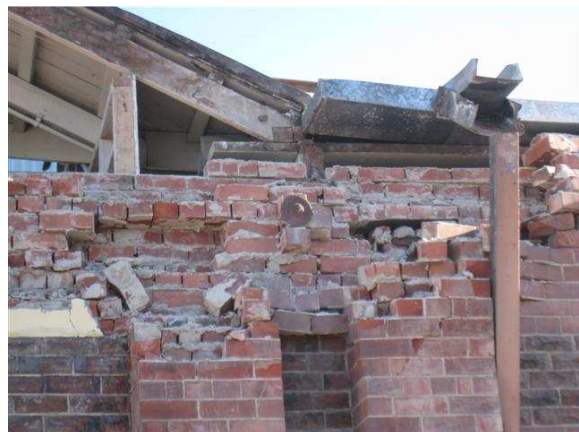
(b) Wall anchor still intact

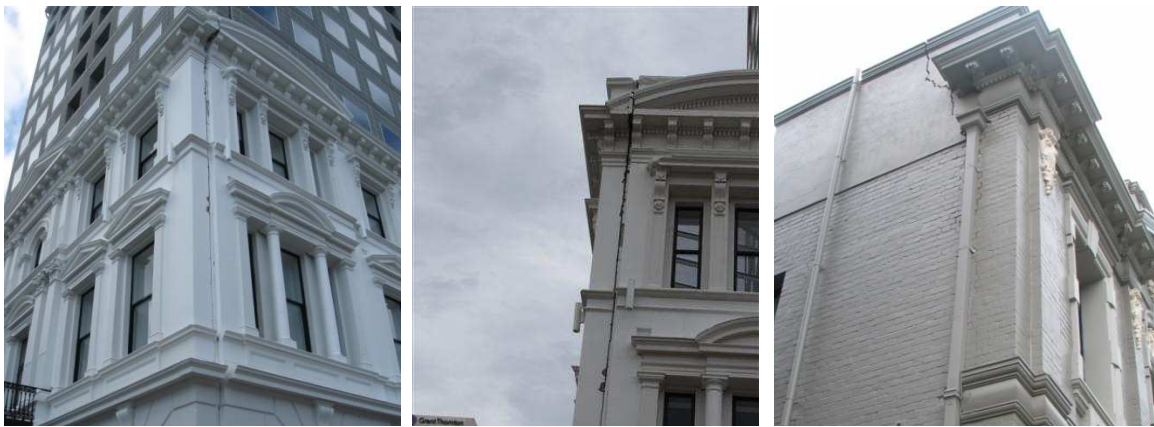
Many buildings exhibited substantial cracking between their front wall and side (return) walls. This damage is not necessarily a catastrophic problem if stiff horizontal diaphragms are well connected to the walls in both directions, but where there is not good diaphragm connectivity, there is the potential for complete out-of-plane collapse of one or both walls. Figure 12 shows some examples where major cracking was observed between the side return walls and the front parapet and wall without collapse.

Figure 12. Examples of wall separation at corners of buildings.

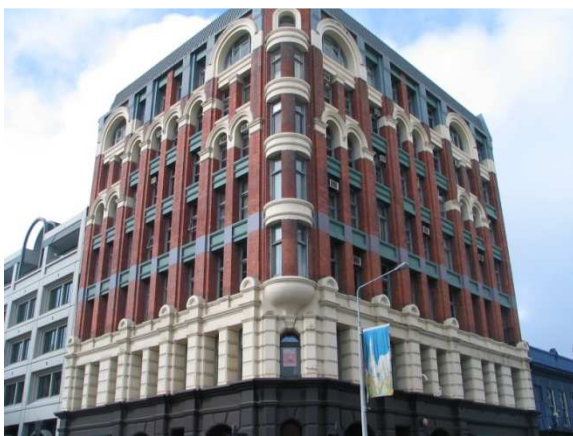
160 Manchester Street is a 7-storey, heritage listed (NZ Historic Places Trust 2010), URM office building that was built in 1905 (Figure 13). The building suffered significant damage to its masonry piers at levels 3 and 4. After much debate, the city council gave approval to demolish the building as it poses a significant falling hazard to the dozen or so businesses and buildings within the 70 m radius ‘fall zone’.

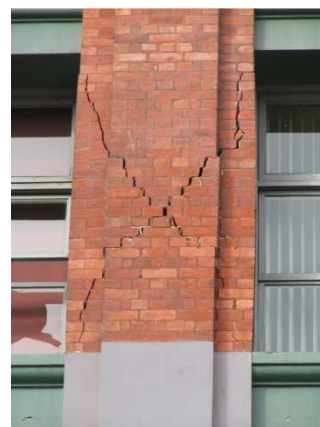
(b) North wall pier, level 3.

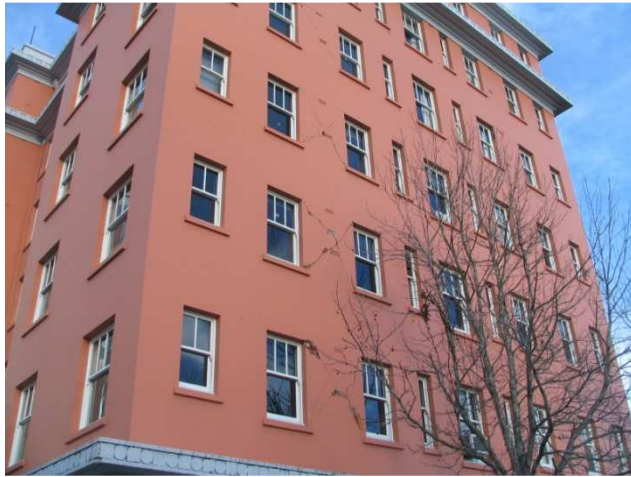
St Elmo Chambers is also a 7-storey building, reported to be a reinforced concrete frame building with external clay brick masonry piers. Owing to the absence of control joints between the masonry and concrete frame, the masonry piers attracted sufficient seismic in-plane forces to cause shear failure (refer Figure 14). Judging by the extent of cracking in the brickwork, it appears that the storey drifts were less than 1%, implying that the concrete frame was not pushed to its maximum capacity (strength or drift).

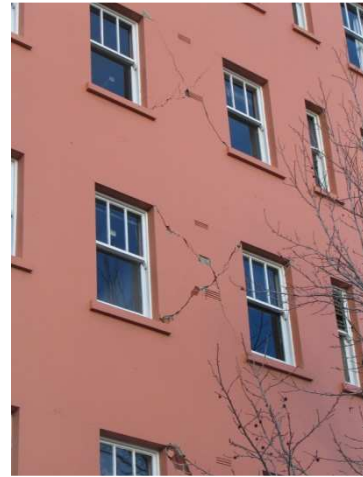
(b) damaged brickwork

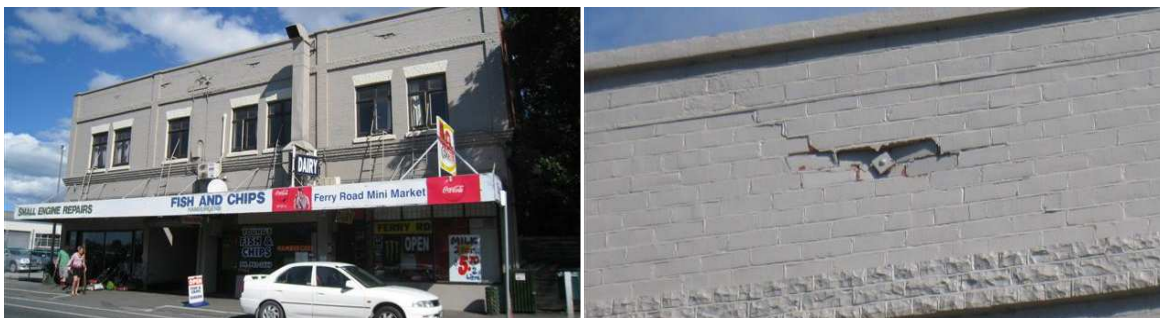
Another interesting feature of this earthquake is the observation of walls that only partly failed, allowing for identification of the specific failure mode at its onset. An excellent example is a 2-storey URM building on Ferry Road (see Figure 17) where the front, street facing, wall of the building had started to fail out-of-plane despite the presence of wall-roof diaphragm anchors. As shown, the anchors were on the verge of pulling through the masonry wall. Internal inspection of the building revealed that the front wall had separated from the long side walls of the building and moved approximately 50 mm towards the road with respect to the ceiling/roof diaphragm.

(b) Detail of partial anchorage failure
