PERFORMANCE OF MASONRY BUILDINGS DURING THE 2010 DARFIELD (NEW ZEALAND) EARTHQUAKE

Abstract

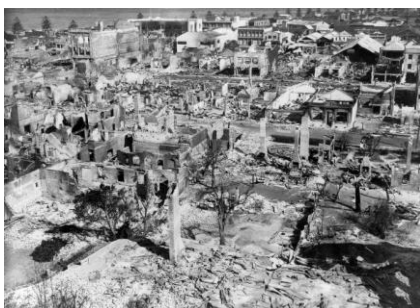
- The M7.8 1931 Hawke's Bay (New Zealand) earthquake caused widespread devastation to URM buildings in the city of Napier (see Figs 2a and 2b), with 256 fatalities. This earthquake remains the worst disaster of any type to occur on New Zealand soil [Dowrick 1998].

(a) The buildings destroyed by the 1931 earthquake and fires [Alexander Turnbull Library]

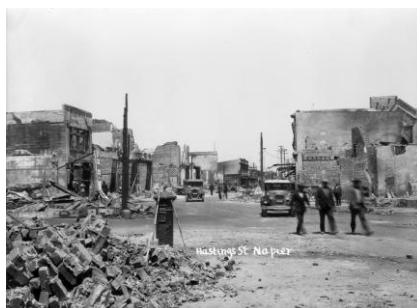
(b) Hastings Street, Napier after the 1931 earthquake [Alexander Turnbull Library]

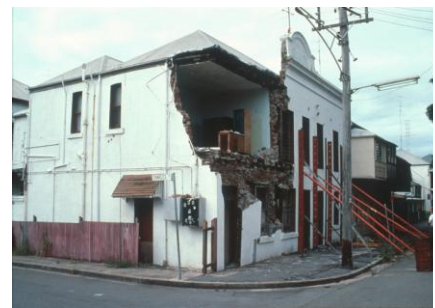
(c) Out-of-plane wall failure in the 1989 Newcastle earthquake

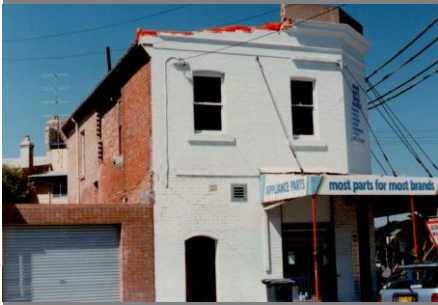
(d) Parapet and cavity wall damage in the 1989 Newcastle earthquake

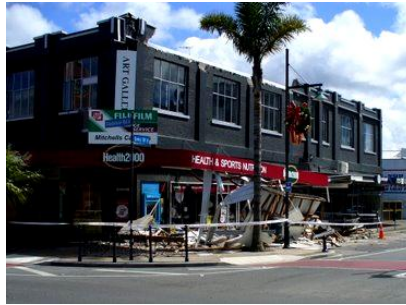
(e) Topped parapet in the 2007 Gisborne earthquake

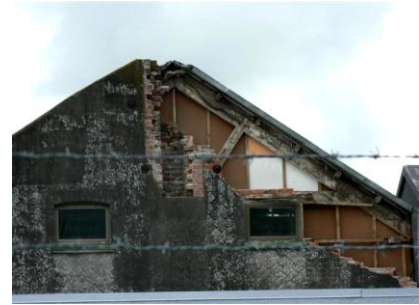
(f) Out-of-plane failure of a gable wall in the 2007 Gisborne earthquake

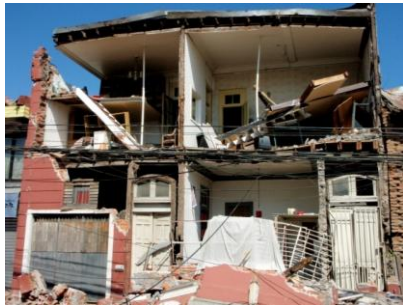
- The M8.8 2010 Maule (Chile) earthquake caused extensive damage to older houses, churches and other buildings constructed of unreinforced masonry or adobe, as shown in Figs 2g and 2h [EERI 2010].

(g) 1940's URM house, Maipú Street, Concepción, Chile

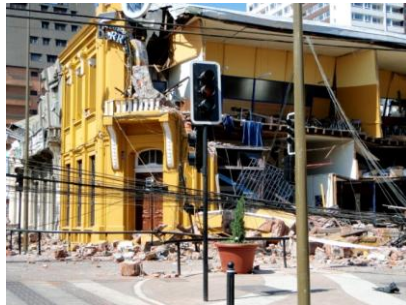
(h) Barros Arana Institute, Concepción, Chile

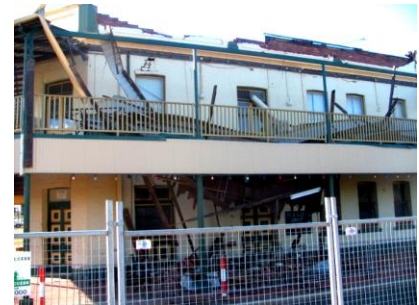
(i) Damage to parapet and awning in Kalgoorlie-boulder

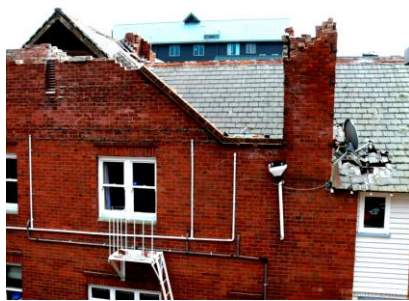
Unsupported or unreinforced brick chimneys performed poorly in the earthquake (Figure 5(a)), with numerous chimney collapses occurring and many examples of badly damaged

(a) Damaged chimneys

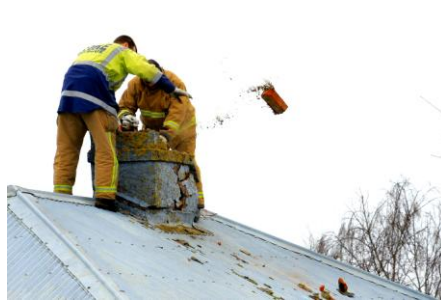
chimneys. It was reported that one week after the earthquake, 14,000 insurance claims involving chimney damage had been received, from a total of 50,000 claims [NewstalkZB 2010]. The damaged chimneys pose a 'falling hazard' and were rapidly removed or restrained by emergency services personnel (see Figure 5(b)). In contrast, Figure 5(c) shows an example of a braced chimney that performed well.

(b) Chimney removal

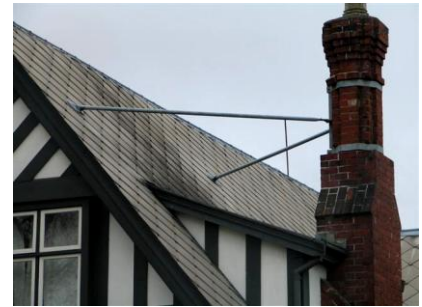
(c) Braced chimney

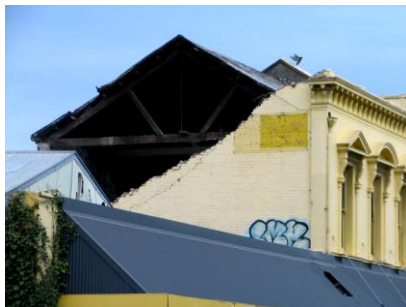
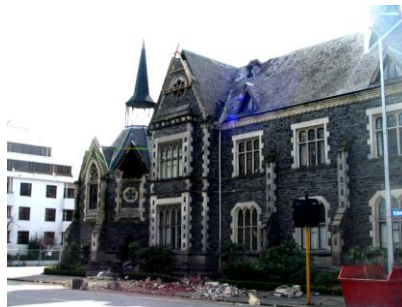
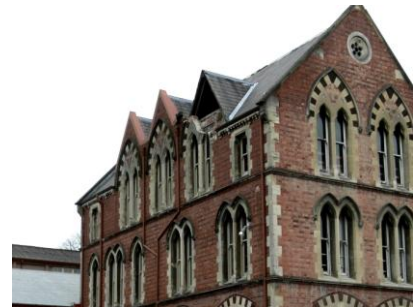
Many gable end failures were observed, often collapsing onto or through the roof of an adjacent building (refer Figure 6). However, there were also many gable ends that survived, with the majority having some form of visible restraints that tied back to the roof structure.

Figure 6. Examples of gable end wall failures

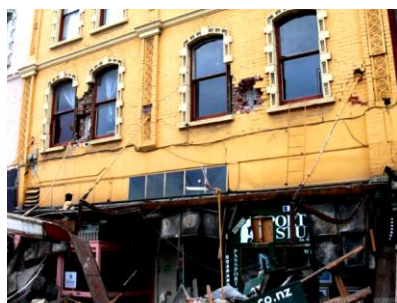
Numerous parapet failures were observed along both the building frontage and along their side walls, and for several URM buildings located on the corners of intersections, the parapets collapsed on both perpendicular walls (refer Figure 7). Awnings were typically supported using a tension rod tied back into the building front wall. Falling parapets typically landed on awnings, resulting in an overloading of the braces that supported these awnings and causing a punching shear failure in the masonry wall, identified by a crater (refer Figure 7(a)). Restraint of URM parapets against lateral loads has routinely been implemented since the 1940s, so whilst it is difficult to see these restraints unless roof access is available, it is believed that the majority of parapets that exhibited no damage in the earthquake were

(a) Awning failure

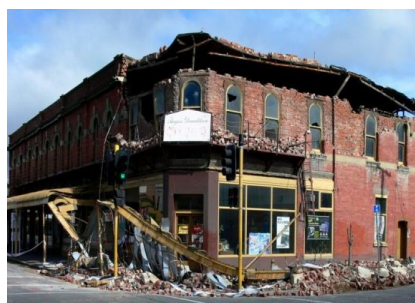
(b) Extensive parapet failure

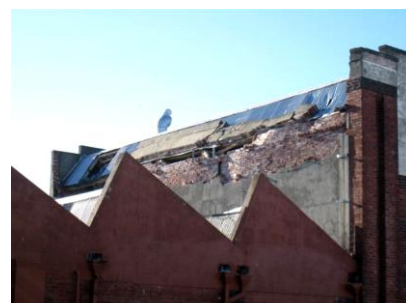
(c) Collapse onto roof

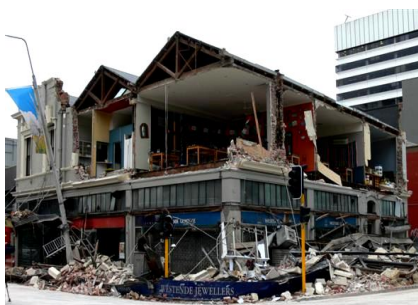
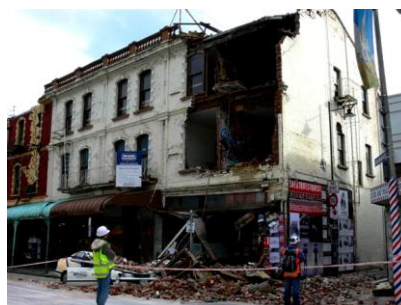
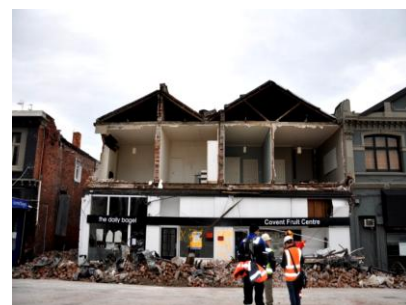
Out-of-plane failure was observed in numerous buildings and was attributed to poor or no anchorage of the wall to its supporting timber diaphragm. In the three instances shown in Figures 8(a), 8(b), and 8(c), it appears that the walls were not carrying significant vertical gravity loads, other than their self weight, due to the fact that the remaining roof structures appear to be primarily undamaged. In contrast, Figure 8(d) shows an out-of-plane failure of a side wall which was supporting the roof trusses prior to failure.

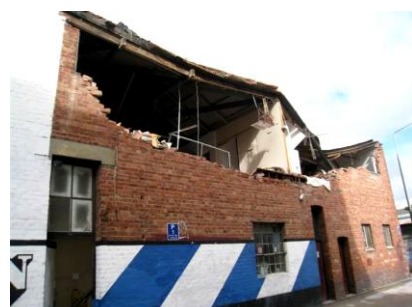
(d) Load bearing wall failure

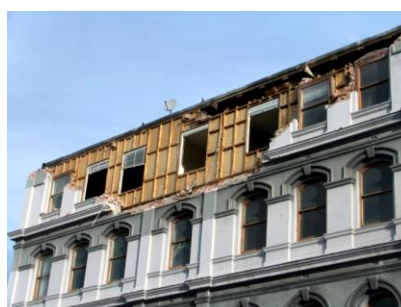
(e) 140 Lichfield Street

Several examples of face load wall failure (see Figure 8(e)) closely resembled observed damage (see Figure 8(f)) in dry stack masonry experiments [Restrepo-Velez and Magenes 2009], providing further support to the supposition that many of the wall failures were partly attributable to poor mortar strength. Cavity wall construction is generally believed to be much less common in New Zealand than is solid multi-leaf (or multi-wythe) construction. However, cavity wall construction can be extremely vulnerable to out-of-plane failure in earthquakes, particularly in situations where the cavity ties were poorly installed, or more commonly have corroded over time, as the wall is then comparatively slender and less stable than for solid construction. Figures 9(a) and (b) show examples of cavity wall buildings that suffered out-of-plane wall failures. Figure 9(c) shows that cavity ties were present but were insufficient to prevent the outer leaf from failing.

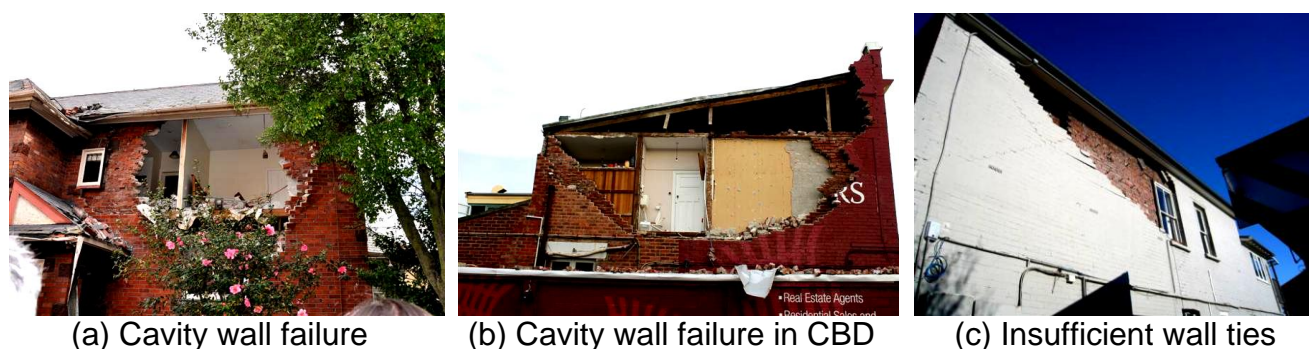
Figure 9. Examples of typical out-of-plane cavity wall failures

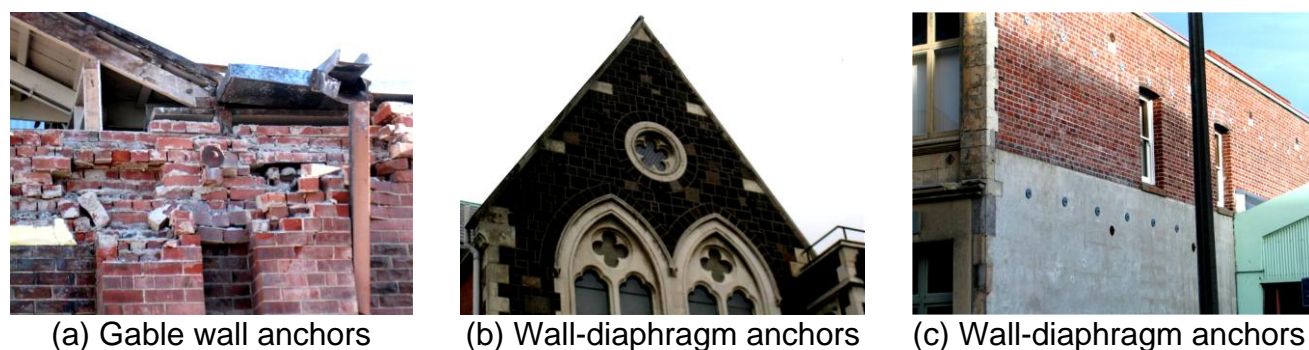
A typical wall-to-diaphragm (roof or floor) anchor typically consists of a long 20 mm bolt with a large circular disk of about 150-200 mm diameter between the wall exterior and nut that clamped the disk to the wall. In some cases wall-diaphragm anchors remained visible in the diaphragm after the wall had failed (refer Figure 10(a)), again indicating that failure had occurred due to bed joint shear in the masonry. It was observed in some buildings that the anchor successfully prevented the restrained wall from failing, but was not able to prevent toppling of the parapet that was located above the anchor. A significant feature of the earthquake was the number of occasions where anchored walls performed well during the earthquake (see Figure 10 (b) and (c)).

Figure 10. Examples of insufficient and successful anchors

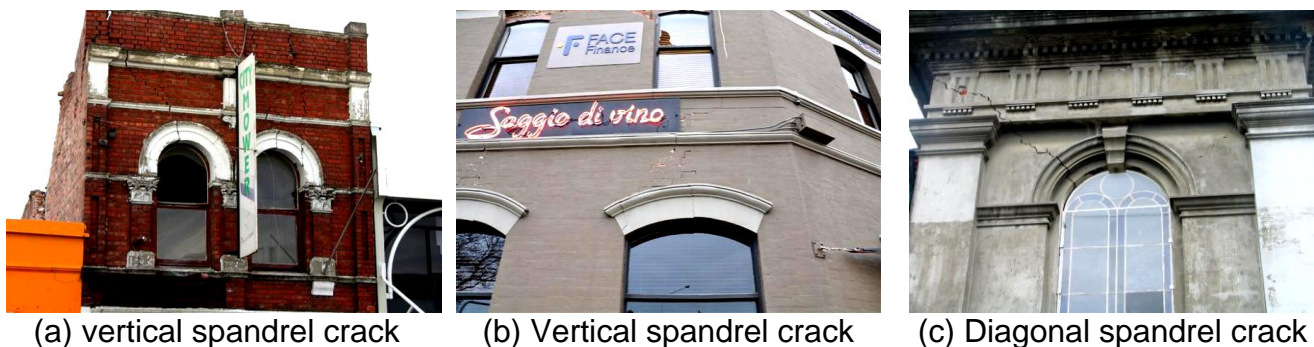
Where walls exhibited some damage to in-plane deformation the cracks were mostly seen to pass vertically through the lintels over door or window openings (refer Figure 11). In some cases, diagonal shear cracks in piers (refer Figure 12(a)) were also observed and were attributed to the relative geometric characteristics of the pier to the spandrels of the wall. Figures 12(b) shows a 7-storey office building that is reported to consist of load bearing masonry and is the most significant masonry building, at least in terms of height, in Christchurch. The bottom two stories are reported to be reinforced concrete while the top five stories are reported to have load bearing unreinforced masonry piers around the exterior of the building and a steel frame internally (columns spaced roughly at 5 m) with timber floors throughout [NZHPT 2010]. The masonry piers, having dimensions of approximately 1200 x 900 mm, were badly cracked at levels 3 and 4. Further inspection by the assessment team exposed the internal face of one pier on the western face of the building to reveal that the external cracking continued through the entire pier thickness. After considerable community discussion, including recognition that surrounding buildings were required to remain vacated due to the potential for building collapse, it was decided that the building would be demolished. St Elmo Chambers is also a 7-storey building, reported to be a reinforced concrete frame building with external clay brick masonry piers. Owing to the absence of control joints between the masonry and concrete frame, X shape cracks suggest that the piers failed in diagonal shear (refer Figure 12(c)).

Figure 11. Examples of in-plane wall damage above window openings

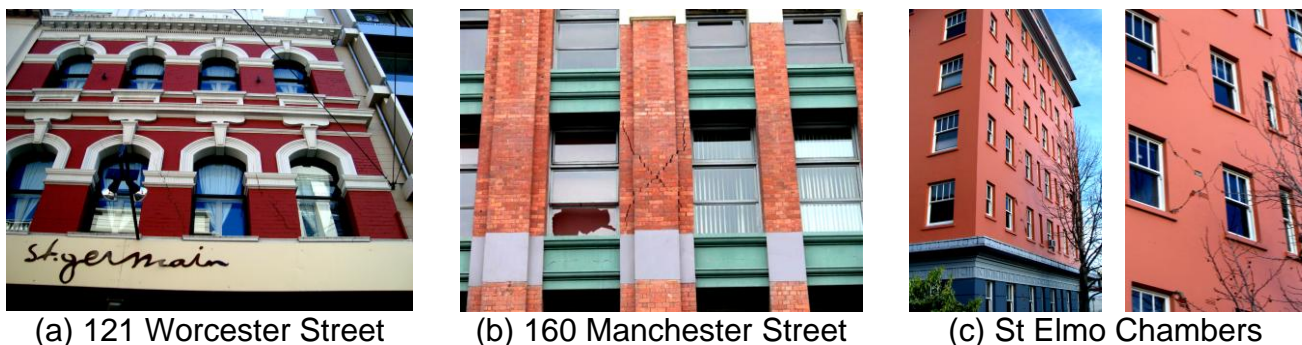
Figure 12. Examples of piers damaged with in-plane shear cracking

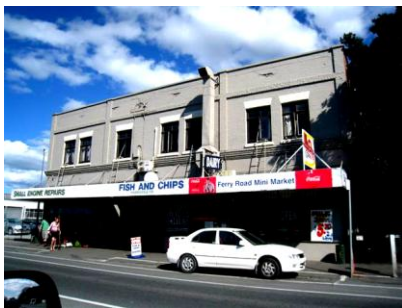
Another interesting feature of this earthquake is the observation of walls that only partly failed, allowing for identification of the specific failure mode at its onset. The first example is a 2-storey URM building on Ferry Road (see Figure 13) where the front facade of the building had started to fail out-of-plane despite the presence of wall-roof diaphragm anchors. As is shown, the anchors were on the verge of pulling through the masonry wall. Internal inspection of the building revealed that the front wall had separated from the long side walls of the building and moved approximately 50 mm towards the road with respect to the ceiling/roof diaphragm (Figure 13(c)).

(a) Building overview

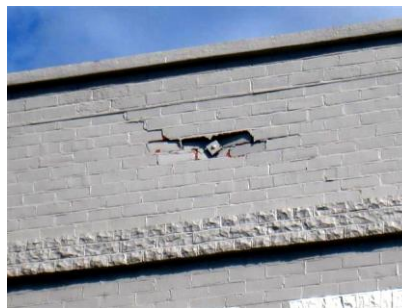
(b) Partial anchorage failure

It is believed that due to the nature of strength degradation of the brickwork at the onset of a punching shear failure, the anchorage had effectively failed and offered little residual resistance against further shaking. The only reason for why the wall did not completely collapse is probably due to the earthquake not imposing sufficient displacement on the wall after the anchorage failure. A similar style of partial failure was observed in another building (refer Figure 14(a)) but the building was observed externally only. An example of a gable end partial failure is shown in Figure 14(b). There were frequent examples of wall-diaphragm anchors that had deformed plastically or alternatively were inadequately fixed (refer Figure 14(c) where a circular plate can be seen to be slack due to plastic stretching of the anchor rod).

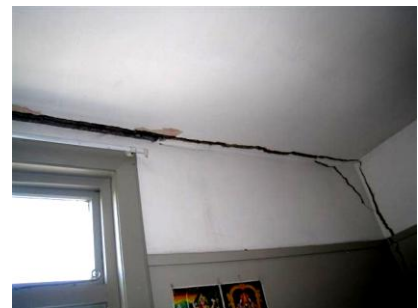
(c) Separation of wall

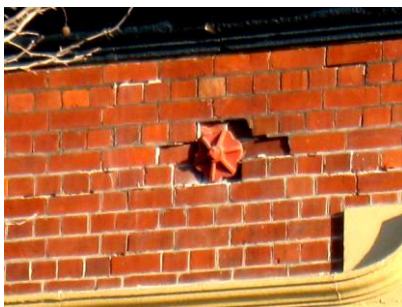
(a) Anchor failure

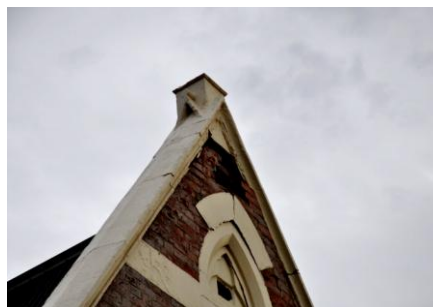
(b) Gable anchor failed

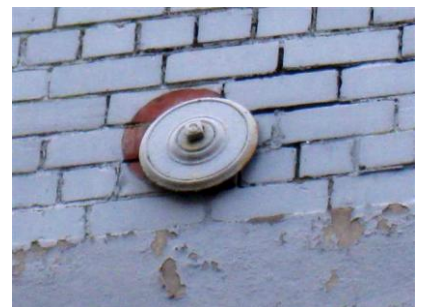
(c) Yielded anchor

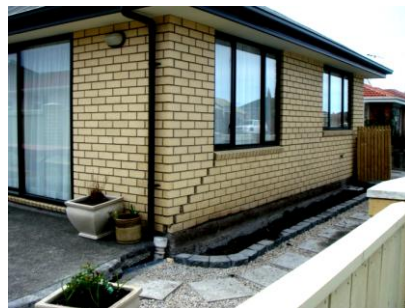
As shown in Figure 16, several cases of extreme ground deformation were observed, and there were numerous cases where large crack widths formed in residential timber framed structures having a masonry veneer (Figure 16(b)). There were also cases where ground liquefaction had resulted in masonry structures having sunk into the ground (Figure 16(c)).

(b) Veneer damage

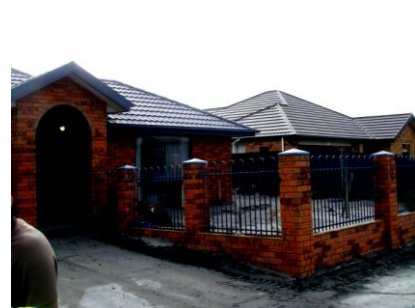
(c) Liquefaction
