Interferometric Synthetic Aperture Radar (InSAR) and field-based observations of rainfall-triggered landslides from the November 2021 storm, Gisborne/Tairāwhiti, New Zealand

Matt Cook¹ | Martin Brook¹ | Murry Cave²

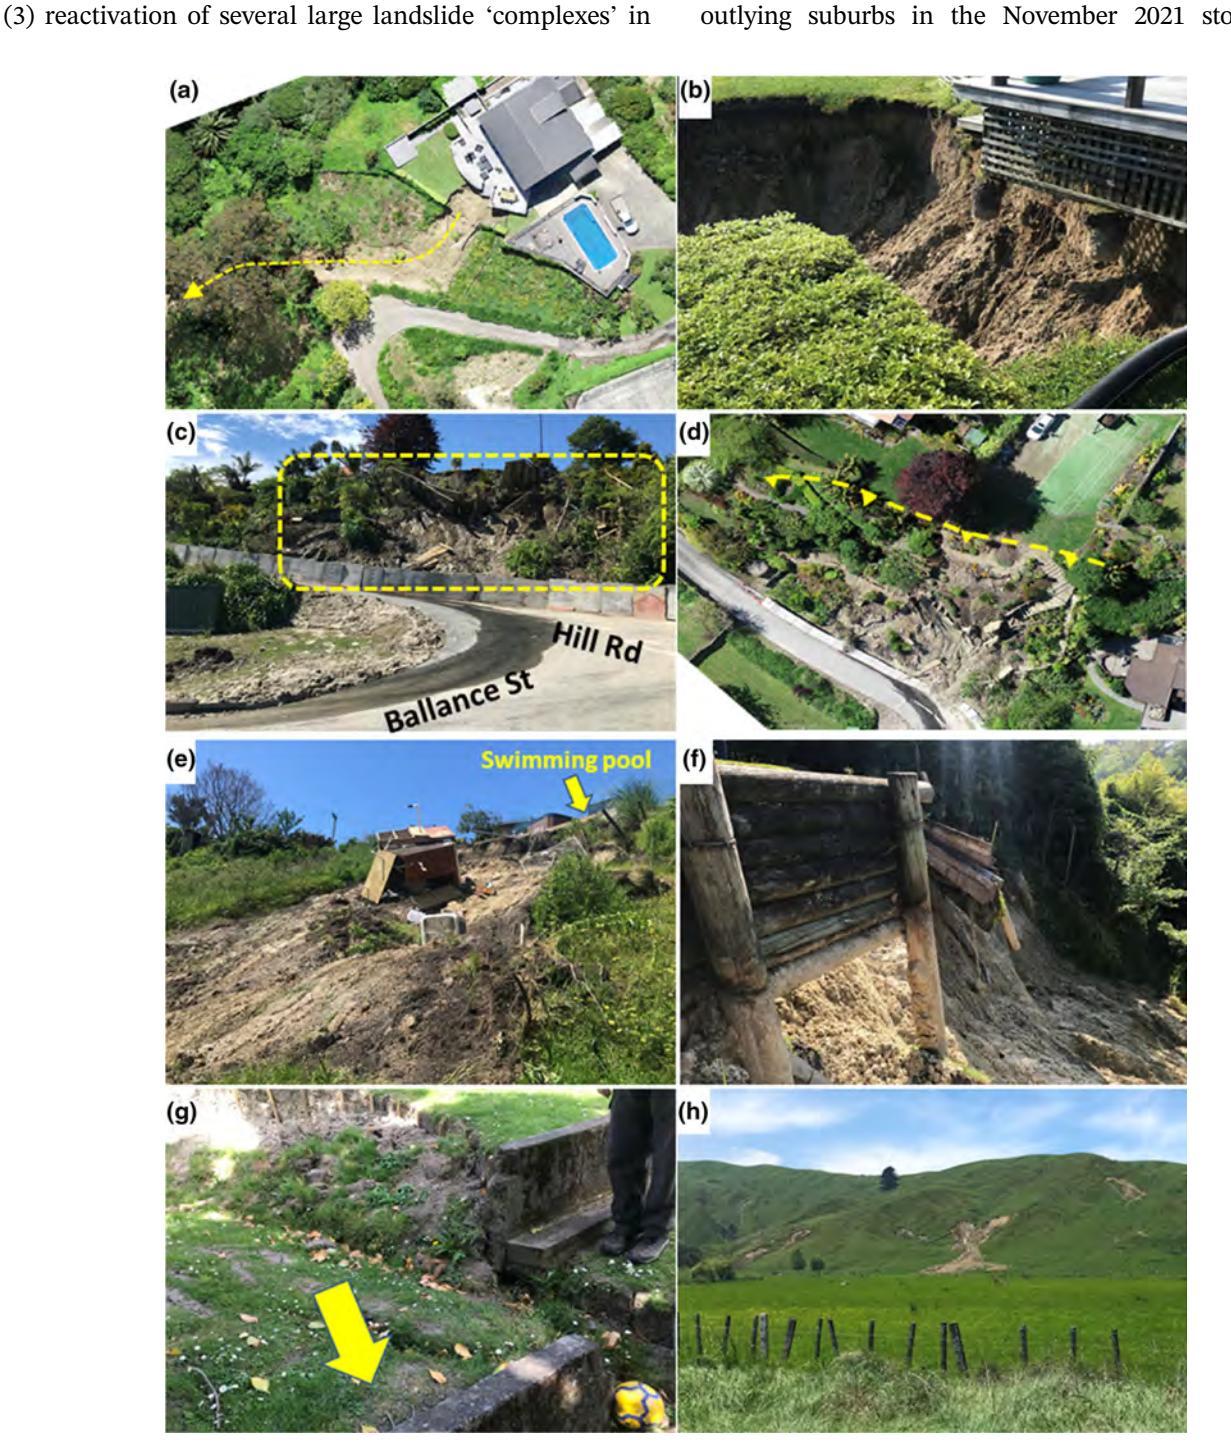
FIGURE 3 (a and b) Slump-flow at Clifford Street undermining deck, tilting swimming pool; (c and d) Ballance Street fill/retaining wall failure, where cantilever embedded pole retaining wall has rotated; (e) Gaddum's Hill Road earthflow downslope towards 17 Darwin Road; (f) retaining wall failure at Owen Road above Waimata River; (g) scarplet and offset retaining wall from low angle slump at Argyll Street; (h) shallow earthflows at Wheatstone Road.

| L# | Location | Landslide characteristics | $A_{ m s}^{~\circ}$ | L m |
|---|---|---|---|---|
| L6 | Clifford St | Significant landslide undermined deck at 371; stormwater discharge onto unstable slope & weight of swimming pool on edge of steep face contributed; s124 notice; debris & threat to 395 Clifford | 36 | 70 |
| L7 | Hill Rd | Major landslide; large unconsented retaining wall and fill with poor drainage controls failed; blocked Hill Rd isolating occupant requiring urgent medical treatment; runout onto Ballance St | 40 | 70 |

A remarkable landslide occurred at the intersection of Hill Road and Ballance Street (Figure 3c,d). This was a fill failure, where the natural land surface had been extended southwest to accommodate a tennis court and floodlights, as 'made ground'. This was composed of locally-sourced soil as the fill, which was retained via a retaining wall consisting of embedded timber poles, with timber planks as the 'lagging'. The earthflow extended ~40 m down Ballance Street, across the road and grass verge. At the Darwin Road slump-earthflow, a swimming pool was also present immediately adjacent to the headscarp (Figure 3e). This landslide exhibited high mobility, extending >120 m downslope into a property on Darwin Road, below. Embedded timber poles in the retaining wall were exposed at Owen Road, where the riverbank below the property was under-cut, and slumped, and the retaining wall failed (Figure 3f).

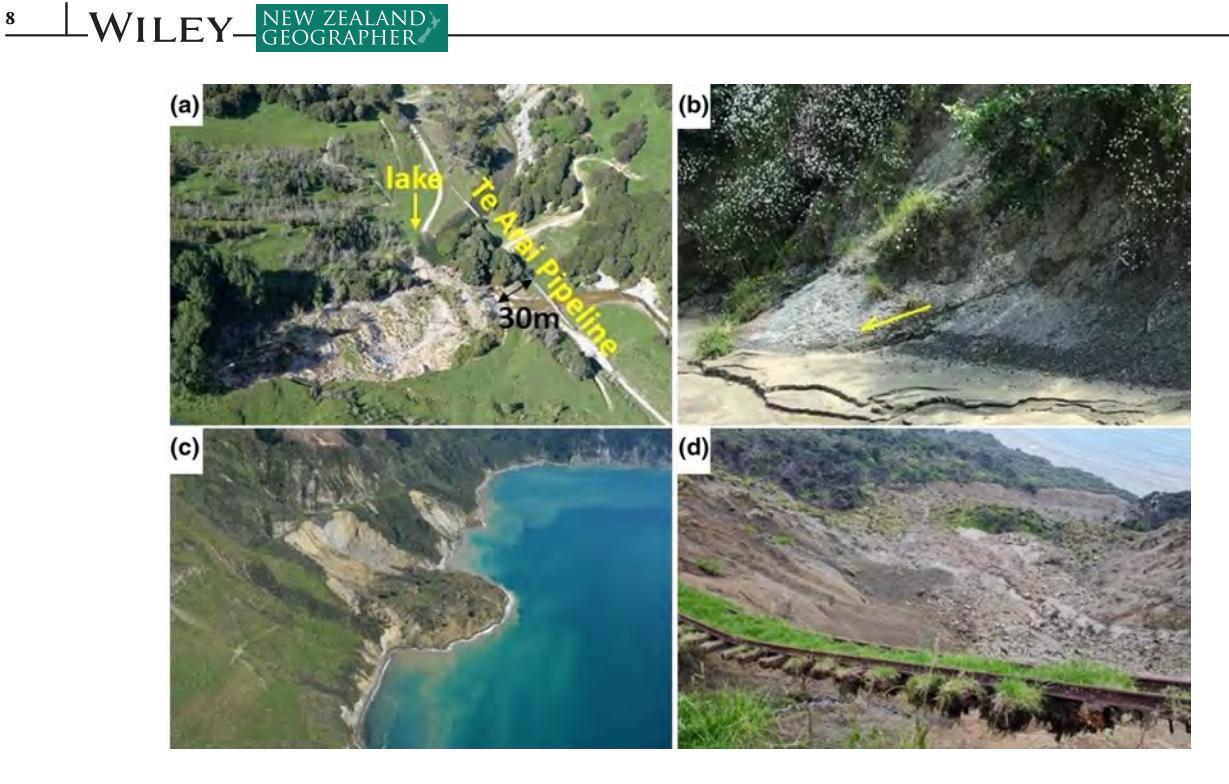
In contrast to the above earthflows, examples of large volume landslide 'complexes' are shown in Figure 4. The \sim 0.17 km² Te Arai landslide, 24 km southwest of Gisborne is a large earthflow 'complex', and is \sim 700 m long and has an overall gradient of 18°. Failure is possibly facilitated by bedding planes in the underlying Tolaga Group mudstones (Figure 4b). In November 2021, the landslide terminated 30 m from the Te Arai water pipeline, which transfers the majority Gisborne's city water supply from Mangapoike Dams to the Waingake Water Treatment Plant. Unfortunately, subsequently during Cyclone Gabrielle in February 2023, the Te Arai pipeline was severely damaged by multiple landslide reactivation and associated mobilisation of large woody debris from adjacent forests, cutting off the majority of Gisborne's water supply (Sharma, 2023). The November 2021 storm also triggered large volume coastal landslides

FIGURE 4 Large volume, rural landslide examples: (a) Te Arai landslide complex that reactivated and extended to ~30 from the Te Arai water pipeline, damming the Waingake/Te Arai River, forming a lake; (b) unfavourable mudstone bedding dip exposed near toe; (c) Whareongonga Landslide including (d) view from headscarp and undercut Wairoa-Gisborne railway line.

in the Tolaga Group sediments, and the Whareongaonga Landslide is one example (Figure 4c,d), \sim 30 km south of Gisborne. The landslide destroyed culturally important pā and fishing ground for Ngāi Tāmanuhiri. Rosser and Wolter (2022) reported 1.3 million m³ of soil and rock was displaced by the November 2021 event, with runout below the intertidal zone. The landslide also undercut the Wairoa Gisborne railway line (Figure 4d).

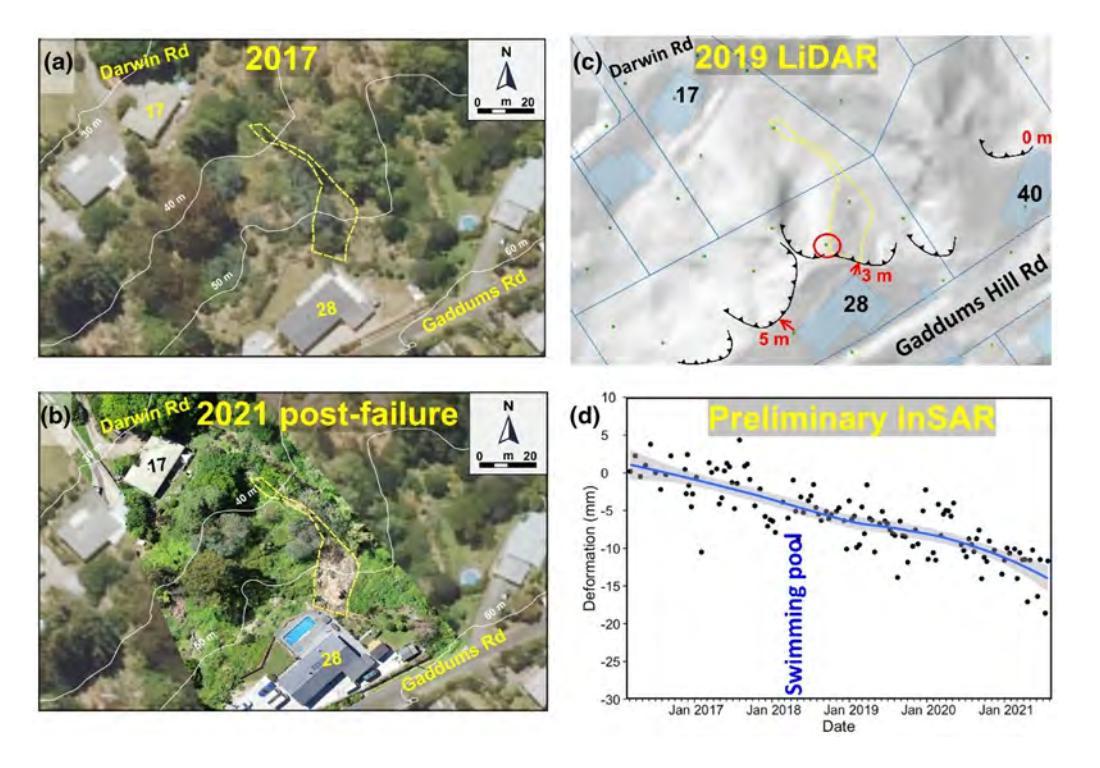
| L# | Location | Landslide characteristics | $A_{ m s}^{~\circ}$ | L m |
|---|---|---|---|---|
| L16 | Gaddums Hill Rd/ Darwin Rd | Major slip at 28 Gaddums Hill; swimming pool at edge of steep slope contributing factor (0.3 m setback); debris and threat to 17 Darwin Rd below; minimal setback | 32 | 65 |

An example is at Gaddums Hill Road (Figure 8). Indeed, the 2019 LiDAR digital elevation model reveals that several landslide headscarps are present along the northfacing ridgeline (Figure 8c). Below these landslide source areas, undulating topography on the slope is indicative of landslide debris. The InSAR data trendline (Figure 8d) shows that the slope velocity prior to swimming pool installation was at a rate of \sim 2–3 mm/year, and this rate continued until around early 2021. Since then, the slope appeared to show a very slight increase in velocity. In November 2021, the landslide (#16) initiated via rotational slumping adjacent to a swimming pool (installed early 2018), and transitioned in a mobile channelised earthflow, extending downslope onto the 17 Darwin Road property (Figure 8b). So, the November 2021 landslide (yellow hash in Figure 8c) was actually the reactivation of existing landsliding at the site. Thus, the Sentinel-1 InSAR is also useful in monitoring slope velocity in areas of existing landslides within urban Gisborne, that are vulnerable to reactivation.

FIGURE 8 Slump-earthflow at Gaddums Hill Road, which flowed downslope from north end of swimming pool towards 17 Darwin Road (landslide #16, Table 1): (a) pre-failure imagery from 2017; (b) post-failure imagery from 2021; (c) 2019 pre-failure LiDAR showing existing landslide headscarp areas (black lines) and InSAR target (dot inside red circle); (d) 2016–2021 InSAR LOS displacement showing gradual downslope movement, with slight increase through 2021. Blue line is the 7-day rolling mean and grey shading is the 95% confidence interval.
