12th Canadian Masonry Symposium, Vancouver, British Columbia, Canada, 02 Jun 2013 - 05 Jun 2013. Editors: Anderson D, Brzev S. Proceedings of the 12th Canadian Masonry Symposium. Canadian Masonry Symposium. 02 Jun 2013
Retrieved from <http://cms2013.ca/index.php/cms/2013/index>

IMPLICATIONS OF THE CANTERBURY EARTHQUAKE SEQUENCE FOR ADELAIDE, SOUTH AUSTRALIA

M. Griffith¹, L. Moon², J. Ingham³ and H. Derakhshan⁴

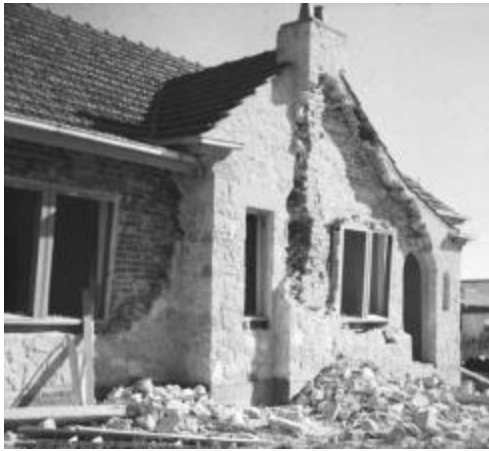
a

Figure 1: Representative examples of damage to URM buildings in past New Zealand and Australian earthquakes: a) Damage to stone veneer house in the 1954 Adelaide Earthquake [2]; b) Out-of-plane wall failure in the 1989 Newcastle earthquake; c) Toppled parapet in the 2007 Gisborne earthquake; d) Toppled parapet in Boulder after the 2010 Kalgoorlie-Boulder earthquake

- The M5.4 1954 Adelaide (Australia) earthquake caused damage to an estimated 3,000 buildings and involved 30,000 insurance claims totalling 70 AUD million in today's value [1]. The damage was mainly confined to URM chimney damage and partial wall failures near the epicentre [2] (see Figure 1(a)).

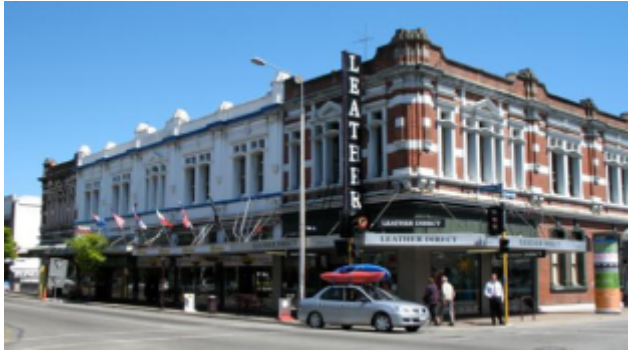
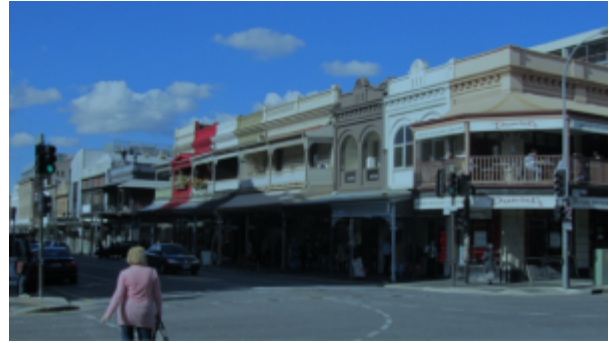
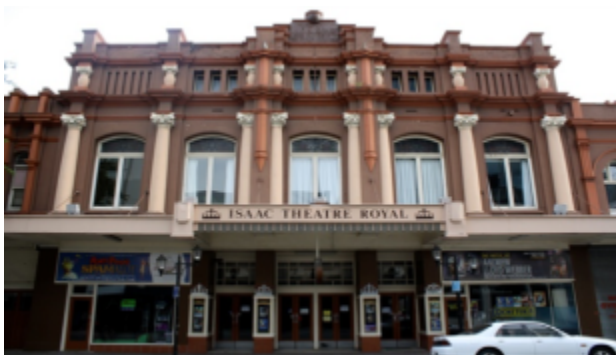
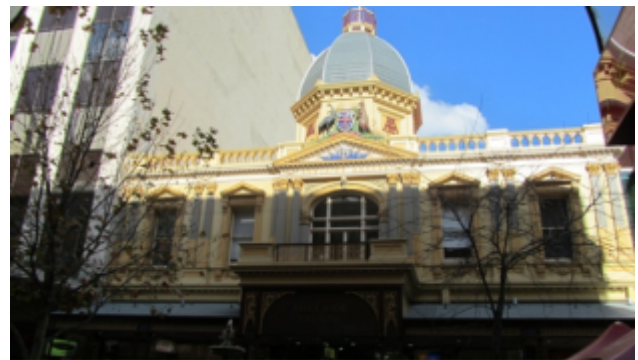
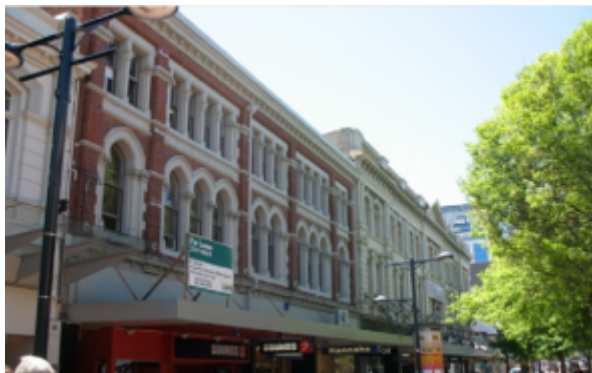
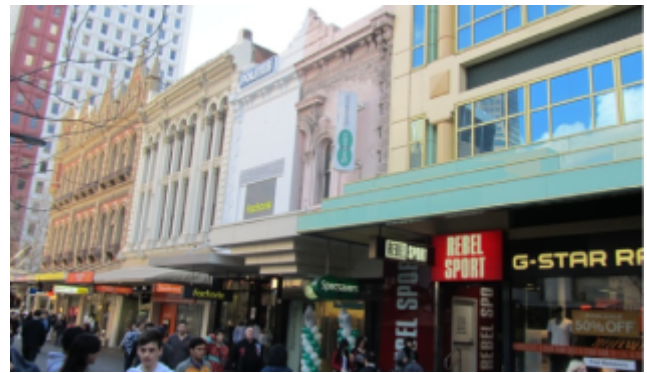
Figure 2: Representative examples URM buildings in Christchurch and Adelaide: a) Corner shops in Christchurch; b) Corner shops in Adelaide; c) Christchurch Theatre; d) Adelaide Arcade; e) Christchurch Mall; f) Adelaide Mall; g) Christchurch Cathedral; h) Bonython Hall, University of Adelaide

Figure 2 shows several examples of the similarities between the existing construction form in Adelaide City and that of Christchurch city before the 2010 Canterbury earthquake.
