# DIAGONAL TENSION STRENGTH OF VINTAGE UNREINFORCED CLAY BRICK MASONRY WALL PANELS

Dizhur D. and Ingham J.M.

An experimental program was implemented where wall panels were obtained from two existing vintage unreinforced clay brick masonry (URM) buildings and subjected to a diagonal compression loading condition in order to induce a diagonal tension failure mode. The principal aims of the experimental program were to establish the diagonal tension strength of the vintage clay brick URM walls present in the two buildings and to establish a benchmark mortar mix suitable for use when manufacturing replica clay brick test assemblages that adequately represent the strength characteristics present in vintage URM buildings. It was concluded that the use of recycled clay bricks acquired from vintage URM buildings and a mortar mix of 1:2:9 (cement:lime:sand) appropriately replicates the material strength characteristics that are present in existing vintage clay brick URM buildings located in New Zealand.

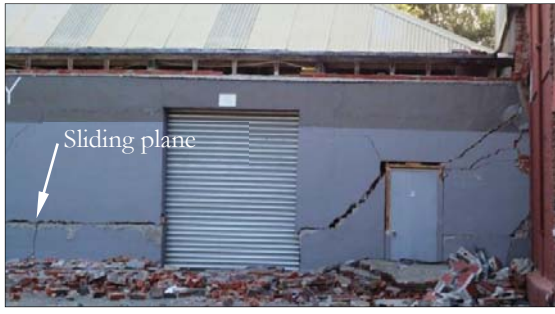
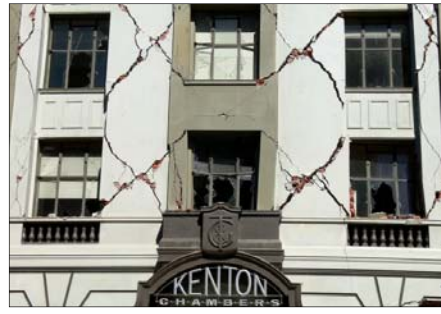
(a) Sliding of a low aspect ratio pier

(b) Failure of piers in diagonal tension

**Figure 1:** Examples of sliding and diagonal tension failure following the February 2011 M6.3 Christchurch earthquake

The in-plane failure modes of URM walls may be categorised as either flexural or shear controlled [7]. The flexural mode of failure is characterised by rocking with associated masonry crushing, while the shear failure mode of URM wall components is identified by two main mechanisms: horizontal bed joint sliding and diagonal shear (tension) cracking [7]. Depending on the ratio of mortar strength to brick strength, diagonal tension cracking may result in diagonally inclined cracks through the brick units or may follow a diagonally inclined stepped pattern through the mortar bed and head joints. The latter is due to the formation of tensile horizontal cracks in the bed joints which can potentially become sliding planes when subjected to reverse earthquake loading. During earthquake shaking, sliding (see Figure 1a) and rocking failure modes may allow URM wall components to exhibit considerable displacement capacity, whereas diagonal tension cracking (see Figure 1b) is typically considered as a brittle failure mode where the initiation of visible diagonal cracking is associated with the peak lateral force capacity, followed by rapid strength degradation. Hence, the diagonal tension strength of URM wall components that are subjected to in-plane loads is a paramount strength parameter that is required for assessing the seismic performance of URM buildings, with invasive in-situ testing of existing URM wall components being a preferred method to establish these diagonal tension strength characteristics accurately. However, the feasibility of in-situ testing is limited due to the highly destructive nature, high cost, and prolonged preparation and testing duration constraints that are typically associated with this form of testing. Instead, ‘indirect’ approaches based on simplified theoretical models provided in building assessment codes and guidelines are typically used. One such simplified model that is commonly used by practicing structural engineers when

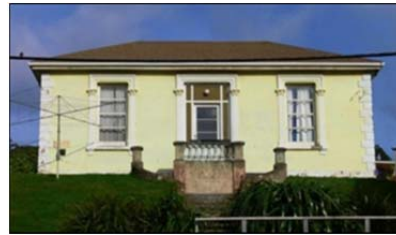
(b) Avon House building (Building 2)

**Figure 3:** Building elevations

Building 2 (as shown in Figure 3b) was constructed in Wellington in 1884 using British architecture and construction techniques. The single storey building has walls constructed of unreinforced clay brick masonry, with a timber framed trussed roof overlaid with corrugated iron sheets. The internal, non-load bearing partition walls consist of single leaf URM walls constructed using running bond pattern (only stretcher courses), and the load bearing internal walls are composed of solid two leaf masonry (irregular bond pattern) with a plaster layer (weak approximately 20 mm thick lime-sand plaster reinforced with horse hair) on both sides of the wall. All walls consist of handmade clay brick masonry with lime-cement mortar. Thin metal strips measuring 25 mm  $\times$  1 mm were found enclosed within the mortar bed joints of the single leaf walls, that extended horizontally throughout the wall length at an irregular vertical spacing of greater than 800 mm. The building was scheduled to undergo seismic strengthening and substantial internal alterations that involved the removal of a number of internal URM walls, which allowed a section of a two leaf load-bearing wall (wall panel 7) and a section of non load-bearing single leaf partition wall (wall panel 8) to be tested in diagonal tension. Geometrical parameters and the masonry bond pattern of the tested wall panels from Building 2 are shown in Figures 5b and 5c, with wall panel dimensions summarised in Table 2.

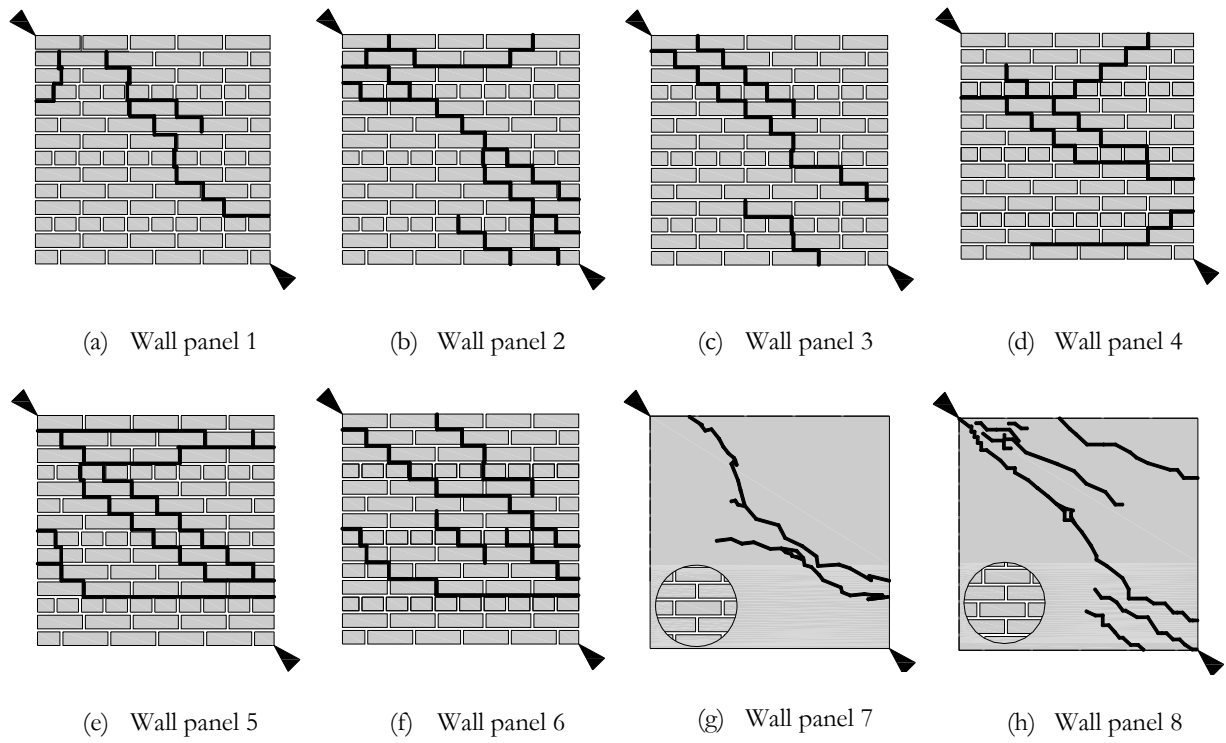
**Figure 7:** Observed crack patterns following testing

Load was applied along one of the wall panel diagonals until the shear stress decreased to approximately half of the peak shear stress or until 1% lateral drift was reached. In all wall panels, cracking occurred predominately through the mortar joints in a diagonal step pattern as shown in Figure 7. Post-test removal of the plaster layer for wall panels 7 and 8 revealed that cracking also occurred mainly through mortar bed joints for these panels, with a small number of cracks propagated through the brick units (see Figure 8). Wall panels 5 and 6 exhibited sliding along the horizontal mortar joint at a height of 3 courses above the loading plate, prior to the formation of a stepped diagonal crack. Wall panel 8 initially exhibited diagonally oriented cracking at the top corner of the wall panel opposite to the loading plate, with the crack extending towards the wall panel diagonal with increasing load. Wall panel 7 exhibited a sudden drop of load and a rapid propagation of diagonal cracking that was clearly visible on both exterior plaster surfaces. Wall panel 4 was damaged during positioning into the testing location, with a horizontal crack developed prior to testing at a location 6 courses above the bottom of the wall panel that extended through approximately half of the wall panel width. For all wall panels, sliding along the mortar bed joints was observed following the formation of diagonally extending cracks. Hence, the response of all tested wall panels was categorised as a diagonal tension failure followed by shear-sliding along the cracked diagonal step joints.

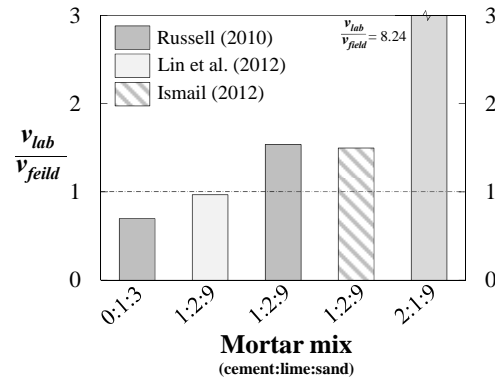
**Figure 10:** Ratio between shear strength of wall panels obtained from two existing buildings and shear strength obtained from testing laboratory-built wall panels having differing mortar mixes

The measured shear strength of wall panels obtained from two tested URM buildings and the measured shear strength of laboratory-built wall panels [20, 23, 39] that resembled the masonry type present in the tested buildings was compared. The comparison was made by expressing the average of the shear strength for the wall panels obtained from the two URM buildings ( $v_{field}$ ) and the average of the shear strength for the laboratory-built wall panels ( $v_{lab}$ ) as a ratio ( $v_{lab}/v_{field}$ ) (see Figure 10). Results that were used for the comparison were: (1) wall panel tested by Russell [20] having a mortar mix of 0:1:3 (cement:lime:sand) and of (2) 2:1:9; (3) wall panels tested by Russell

[20] having a mortar mix of 1:2:9; wall panels tested by Lin et al. [23] (4) and Ismail et al. [39] (5) having a mortar mix of 1:2:9. As noted by Russell [20], laboratory-built wall panels (AP1-AP9) were tested immediately following a 28 days curing period with the exception of wall panels AP2 and AP4 having a 1:2:9 mortar mix, which were cured for over 5 months prior to testing. Consequently, the elevated shear strength of wall panels AP2 and AP4 tested by Russell [20] in comparison to wall panels AP6 to AP9 was attributed to a longer curing period and hence were excluded from comparison made in Figure 10 **Error! Reference source not found..**

The ratio between the shear strength measured for the wall panels obtained from the two URM buildings and the shear strength of wall panels having 1:2:9 mortar mix ranged between 0.97 and 1.54. The ratio between the shear strength of wall panels having 0:1:3 mortar mix and 2:1:9 mortar mix and the average measured shear strength for the wall panels obtained from the two buildings was 0.69 and 8.24 respectively. It is evident that the average shear strength of the wall panels obtained from the two buildings fell between the average shear strength of wall panels constructed using a 1:2:9 mortar mix (Figure 10). It was concluded that a benchmark mortar mix having a ratio of 1:2:9 is suitable for use when manufacturing replica clay brick test assemblages that represent within reasonable accuracy the shear strength characteristics in existing vintage URM buildings, particularly when laboratory-built replicas are tested approximately 28 days after construction is complete.
