Ismail, N., & Ingham, J. M. (2012). In-situ and laboratory based out-of-plane testing of unreinforced clay brick masonry walls strengthened using near surface mounted twisted steel bars. *Construction and Building Materials*, 36, 119-128. doi: [10.1016/j.conbuildmat.2012.04.087](https://doi.org/10.1016/j.conbuildmat.2012.04.087)

Date Written/Revised	02/12/2011
Title	In-situ and laboratory based out-of-plane testing of unreinforced masonry walls strengthened using near surface mounted twisted steel bars (138 Characters)
Submitted to	Journal of Construction and Building Materials
Authors	<p>Name: Najif Ismail</p> <p>Qualification: M.E., B.E. (Hons)</p> <p>Position: Ph.D. Student</p> <p>Organisation: University of Auckland, New Zealand.</p> <p>Address: Department of Civil & Environmental Engineering University of Auckland, Private Bag 92019, Auckland 1142, New Zealand.</p> <p>E-mail: nism009@aucklanduni.ac.nz</p> <p>Tel: +64212166562</p>
	<p>Co-author</p> <p>Name: Jason M. Ingham</p> <p>Qualification: Ph.D., M.E. (Dist), MBA, B.E. (Hons)</p> <p>Position: Deputy Head of Department (Research)</p> <p>Organisation: University of Auckland, New Zealand.</p>
Word Count	4172 (excluding refer

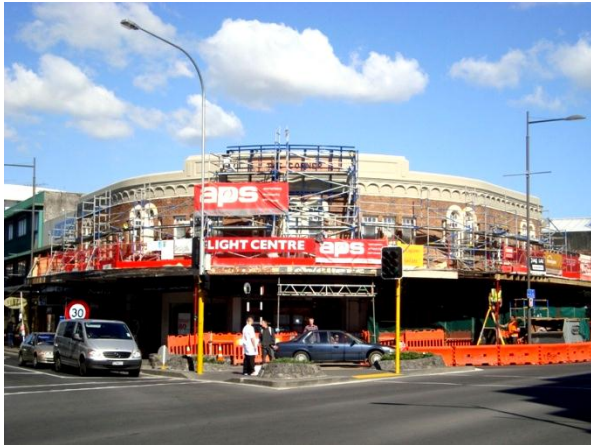
(a) 270 Broadway street, Auckland (NZ)

Figure 1. NSM-TS strengthening application to an actual building

that involve NSM bonding of TS bars in mortar bed joints to create deep beams or lintels, stitching across existing cracks, structural tying between intersecting structural walls, and structural tying of veneers to backing walls. Photographs of a URM building being strengthened using NSM-TS are shown in Figure 1, where the (cavity wall) front façade of the URM building was strengthened by installing replacement cavity ties and NSM bonding of TS bars in mortar bed joints, to increase stability of the masonry and to improve the seismic performance of the building.

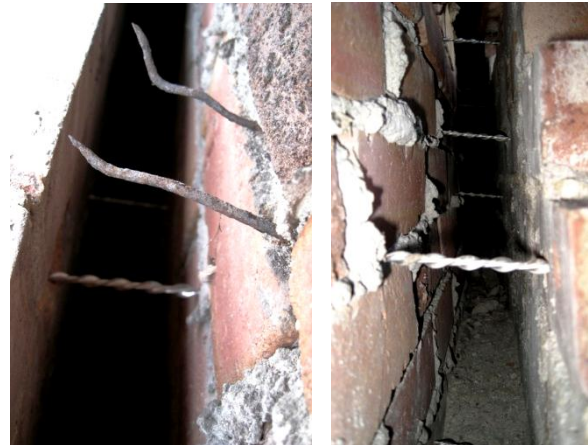
(b) corroded wall ties (left) and newly installed TS ties (right)

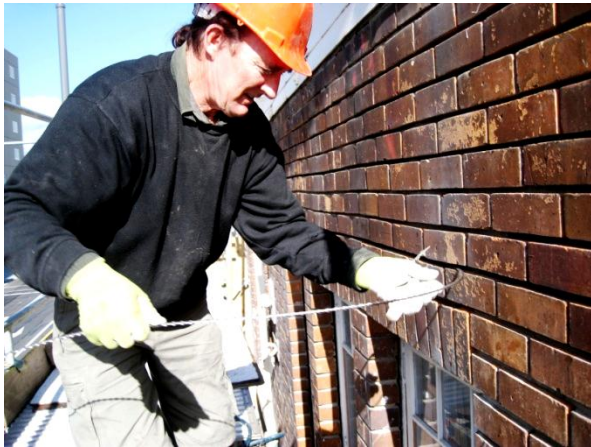
(c) bed joint insertion of TS bars

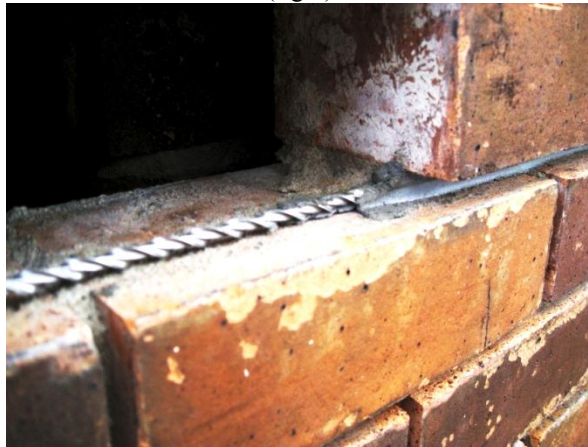
(d) closer view of NSM-TS bars

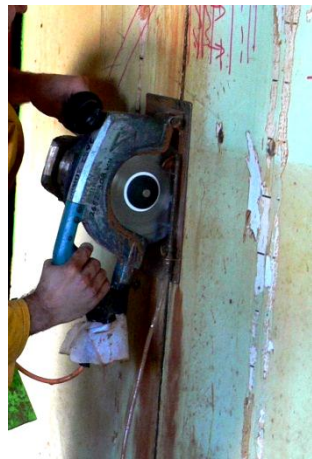
(b) cutting slots

Figure 2. Typical NSM-TS details and application procedure

For NSM-TS strengthening of URM walls, at the onset the masonry substrate surface is prepared by grinding any surface undulations and removing dust, paint, oil and/or any loose masonry fragments. Thin surface slots (being 30 mm deep and 4 mm wider than the outer bar diameter) are cut into the masonry surface using a hand held wet circular masonry saw that typically required two closely spaced cuts and removal of the masonry strip formed between these two cuts using a chisel. Additionally, commercially available wet masonry saws can be mounted with an adjustable guide to maintain the depth and alignment of cutting. To reduce

the amount of brick cutting, straight slots may be positioned to pass through a maximum number of mortar head joints. This cutting strategy was adopted for the strengthened walls reported herein, and was found to provide adequate bar anchorage. The cut slots are cleaned with an air blower or flushed with water and are left to dry until a saturated surface dry condition is reached. A water based primer can also be sprayed in the slots by using a blow pump to avoid moisture movement between the injected grout and the substrate masonry.

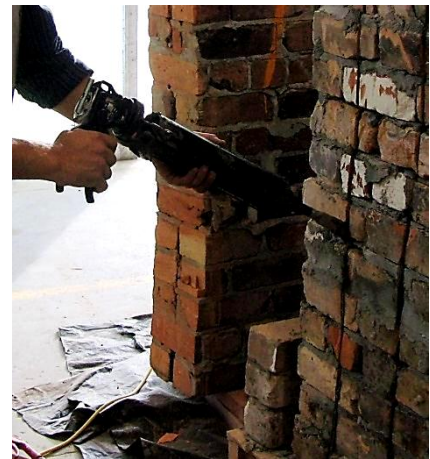
(c) grout injection

An approximately 10 mm thick bead of grout is injected into the back of the slot using a hand held injection gun. The twisted steel reinforcing bars are inserted into the slot by pushing the bars with a finger trowel into the injected bead of grout, and the slot is filled with grout. The slot is concealed by re-pointing using a tinted hydraulic mortar to match the existing masonry bond pattern. Figure 2 show a typical NSM-TS section and photographs illustrating the strengthening procedure.

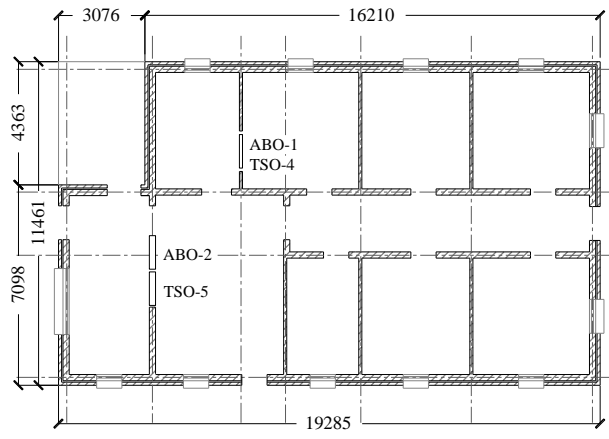
(b) location of test walls inside Avon house

Figure 4. Location of series 1 test walls

In series 1 testing, two URM walls were strengthened using NSM-TS and were tested in-situ as a part of a large field testing program that involved masonry material testing, in-plane testing of as-built URM wallettes, out-of-plane testing of as-built slender URM walls and out-of-plane testing of URM walls strengthened using NSM-TS and NSM bonding of carbon fibre reinforced polymer strips. The out-of-plane behaviour of as-built URM walls was reported by Derakhashan [21] and the results are reproduced herein for comparison. Figure 4a shows a photograph of Avon house and Figure 4b shows the location of the test walls inside

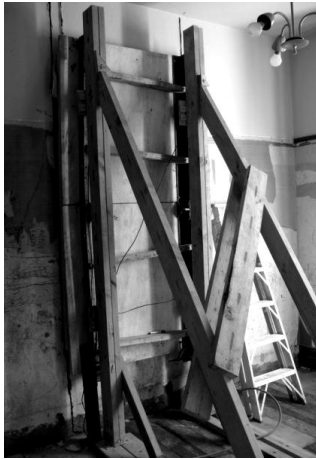
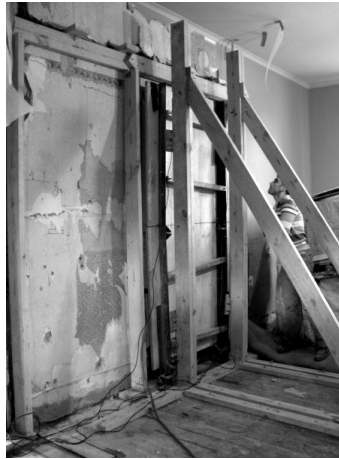
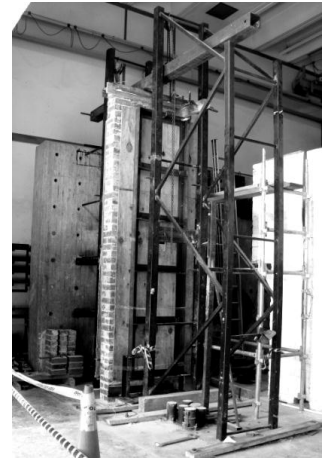
Figure 8. Photographs of test walls ready to be tested

The cross section of the test setup used for series 2 testing is shown in Figure 7. In series 2 testing, two backing frames were positioned on either side of the wall and a reversed cyclic face loading was applied by alternatively inflating the air bags positioned on either side of the wall. Additionally, a total of six 2 mm long strain gauges were directly attached to the NSM-TS bars that allowed the strain distribution to be monitored over their entire length. Figure 8 show photographs of the test walls ready to be tested.

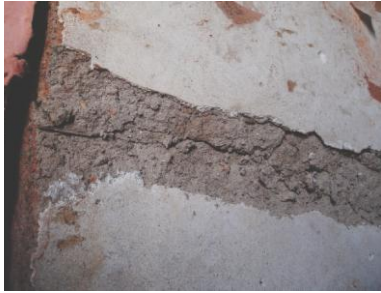
(a) mortar deterioration

Figure 10. Photographs of cracked wall sections

Figure 9 shows the damage patterns observed at the conclusion of testing. As-built walls behaved linearly until a single large crack developed at or near midspan and subsequently excessive mortar deterioration occurred at the crack location (Figure 10a). The cracking was mostly concentrated at mortar bed joints except in wall ABO-2, where the crack propagated through bricks (Figure 10b). The observed crack propagation through bricks was attributed to the presence of the strong cement based plaster (established by performing in-situ scratch tests) on the wall tension face and the relatively low brick strength. Upon further application of lateral loading, the upper and the lower portions of the walls started to rock about the crack location until the test was discontinued (prior to reaching a midspan instability displacement).

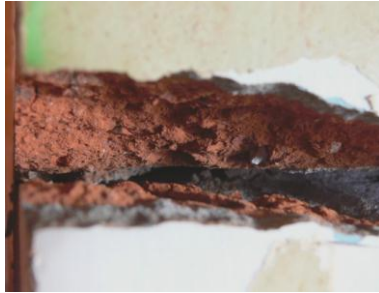
(b) cracking through bricks

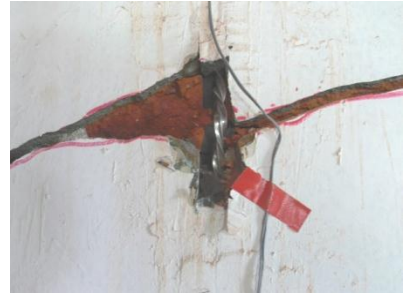
(c) local bending of a NSM-TS bar

In all strengthened wall tests, opening of one or two large horizontal cracks in the upper one third portion of the wall and hairline cracking in the vicinity of NSM-TS bars was observed. Once the cracking initiated, the NSM-TS bars started to resist lateral wall deformations by restraining further opening of the cracks. At large displacements the grout used to install the NSM-TS bars around the crack location was observed to deteriorate due to excessive local bending of NSM-TS bars, with bar slippage not observed during any test. Residual displacements were observed after large displacement excursions in test wall TSO-5, which was partially attributed to local bending of the NSM-TS bar and partially to loose masonry fragments wedging into the vertical cuts made to isolate the wall section and engaging the remaining portion of the main wall. Figure 10c shows a photograph of one such exposed bent

NSM-TS bar at the crack location.
