Experimental modal analyses of buildings during the Cook Strait earthquake sequence

G.B. Simkin, S. Beskhyroun, Q.T. Ma, L.M. Wotherspoon & J.M. Ingham

2014 NZSEE
Conference

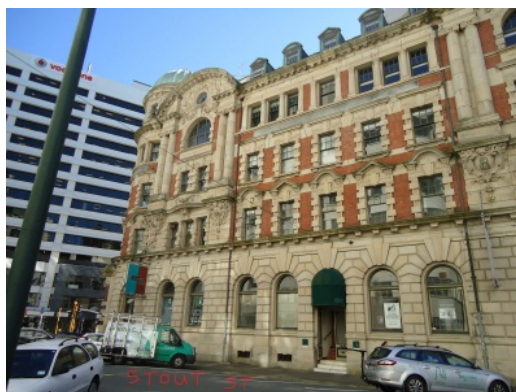
(a) Old Public Trust Building

Figure 2. Images of two buildings that were instrumented.

The opportunity to capture data on the performance of buildings during actual ground motions arose after the initial M_w 6.5 Cook Strait earthquake which occurred on 21 July 2013. Figure 1a shows the locations of the earthquake epicentres, which were approximately 50 km from Wellington CBD (GNS Science, 2013). Six buildings located in the Wellington CBD were instrumented during the Cook Strait aftershock sequence, as shown by the approximate locations in Figure 1b. Sensors were first installed into four buildings on 24 July, and all sensors were retrieved by 28 November, 2013. A range of building types were instrumented, including a variety of different construction materials, structural designs, soil types, number of storeys and age of building. For confidentiality reasons, the first four instrumented buildings are referred to in this paper as Buildings 1-4. The remaining two buildings, the Old Public Trust Building (Fig. 2a) and the Saint Mary of the Angels Church (Fig. 2b), were instrumented on 9 September, 2013.

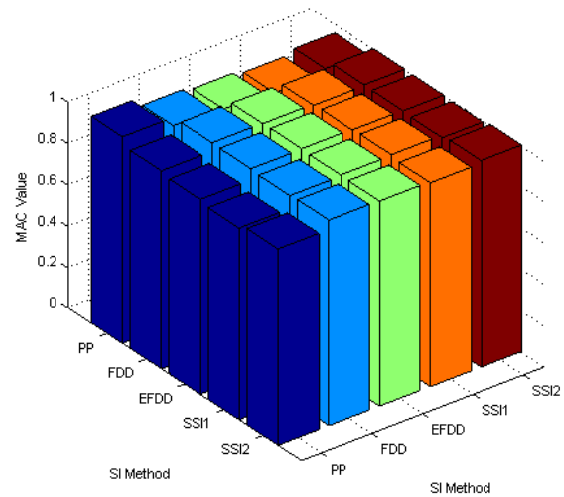
Figure 5. Comparison of the four system identification techniques for detecting modal parameters.

(a) Difference in frequency values

(b) MAC values showing a strong correlation

The accuracy of the four system identification techniques, PP, FDD, EFDD and SSI, for determining modal parameters were compared using MAC values. Data collected during the M_w 4.29 event for the Old Public Trust building is shown as an example in Figure 5, below. Figure 5a reveals that all five techniques returned natural frequency values within 0.06 Hz, and the high level of accuracy between techniques is reinforced in Figure 5b with all MAC values greater than 0.95.
