In-situ out-of-plane testing of unreinforced masonry wall segment in Wintec Block F building

2010 NZSEE
Conference

ABSTRACT: Most research considering seismic assessment of URM walls has been conducted using laboratory-based studies with well defined but artificial conditions. Thus, in-situ testing is required to provide data with which to validate the accuracy of laboratory-based studies of URM walls. Seismic strengthening of the Wintec Block F building in Hamilton allowed an opportunity for a team of researchers from the University of Auckland to conduct in-situ testing of a wall segment in the building. This allowed comparison with companion experiments that had previously been undertaken in a laboratory setting. This field testing involved the extraction of clay brick and mortar samples, flexural bond tests, and out-of-plane testing of a wall both in the as-built condition and after the installation of a near-surface mounted (NSM) carbon fibre reinforced polymer (CFRP) retrofit solution. Testing confirmed that the boundary conditions in real buildings can significantly affect experimental response, and also confirmed that the near-surface mounted FRP solution is an excellent

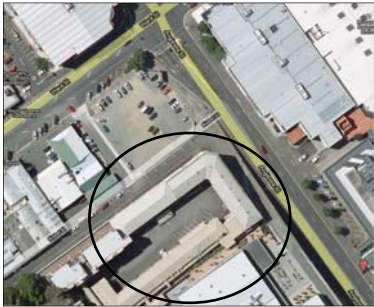
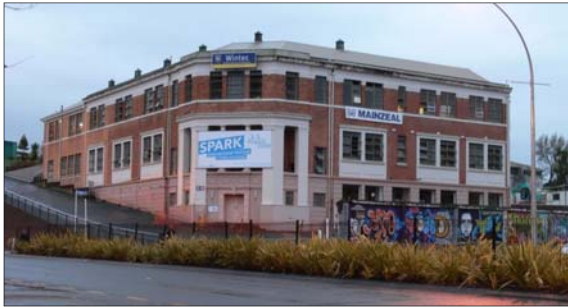
Figure 1: Wintec Block F building

(a) Wintec Block F satellite view, Hamilton

(c) Wintec Block F, located at the intersection of Anglesea and Ward Streets, Hamilton

Wintec is one of New Zealand's largest Institutes of Technology/Polytechnics (ITPs) and is a provider of vocational and professional education in the Waikato region. The condition remediation and seismic strengthening of the F Block building near the corner of Anglesea and Ward Streets was part of Wintec's on-going project to modernise its Hamilton city campus (Refer to Figure 1 for building location).

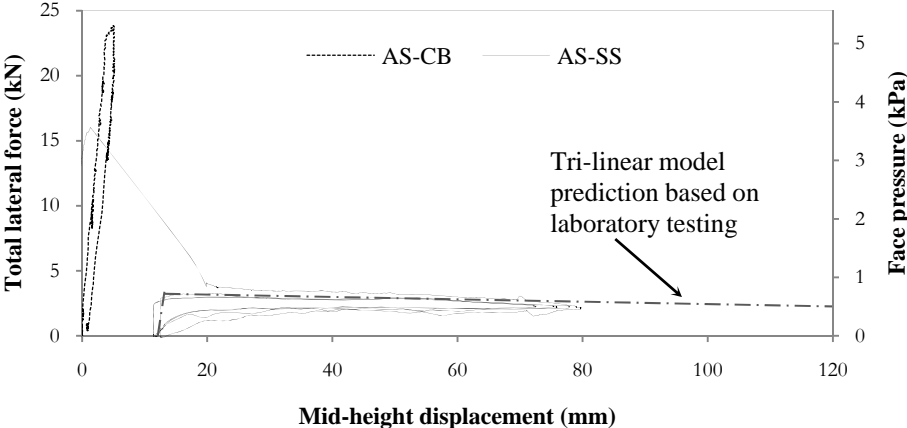
Figure 6: Total lateral force - mid-height displacement response for AS-CB and AS-SS tests

Test AS-CB test was performed by uniformly increasing the pressure in the airbag until the capacity of the setup was reached. At the maximum loading pressure no evidence of wall movement at the boundaries and no cracks were visually detected on the wall surface. Due to a potentially explosive brittle failure of the wall, attributed to the sudden release of potential energy stored in the airbag and limitations of the setup, the airbag pressure was not further increased. Consequently, the obtained results (shown in Figure 6) for AS-CB test were within the elastic range.

Following the preparation for the AS-SS test, the pressure in the airbag was again gradually increased until the sudden formation of a large crack and a displacement of approximately 30 mm was observed. The force to develop the crack was not only attributed to the bond strength of the mortar joint but also to the relatively small portions of brick that remained uncut within the vertical wall segment. The single crack was located at 2250 mm above the floor level, at 56% of the wall height as shown in Figure 7. The test was continued until mid-height wall displacements of up to 135 mm were reached, at which point the testing was stopped and the air bags deflated. Three semi-cycles were performed with the resulting total lateral force - mid-height displacement response is shown in Figure 6. The wall segment had 19 mm of residual displacement after the completion of test AS-SS.

The location of crack formation at 56% of the strip height during test AS-SS was comparable to the results obtained during laboratory testing of walls with similar geometry. Also, the measured post-cracking behaviour of the tested wall (AS-SS test) closely matched the corresponding prediction using

a tri-linear model (shown in Figure 6) developed based on laboratory testing conducted at the University of Auckland (Derakhshan et al. 2009). It is clear that boundary conditions that are encountered in real buildings are different from those simulated in the laboratory. Therefore, further investigation and analysis is required prior to establishing any recommendations on the assessment of such walls.

Using the New Zealand Standard, NZS 1170.5:2004 - Earthquake Actions (SNZ 2004), assuming a shallow soil site, an annual probability of exceedance of 1/500 and a near-fault factor of 1.0, the wall strip was predicted to encounter a face pressure loading of 2.93 kPa during a design level earthquake. Figure 6 clearly shows that during testing, the face pressure value specified by NZS 1170:5 was exceeded for the AS-CB test, but not for the AS-SS test. This indicated that the simply supported walls required seismic strengthening (all walls in the building were bounded by a concrete ring beam).

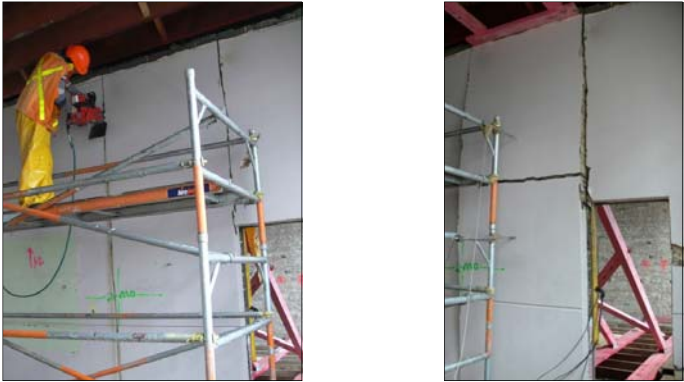
Figure 7: Out-of-plane tests

(a) Cutting through concrete ring beam (b) AS-SS test crack location

Due to the presence of the concrete ring beam, the as-built testing consisted of two schemes and investigated the effects of different boundary conditions. The first scheme, designated AS-CB, involved cutting the wall segment up to the concrete ring beam and testing with the continuous concrete beam extending across the wall segment. This provided a “fixed” boundary condition at the top part of the wall, inducing arching action of the wall segment. The second scheme, designated AS-SS, involved cutting the concrete ring beam, including the beam’s longitudinal reinforcement and constructing an additional horizontal support at the top of the wall segment as shown in Figure 3.

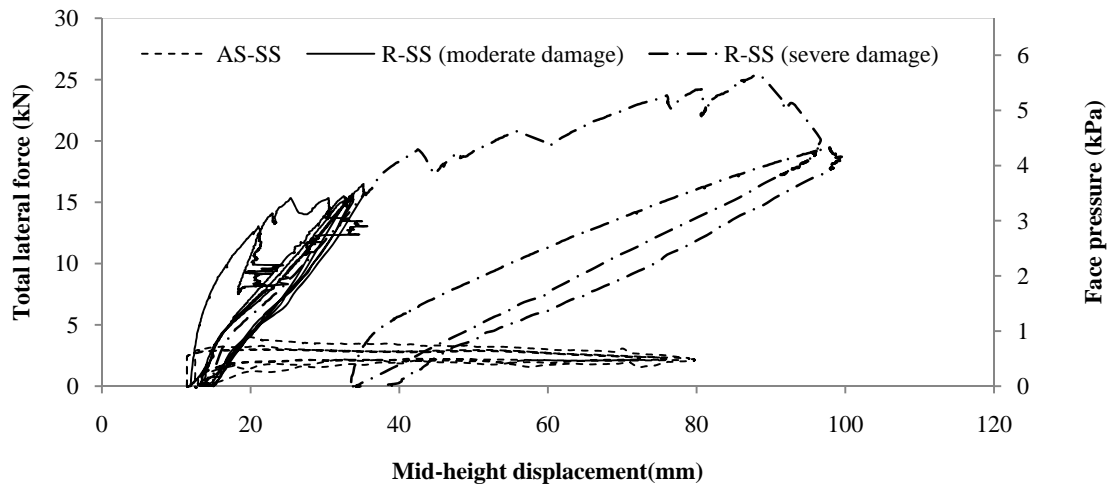
Figure 9: Total lateral force - mid-height displacement response for R-SS test

The test was continued until moderate cracking in close proximity to the CFRP strip occurred and a total mid-height lateral wall displacement of 60 mm was reached, with five additional semi cycles performed to the same displacement level. The resulting lateral force - mid-height displacement response is shown in Figure 9. It should be noted that the noise in the data was due to timber floor

vibrations (foot traffic) on which the LVDT's support frame was resting.
