Forcael, E., Gonzalez, V. A., Orozco, F., Opazo, A., Belmar, C., & Vera, J. (2013). Study of structural capacity and serviceability affecting the obstruction of residential doors. *Latin American Journal of Solids and Structures*, 11(3), 410-436. Retrieved from <http://www.lajss.org/index.php/LAJSS/index>

Study of Structural Capacity and Serviceability affecting the obstruction of Residential Door

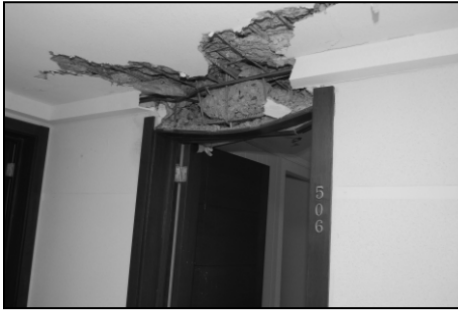
Figure 3 Deflection of lintel above the door

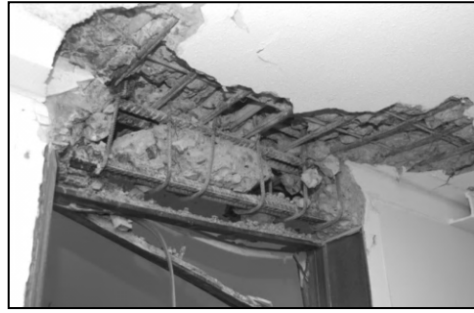
Figure 4 Lack of confinement in lintel

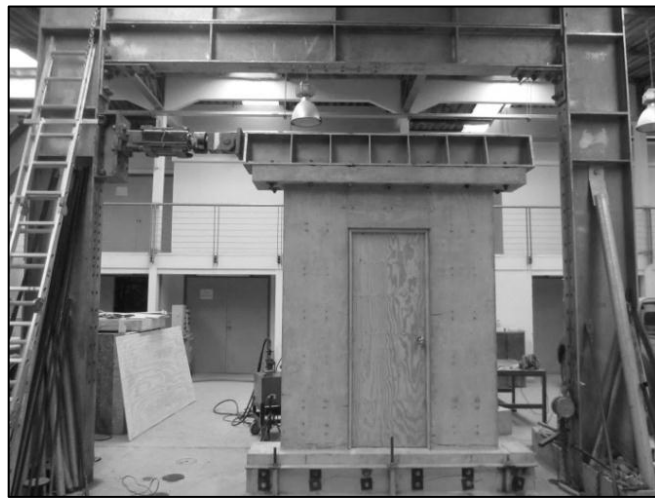
Figure 7 Starting up the test.

The experimental work was conducted in the Center for Research in Construction Technology (CITEC, Centro de Investigación en Tecnologías de la Construcción) at the University of Bío-Bío, Chile, using a full-scale testing framework for structural elements. The test protocol included the use of coupling systems, anchoring, control and monitoring, based on studies conducted by previous researchers (Díaz, 2008; Toloza, 2008). The proposed test consisted of subjecting the structural system that confines the door (Figure 7), to excitation seismic loading and unloading using a hydraulic actuator. The actuator was arranged horizontally in a steel frame of 4 meters width and 4 meters height. The testing procedure also included anchoring systems for attaching the top and bottom of the prototype, simulating the actual conditions at the time of a seismic event.

The shear force at the top is distributed by incorporating a steel bar anchored to the slab and the head system of the hydraulic actuator, which are aligned with the test frame allowing a stroke for the piston with a maximum development of 25mm “peak to peak”. Meanwhile, control and monitoring of the experiment is done through displacement transducers interfaced with a computer for data acquisition and processing of load versus displacement in real time.

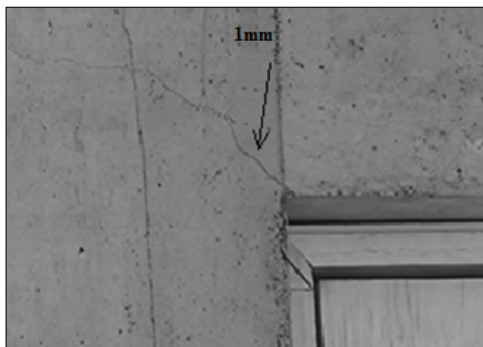
Figure 12 Cracking in the corner.

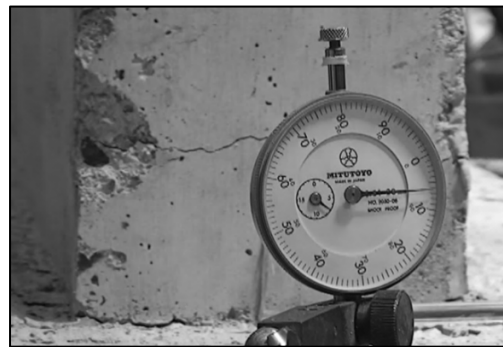
Figure 13 Cracking at the bottom.

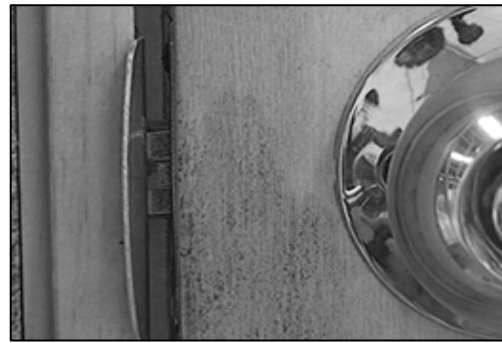
Figure 15 Distortions in the lock.
