Dizhur, D., Lumantarna, R., & Ingham, J. M. (2016). Assessment of mortar properties in vintage clay brick unreinforced masonry buildings. *Materials and Structures*, 49(5), 1677-1692. doi: [10.1617/s11527-015-0604-8](https://doi.org/10.1617/s11527-015-0604-8)

Assessment of Mortar Properties in Vintage Clay Brick Unreinforced Masonry Buildings

D. Dizhur¹, R. Lumantarna², and J. M. Ingham³

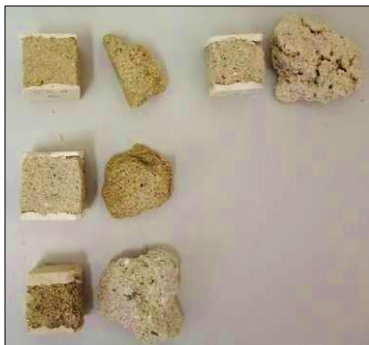
(a) Preparation of irregular mortar samples

The Mohs hardness test and the irregular mortar compression test were performed on 365 irregular mortar samples that were extracted from 60 existing New Zealand URM buildings. Similar to that performed by Válek and Veiga (2005), the irregular mortar samples were cut using a diamond tipped circular saw to form parallel top and bottom loading surfaces. These samples were furthermore trimmed to form approximately rectangular test pieces as shown in **Figure 1a**. The cutting process was controlled to minimise disturbance to the mortar samples, which were then capped using gypsum plaster to ensure a flat loading surface.

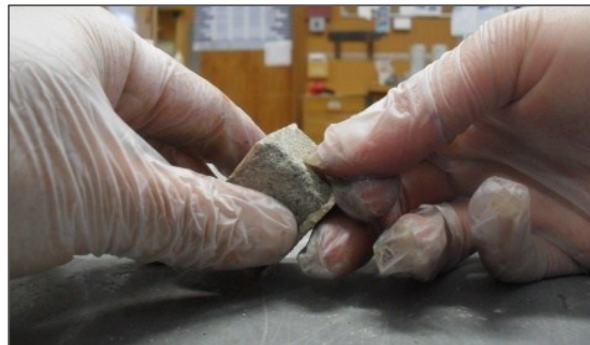
(b) Modified Mohs scratch test procedure

Figure 1: Preparation of mortar samples

Prior to compression testing, the rectangular test pieces were subjected to the Mohs scratch test, which was modified to be suitable for use on vintage mortars (referred to here as the “modified Mohs scratch test”). Because the Mohs minerals are not commonly available, and with the aim to simplify the scratch test for possible future use by industry practitioners, materials which are known to have similar hardness values to the Mohs minerals (denoted as “equivalent materials”) were sourced (Nicholson and Shaw 2000; MineralTown 2010). The validity of adopting these equivalent materials was confirmed by testing 365 mortar specimens that were extracted from 60 different building sites. The mortar surface was cleaned and levelled using a 400 grit sandpaper prior to performing the modified Mohs scratch test (see **Figure 1b**).

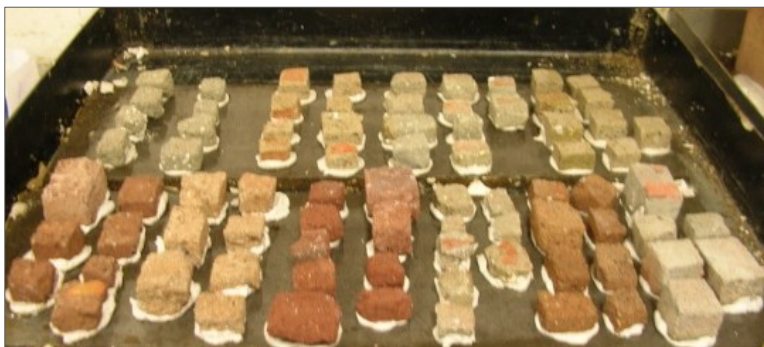
(a) Preparation of extracted mortar samples

Figure 2: Irregular mortar samples prepared for compression testing

a height to thickness (h/t) ratio and a thickness to length (t/l) ratio other than 1.0. Thus, all mortar samples included in the experimental programme were normalised using the mortar compressive strength normalisation technique described by Lumantarna (2012). **Figure 2** shows the compression testing of irregular mortar samples.

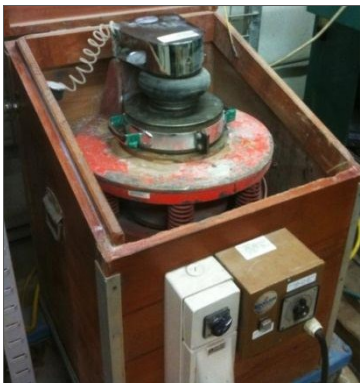
Figure 3: Preparation of fine mortar powder using a grinding mill

Mortar samples from each group were disaggregated using a hammer, and then crushed into a fine powder using a grinding mill, as shown in **Figure 3**. The powder samples were used for 2 different tests: the acid digestion test and the powder X-ray diffraction analysis.

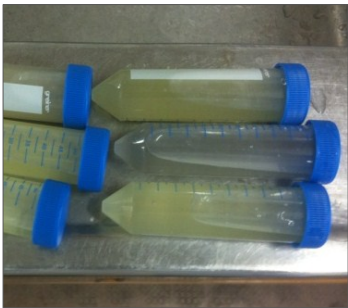
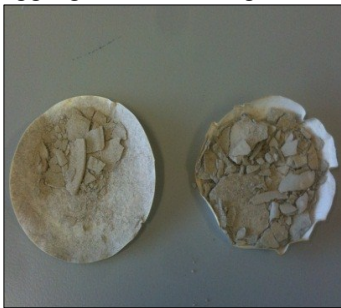
(a) Mortar powder, HCL and water

(b) Placement of liquid + aggregate in centrifuge tubes

(c) Placement of centrifuge tubes in the centrifuge machine

(d) Separated aggregate after drying

Figure 4: Acid digestion test procedure

enable variations in the mortar binder:aggregate ratio to be identified. **Figure 4** shows the acid digestion test procedure. It is noted that after the acid digestion test, separation between the liquid and the aggregate was achieved using a centrifuge which rotated at 4000 rounds per minute (see **Figure 4** (b) and (c)).

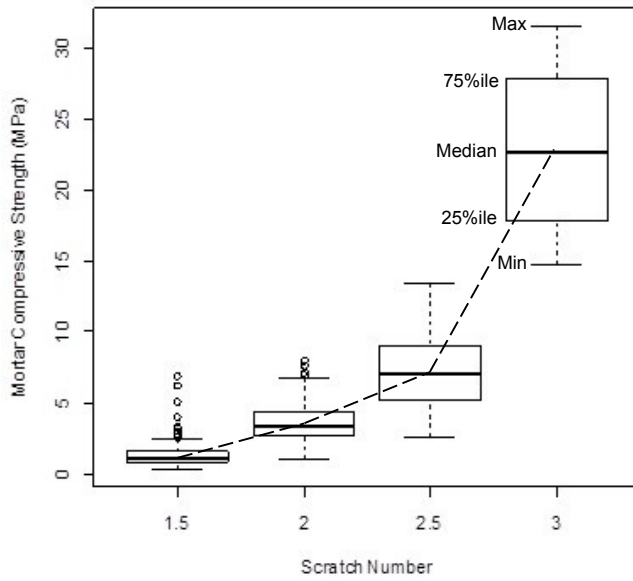
Scratch Number 1.5 (223)

Minimum = 0.4 MPa
Median = 1.1 MPa
Maximum = 6.9 MPa

Minimum = 14.8 MPa
Median = 22.7 MPa
Maximum = 31.6 MPa

Figure 5: Relationship between normalised compressive strength and Mohs scratch number

increased with an increase in the Mohs scratch number. The Mohs scratch numbers were generally consistent within each mortar group, except for some mortar groups where slight variability in the scratch numbers was observed. **Figure 5** illustrates the relationship between the normalised mortar compressive strength and the Mohs scratch number. The majority of the samples (315 samples out of 365 samples) were scratched using a fingernail, where 223 samples out of 315 samples could be scratched easily using a fingernail. There were 42 and 8 mortar samples that were scratched using an aluminium pick and a copper coin respectively.

The normalised mortar compressive strength-Mohs scratch number relationship was expressed using the box and whisker plot shown in **Figure 5**, with data calculated according to Peck et al. (2009). The group median was used to express each mortar category (each box and whisker plot) as median is less influenced by data extremes than is the mean, and therefore was considered to be suitable when dealing with a large data population. **Figure 5** shows that the median normalised compressive strengths of mortar samples having scratch numbers of 1.5, 2.0, 2.5 and 3.0 were 1.1 MPa, 3.3 MPa, 7.0 MPa and 22.7 MPa respectively. It is noted that mortar groups C15 and C39 were modern repointing mortars that were likely to be cement based, and therefore these mortar groups had high compressive strengths and scratch numbers of 3.0.

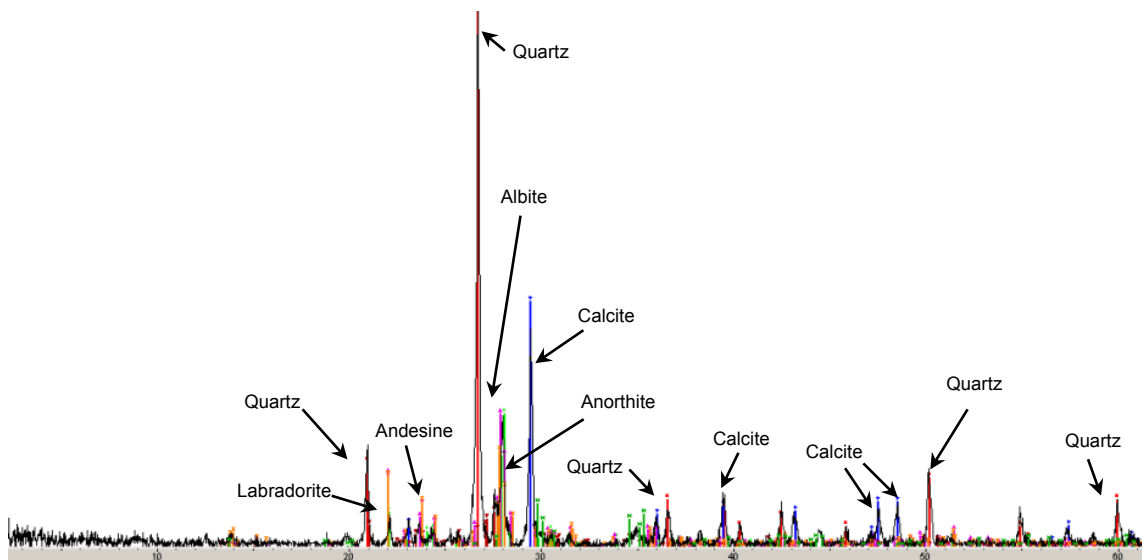
(a) XRD pattern of mortar group C1

(b) XRD pattern of mortar group C13

Figure 8: Examples of XRD patterns for mortar samples
