Lin, Y. W., Wotherspoon, L. M., Scott, A., & Ingham, J. M. (2014). In-Plane Strengthening of Clay Brick Unreinforced Masonry Wallettes using ECC Shotcrete. *Engineering Structures*, 66, 57-65.

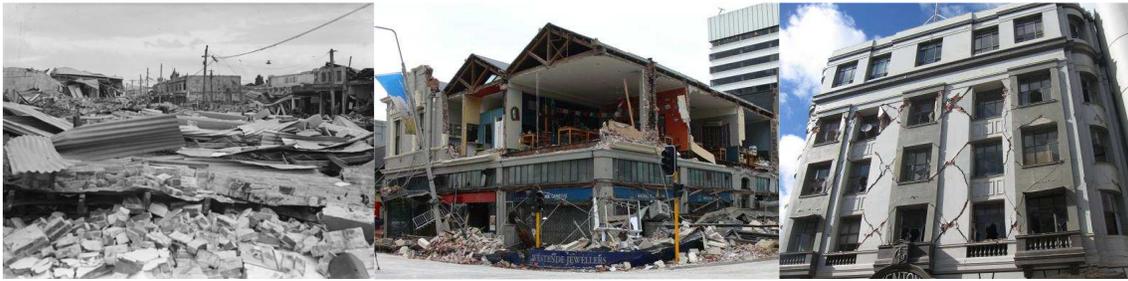
Figure 1: Examples of damage to New Zealand URM buildings as a result of seismic loading

(a) Damage caused by the 1931 M7.8 Hawke's Bay earthquake, [reproduced from 7]

(b) Collapse of out-of-plane loaded URM walls in the 2010 M7.1 Darfield earthquake

(c) In-plane diagonal cracks caused by the 2011 M6.3 Christchurch earthquake

8 The earthquake vulnerability of New Zealand URM buildings has been clearly demonstrated in a number of
9 previous earthquakes with the 1931 M7.8 Hawke's Bay earthquake [2] and more recently in the 2010 M7.1
10 Darfield earthquake [3-4] and 2011 M6.3 Christchurch earthquake [5-6] being responsible for causing the
11 greatest extent of damage to URM buildings. The level of damage to URM buildings in these earthquakes
12 included complete collapse (see Figure 1(a)), individual walls having completely or partially collapsed
13 out-of-plane for earthquake loading oriented perpendicular to the wall (see Figure 1(b)); or varying levels of
14 damage, including pier diagonal shear cracking, when earthquake loading was oriented parallel to the wall (see
15 Figure 1 (c)).

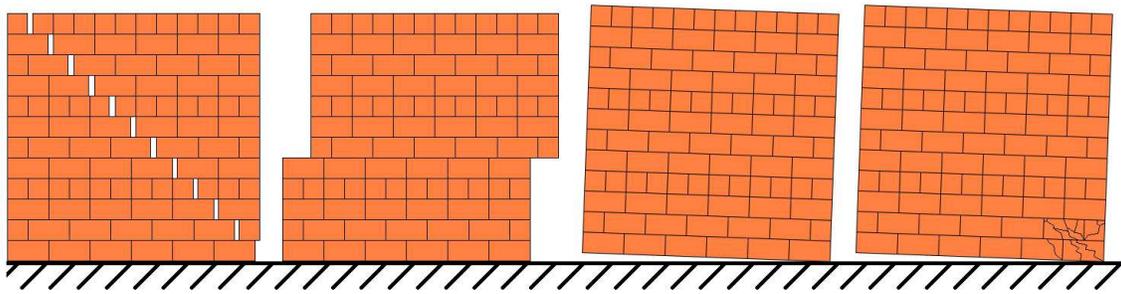
Figure 2: Masonry in-plane failure modes

(a) Diagonal cracking

(b) Shear sliding

25 common in-plane failure modes are shown in Figure 2 [10]. The research reported here focused on the diagonal
26 cracking failure mode, as this mode is regarded as being the most detrimental to the vertical load carrying
27 capacity of a URM wall or pier [11].

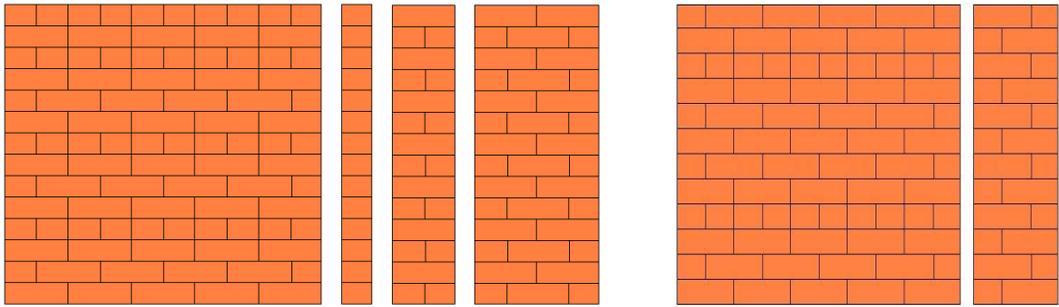
(a) Front and side view of 1, 2 and 4 leaf wallettes

(b) Front and side view of 3 leaf wallette

25 25 unreinforced masonry wallettes were constructed and tested, with the wallettes intentionally constructed
26 in a manner that simulated the typical current condition of existing historical URM buildings. The wallettes were
27 approximately 1.2 m high \times 1.2 m long, with the thickness varying between 100 mm to 470 mm depending on
28 the number of masonry leaves used. The vintage clay bricks used to construct the wallettes were recycled from
29 demolished URM buildings and ASTM type O mortar was used with a cement: lime: sand ratio of 1:2:9 [32].

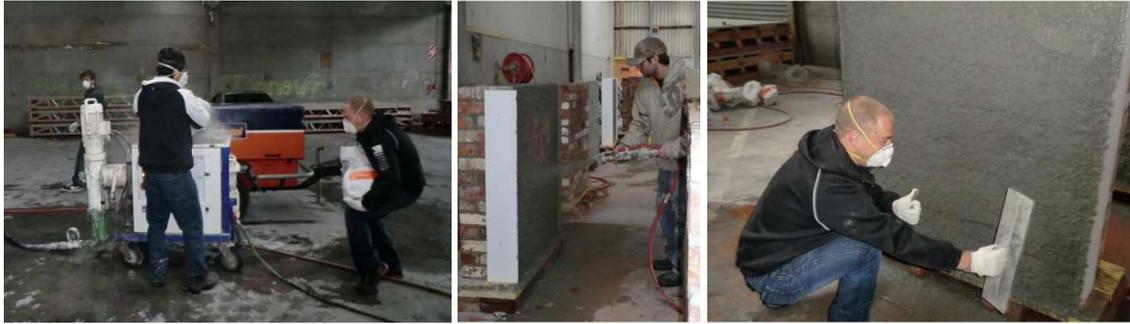
(a) Adding prebagged ECC into mixer

(b) Spraying of ECC shotcrete onto wallette

15 After the wallettes were built, the mortar was air cured for 28 days and then ECC shotcrete was sprayed onto
16 those wallettes that were to be strengthened. Prior to spraying, the wallette surfaces were water blasted to both
17 remove loose material and to pre-wet the surface. Polystyrene planks were then attached to the sides of the
18 wallettes, to serve as an indicator of the thickness of ECC that needed to be sprayed. The ECC shotcrete was
19 supplied in bagged form and added to a two stage mixer (see Figure 5(a)) from which the mixed material was
20 pumped through a hose and sprayed onto the masonry wallettes (see Figure 5 (b)). An interval of approximately
21 45 minutes was provided between the applications of each successive ECC layer, which allowed the previously
22 applied layer to harden. Each sprayed layer was trowelled flat so that the following layer of ECC was applied
23 onto a flat surface (see Figure 5 (c)). Once spraying was completed, the polystyrene planks were removed and a
