Ismail, N., & Ingham, J. M. (2016). In-plane and out-of-plane testing of unreinforced masonry walls strengthened using polymer textile reinforced mortar. *Engineering Structures*, 118, 167-177.

In-plane and out-of-plane testing of masonry walls strengthened using polymer textile reinforced mortar

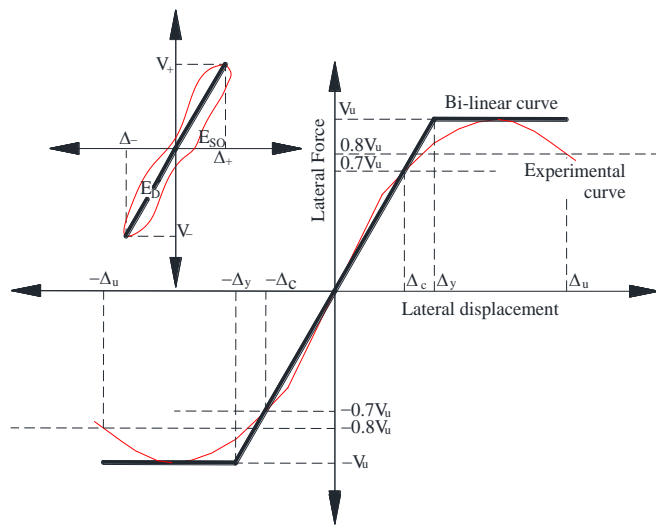
Figure 4. Notations and definition of the adopted elasto-plastic model

wall, where Δ_y is the effective yield displacement corresponding to extrapolation of the first cracking limit state when considering a bi-linear elasto-plastic system (refer Figure 4). It should be noted that as the bi-directional cyclic testing was stopped before the walls reached their ultimate strength limit state, the maximum measured drift values determined for test walls ABO-

To quantify stiffness degradation that occurred in each test wall, the wall secant stiffness for each loading cycle was determined as the secant modulus between the maximum excursion points of a hysteretic loop (see Figure 4). The determined wall secant stiffness is plotted in Figures 9a and 9c against the displacement amplitude of the corresponding loading cycle. The energy dissipated in each cycle was determined by integrating the area bounded by the loading and unloading curves of each loop and the cumulative dissipated energy is plotted in Figures 9b and 9d. Equivalent hysteretic damping coefficients were calculated from experimental results using Equation 1 proposed by Chopra [47], where ξ = damping coefficient; E_D = area between loading and unloading curve; and E_{SO} = area of right angle triangle with perpendicular equal to maximum force and base equal to corresponding displacement. The calculated equivalent viscous damping coefficients for the first cycle were also reported in Table 4.

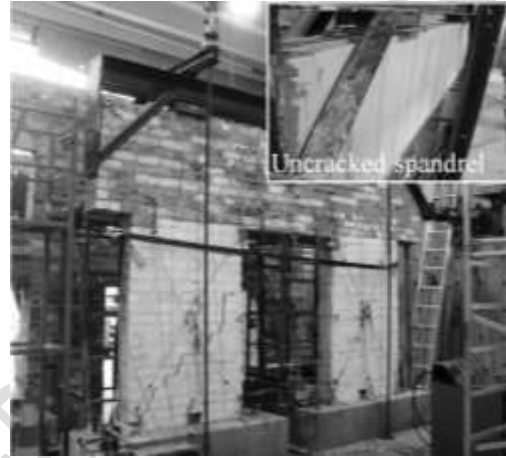
(d) Photograph of TMI-2

(e) Photograph of TMI-3

Figure 5. Damage patterns (series 1)

Figure 5 shows damage patterns observed at the conclusion of series 1 testing. The as-built tested wall ABI-1 exhibited a strong-pier weak-beam failure mechanism, with pier rocking resulting in opening of horizontal cracks at the base of each pier and diagonal shear cracks forming in the middle portion of the spandrel. Some localised cracking was also observed at the projecting edges of the spandrel, which was attributed to stress concentration at the interface between the masonry and the edge of the loading beam. The damage pattern observed for test wall TMI-2 was similar to that for as-built tested wall ABI-1, being rocking induced cracking in the middle portion of the spandrel. The majority of cracks were observed to propagate through mortar joints, which were attributed to the low ratio of mortar strength to brick strength. A horizontal bed joint crack at the unstrengthened spandrel-pier connection was also observed to widen before the textile rovings that crossed the spandrel cracks started to rupture and resulted in rapid loss of wall strength.

Test wall TMI-3 also exhibited pier rocking until one of the piers failed in a step joint sliding shear failure mode, without any visible cracking in the spandrel. It was established from the failure mode observed for TMI-3 that careful consideration was necessary regarding to the amount of strength increase applied to the spandrel, with respect to the assessed pier strength, in order to avoid such brittle shear failure of the piers. Alternatively to avoid pier diagonal shear failure, TRM strengthening of URM piers at selected locations could also be performed, such that the strength corresponding to all three possible failure modes (pier cracking, spandrel

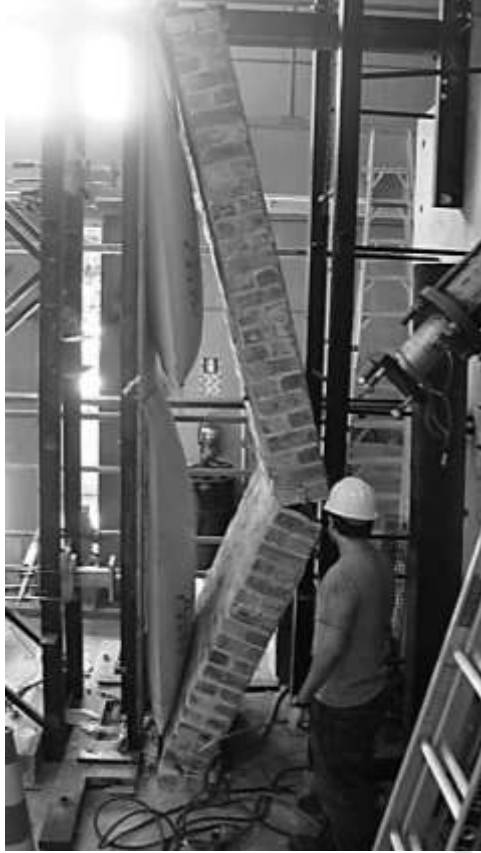
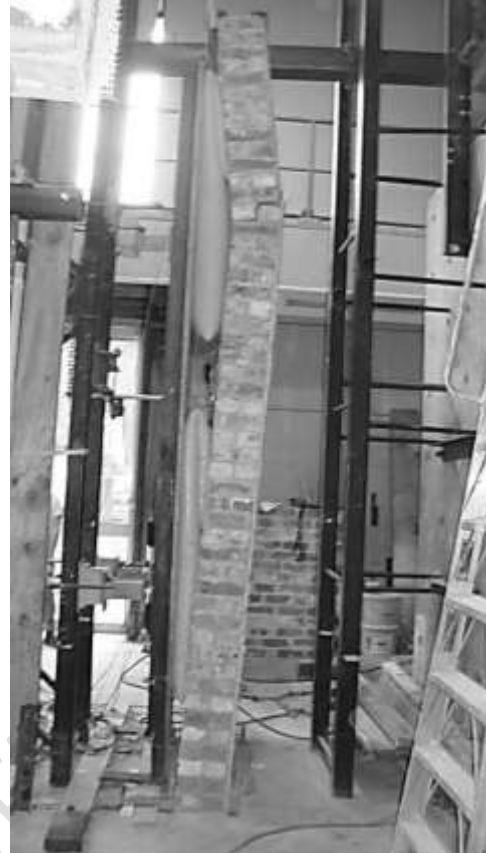
(a) TMO-5'

(b) TMO-6'

Figure 7. Photographs of series 2 test walls at the conclusion of testing

The second stage of series 2 testing was continued until the walls collapsed. Test wall TMO-5' continued to resist the applied loading, with opening of several distributed hairline flexural cracks until rupture of the polymeric textile rovings that crossed a single bed joint crack located near mid-height (refer Figure 7a), resulting in sudden wall collapse. Test wall TMO-6' exhibited a similar failure mode but the additional steel mesh reinforcement provided some lateral resistance even after the polymeric textile reached its ultimate capacity, thus avoiding collapse of the test wall (refer Figure 7b).

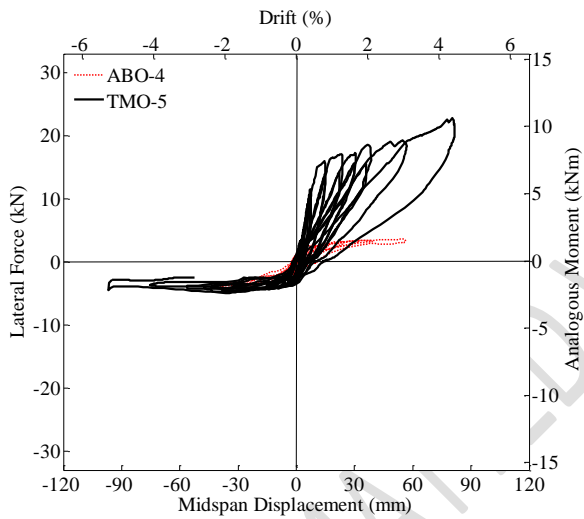
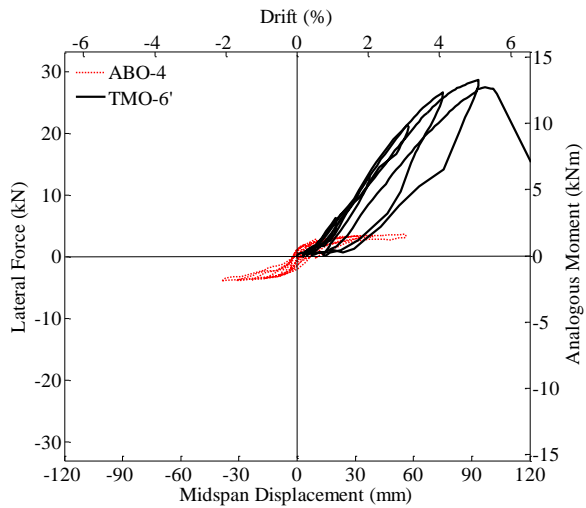
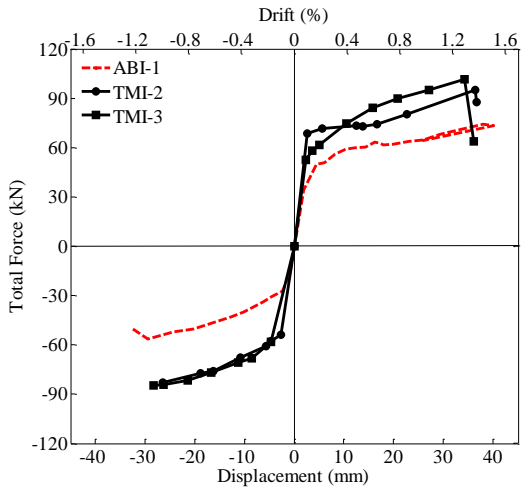
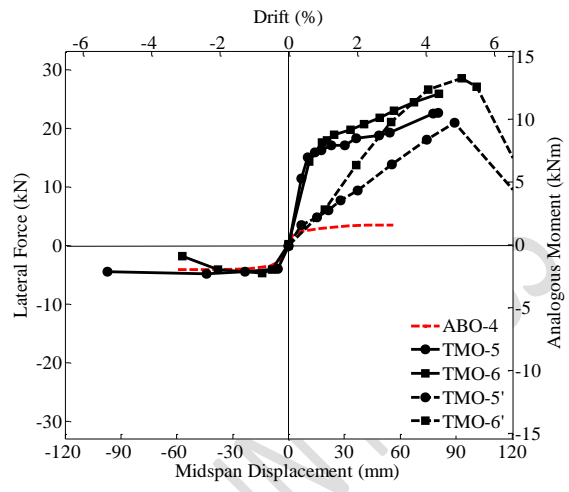
Figure 8. Experimental hysteretic curves

Figures 8a to 8f show the measured hysteretic response for the test walls, with secondary axes to allow comparison of experimental results for walls of different height. The secondary horizontal axis represents drift values, calculated as $\gamma = \frac{\Delta}{H}$ for in-plane loaded walls and as $\gamma = \frac{2\Delta}{H}$ for out-of-plane loaded walls, where Δ is the lateral displacement and H is the wall/assembly height. Additionally, analogous moment values are shown on the secondary vertical axis for out-of-plane loaded walls, calculated as $M = \frac{VH}{8}$ where V is the total applied lateral force and H is the wall height. The result for the corresponding as-built tested wall (dotted line) is also included on each plot, to illustrate the seismic improvement due to TRM strengthening.

The as-built tested wall ABI-1 responded linearly until cracking occurred in the spandrel, resulting in narrow hysteretic loops which are typical for pseudo-statically rocking structures where no account is made for radiation damping due to dynamic rocking. The test wall did not exhibit any loss of strength and continued to resist lateral force even at large displacement excursions until the hydraulic ram reached its stroke capacity and the testing could not be continued further. In test wall TMI-2, the TRM layer resisted crack openings by distributing stresses over a large masonry area until textile rovings spanning across cracks started to rupture at a lateral displacement of 38.5 mm. As a result the repaired wall TMI-2 exhibited larger energy dissipation than the as-built tested wall ABI-1, resulting in larger hysteretic loops. The

strengthened test wall TMI-3 exhibited a rocking response and resulted in relatively pinched hysteretic loops. The strengthened spandrel of TMI-3 did not reach its cracking strength before one pier failed in diagonal shear at a lateral displacement of 36.8 mm, which led to rapid post-peak wall strength loss. Figure 8g shows the comparison between the maximum excursion curves of series 1 walls.

For the bi-directional cyclic testing (ABO-4, TMO-5 and TMO-6), testing of all walls was discontinued prior to reaching ultimate strength and post-peak strength was not observed for any of the test walls, as shown in the experimental force-displacement plots. The as-built tested wall ABO-4 behaved linearly up to cracking and then started to exhibit rigid body rocking without further strength gain. Test walls TMO-5 and TMO-6 exhibited a bi-linear response, with both walls having minor flexural cracking and returning to their original positions without any residual displacement. The flexural strength of these walls was observed to be notably higher than for the as-built wall ABO-4 when the TRM layer acted in tension, but when the walls were loaded in the reverse direction and the TRM acted in compression, the strengthened walls performed similarly to the as-built test wall ABO-4. The observed asymmetric strength increment for single sided strengthened walls suggested that a two sided TRM strengthening strategy should be performed for URM walls, which could either be applied as a full surface overlay or as vertical strips offset on each side of the wall.

In the second stage of testing, strengthened walls TMO-5' and TMO-6' continued to exhibit a bi-linear behaviour, similar to that observed in the first stage, until the tensile strength of the reinforcement textile was exceeded and the walls collapsed. Figure 8h shows the comparison between the maximum excursion curves for series 2 walls. In general, the

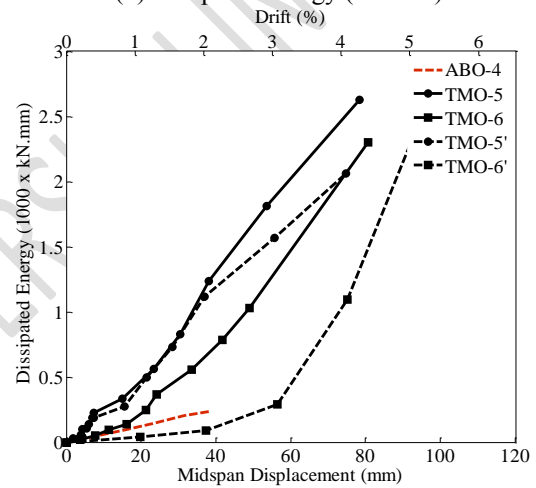
(a) secant stiffness (series 1)

(b) dissipated energy (series 1)

(c) secant stiffness (series 2)

(d) dissipated energy (series 2)

Figure 9. Stiffness degradation and energy dissipation
