1 Title: Compressive, flexural bond and shear bond strengths of in-situ New Zealand unreinforced
2 clay brick masonry constructed using lime mortar between the 1880s and 1940s

3 Ronald Lumantarna¹, David T. Biggs² Dist M. ASCE and Jason M. Ingham³ M. ASCE

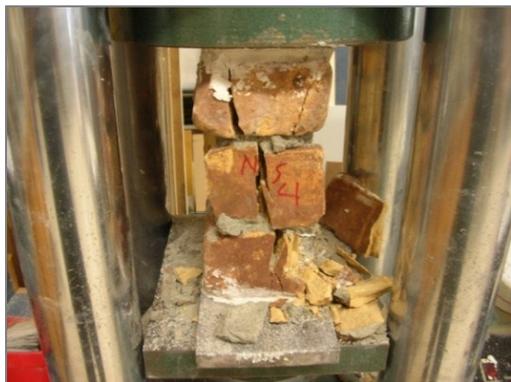
Figure 1: Prism compression test

152 Single leaf three brick high extracted prisms were capped using gypsum plaster to ensure a
153 uniform stress distribution, and were tested in compression using a 2000 kN instron machine
154 following the prism compression test protocol of ASTM C 1314 - 03b (2003a) (see Figure 1).

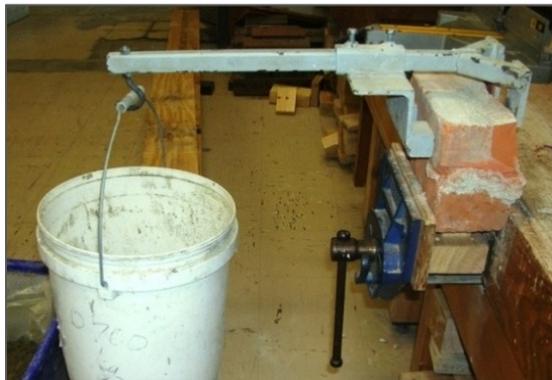
Figure 2: Bond wrench test

156 The bond wrench test AS 3700-2001 (Standards Australia 2001) was adopted for both in-situ and
157 laboratory applications due to its greater portability in comparison to the ASTM C 1072 - 00a
158 (2000) test setup, and therefore the bond wrench test was more suitable for in-situ testing. The
159 bond wrench arm (see Figure 2) was constructed as stipulated in AS 3700-2001 (Standards
160 Australia 2001), with a hook connector installed at the end of the bond wrench arm. An empty
161 container was attached to the hook and then gradually filled using sand to apply bending stresses
162 to the mortar joint until flexural bond failure occurred. The weight of the bucket and sand was
163 measured to the nearest 0.01 gram and used to calculate the flexural bond failure stress.

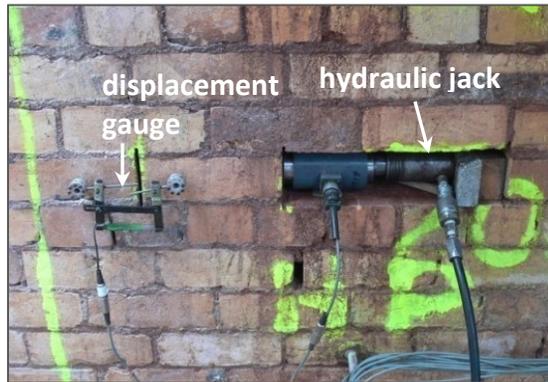
Figure 3: In-situ shear test

169 Figure 3 illustrates the in-situ shear test setup. The hydraulic jack was loaded using a pressure
170 controlled hydraulic pump and a displacement gauge was attached on the wall face adjacent to
171 the vertical cut joint, to identify when bed-joint sliding failure occurred. It was also noted that the

172 contribution of collar joints was not considered in the bed joint shear strength calculation as the
173 collar joints were mostly poorly laid, and therefore their contribution to the bed joint shear
174 strength was minimal.

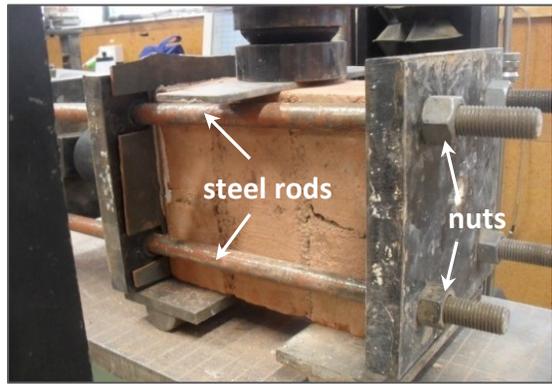
Figure 4: Triplet shear test

175 The triplet shear test setup is shown in Figure 4. Prisms were placed between two steel plates that
176 were interconnected using four steel rods. The axial pre-compression load was applied by
177 tightening the nuts at the ends of the steel rods and was recorded using a load cell. The sample
178 was prepared such that the middle course of the prisms consisted of a full brick unit.

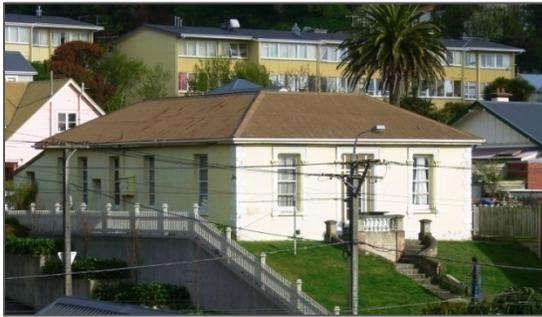
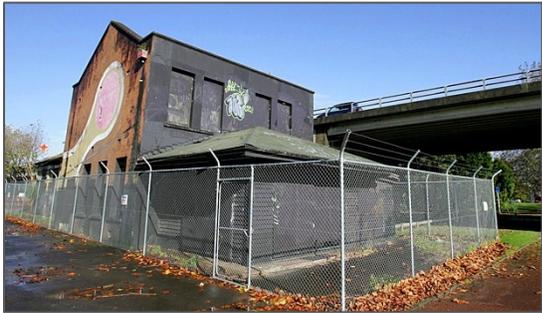
(a) Site AH

Figure 5: Representative field sites

193 buildings is expected, these field sites are deemed to be representative of the majority of New
194 Zealand URM buildings. Two of the field sites are shown in Figure 5.

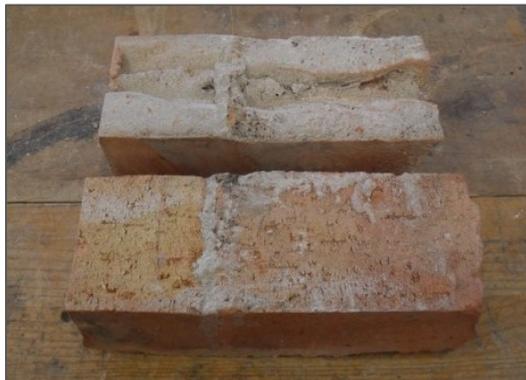
Figure 6: Bond failure type A, failure at brick/mortar interface

227 Table 3. A minimum of three samples were tested for each brick/mortar combination, with most
228 prisms exhibiting a flexural bond failure within the mortar joint (failure type C). It was thought
229 that these bond failures within the mortar joints occurred because the heritage buildings
230 investigated in this experimental programme were constructed using lime-rich mortars, and
231 therefore the mortar did not have sufficient strength to resist the applied tensile force. Also, it is
232 noted that the buildings included in the experimental programme were New Zealand URM
233 buildings which were built during a specific time period (1880s-1940s), and hence the
234 observations from this study may not be applicable for newer URM construction, where cement-
235 based mortars had been used. Furthermore, it was found that samples which exhibited
236 brick/mortar interface bond failure (failure type A) had lower flexural bond strengths than those

237 which exhibited failure type C. It was thought that the samples that exhibited brick/mortar
238 interface bond failure were disturbed during their preparation, resulting in low flexural bond
239 strengths being recorded and therefore those results were disregarded from the analysis. Figure 6
240 and Figure 7 illustrate the observed bond failure types. The average mortar compressive strength
241 (f'_j) for each field site is also included in

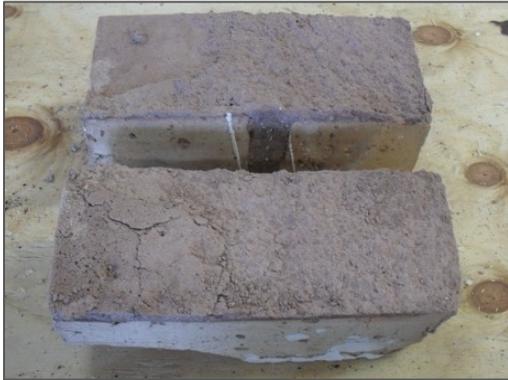
Figure 7: Bond failure type C, failure within mortar joint
