Russell, A. P., Elwood, K. J., & Ingham, J. M. (2014). Lateral Force-Displacement Response of Unreinforced Masonry Walls with Flanges. *Journal of Structural Engineering*, 140(4), 04013087-1-04013087-12. doi: [10.1061/\(ASCE\)ST.1943-541X.0000863](https://doi.org/10.1061/(ASCE)ST.1943-541X.0000863)

## **LATERAL FORCE-DISPLACEMENT RESPONSE OF UNREINFORCED MASONRY WALLS WITH FLANGES**

The experimental in-plane force-displacement response of unreinforced masonry (URM) walls with flanges (return walls) subjected to pseudo-static cyclic lateral loading is presented. Each wall failed in a diagonal tension mode followed by bed-joint sliding. The effect of wall flanges was to increase the displacement capacity of the in-plane loaded wall, when compared with an in-plane loaded wall without flanges. The measured shear strengths of the walls were compared with an analytical model for determining the limiting diagonal tension strength of walls, with a high level of correlation. The initial stiffness of the shear walls before effective yield was compared with the initial stiffness as determined using conventional principles of mechanics for homogeneous materials, and it was found that with so

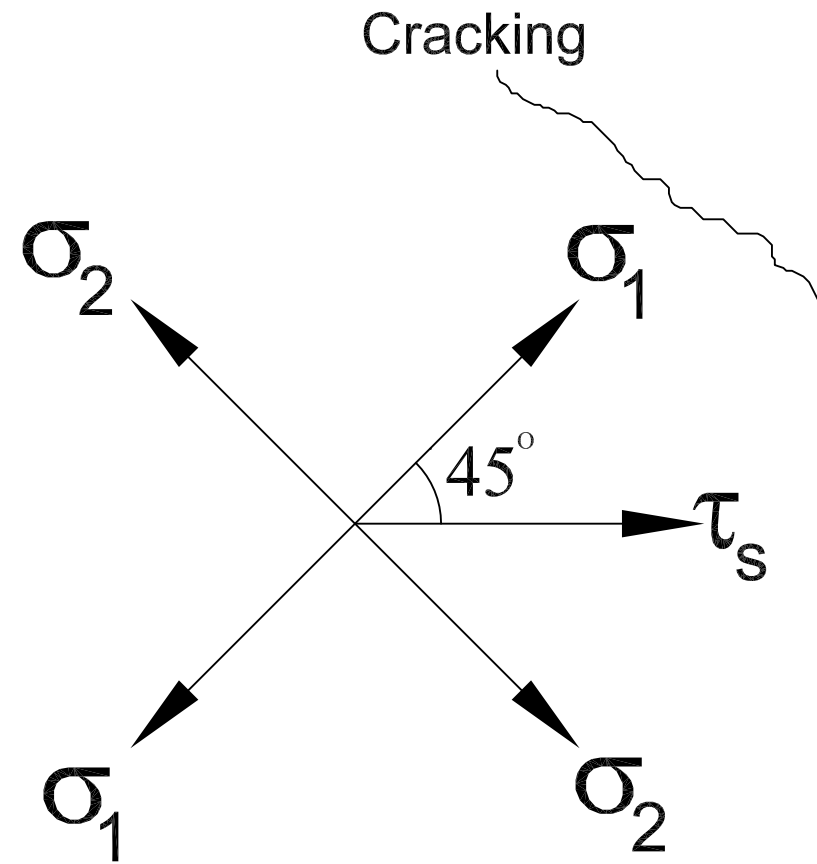
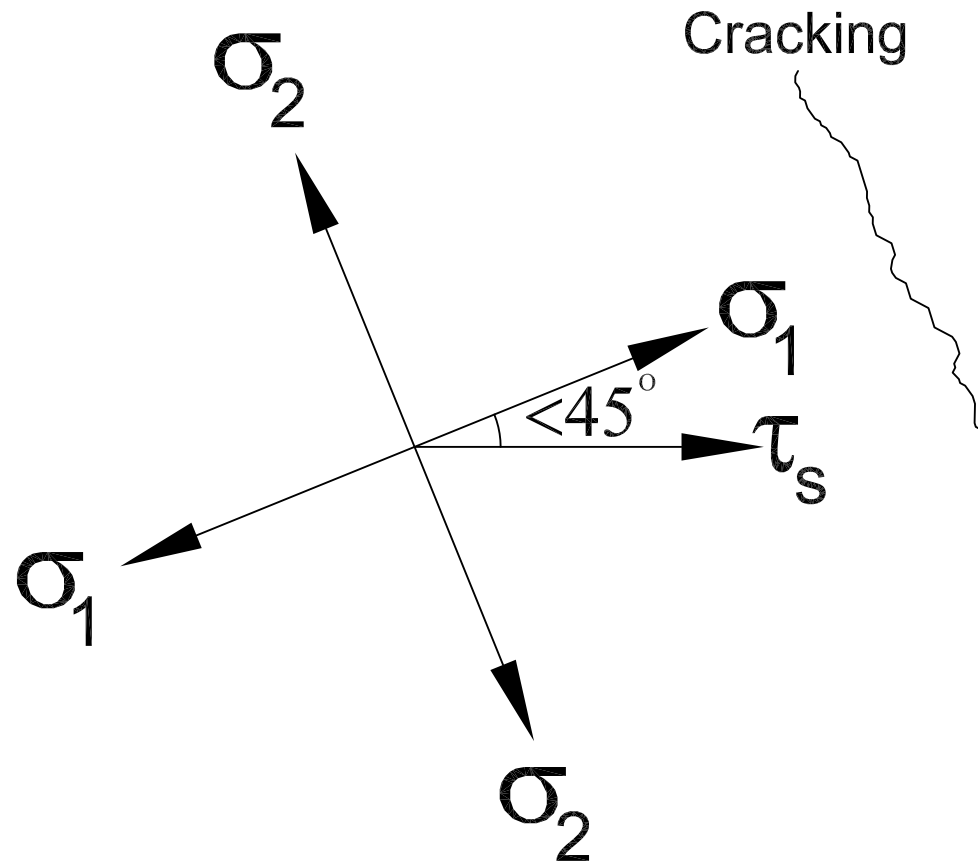
Figure 11: Flange effects on the orientation of cracking of in-plane wall

Conceptualised sketches of the cracking patterns of Walls A4 – A7 are shown in Figure 8. The length of the flange  $l_f$  as shown in Figure 11 refers to the total flange length. The actual cracking patterns are shown in Figure 8.

(a) Principal stress directions when no flange is present

(b) Principal stress directions when long flange is present

For a constant  $l_w$ , the shear stress at the ends of the in-plane wall increases with increasing flange length, relative to the maximum shear stress at the centre of the wall. Then, for a constant tensile cracking strength of masonry  $f_{dt}$ , the angle of cracking increases with increasing shear stress. This increase is because the angle between the direction of maximum principal tension stress and the state of pure stress decreases as the maximum shear stress increases (see Figure 12, where  $\sigma_1$ ,  $\sigma_2$  and  $\tau$  are the maximum principal (tension) stress, the minimum principal (compression) stress and shear stress, respectively). Consequently, walls with longer flanges will develop steeper diagonal tension cracks near the ends of the in-plane wall when compared with walls with shorter flanges (see Figure 11). This effect lessens with increasing flange length, and when the flange is longer than the effective length ( $6b_f$ ), the difference in crack angle is negligible.
