DIAGONAL COMPRESSION TESTING OF FRP-RETROFITTED UNREINFORCED CLAY BRICK MASONRY WALLETTES

Hamid Mahmood¹, S.M.ASCE
Jason M. Ingham², M.ASCE

To address concerns regarding the seismic vulnerability of New Zealand unreinforced masonry (URM) buildings, a research program was undertaken to investigate the effectiveness of fiber reinforced polymer (FRP) systems as a seismic retrofit intervention for in-plane loaded URM walls that are prone to fail in a shear mode during earthquakes. Seventeen URM wallettes were retrofitted with either externally-bonded (EB) glass FRP fabrics, EB pultruded carbon FRP (CFRP) plates or near-surface mounted pultruded CFRP rectangular bars. The wallettes were tested by the application of a diagonal compressive force, and data was recorded for applied force and corresponding wall drift. Results were compared with five nominally identical unretrofitted wallettes. It was determined that the FRP systems substantially increased the shear strength of the wallettes. Significant increases in the pseudo-ductility and the toughness were also obtained, which are all considered to be important goals of any seismic retrofit intervention.

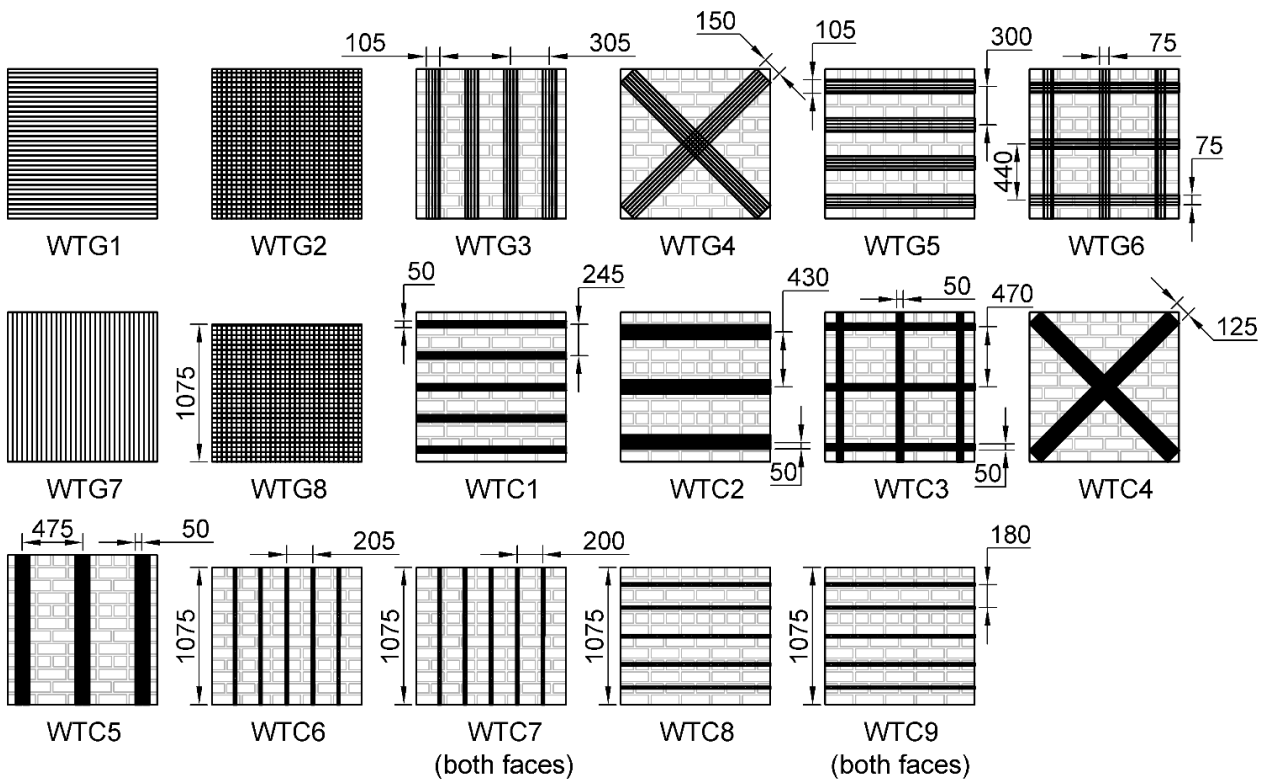
Figure 2: FRP retrofit details (all dimensions in mm). Walette height is 1170 mm unless otherwise noted.

The wallettes were retrofitted with FRP materials, including EB uniaxial and biaxial GFRP fabrics and pultruded CFRP plates and NSM rectangular bars. Consistent with FRP retrofit practice to preserve the architectural façade, retrofitting was applied on one wallette face only, except for wallettes WTC7 and WTC9, which were retrofitted on both faces. The retrofit details for each wallette are depicted in Fig. 2 (also see Table 2).

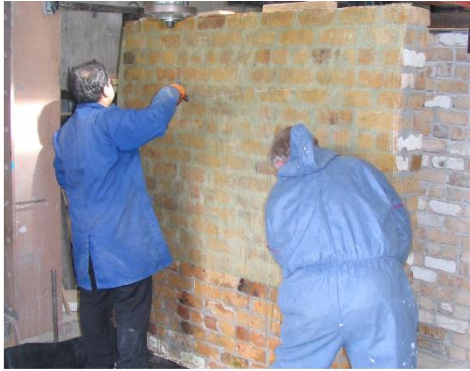
Figure 3: Installation of glass fabric on a wall that was retrofitted similarly to the test wallettes.

Glass fabrics were applied using a multi-stage process. First, the wallette surface was ground, and any imperfections were filled with putty to obtain a near smooth surface. The primer epoxy coat was then applied to the wallette, and an epoxy-saturated glass fabric was positioned (Fig. 3) and worked against the wallette surface with rollers to achieve a good bond. The fabric was anchored to the wallette with glass fiber anchors (Fyfe Co. LLC 2009), which were first soaked with epoxy and then inserted into predrilled holes in the wallette through the first layer of fabric. The anchors were splayed on the surface of the first fabric layer, and the second fabric layer was applied afterwards to achieve an almost plane surface. For full surface coverage of GFRP fabrics, twelve anchors were placed at regular intervals around the fabric perimeter, and for retrofits that involved strips cut from GFRP fabrics, one anchor was placed at each end of the strip. A similar process was used for bonding CFRP plates to the wallette, however no anchors were used. After preparing the wallette surfaces by grinding, plates were bonded using a two-component epoxy. In wallettes WTC3 and WTC4, the plates were overlapped at the junction of two plates. For NSM application of rectangular bars, grooves were cut into the wallettes. Grooves were cleaned using an air gun and solvent, and were left to dry before being filled with epoxy. Epoxy was also applied to rectangular NSM bars, which were then inserted into the epoxy-filled grooves.

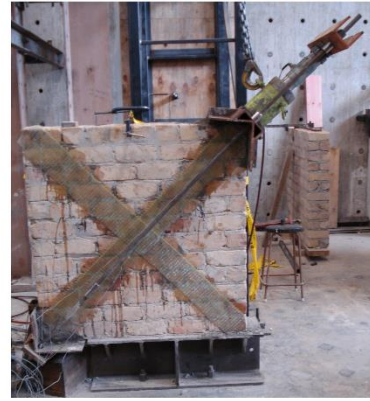
Figure 4: Test setup. For clarity, only one of the two portal gauges is shown. The other portal gauge was located behind the high-strength steel rod.

The test setup is shown in Fig. 4. The test wallettes were built separately and then placed on a steel I-beam for testing, with no mortar or other special connection provided between the wallette and the steel beam. The diagonal force was applied by means of a manually operated hydraulic actuator acting through a steel shoe placed at the top corner and was transferred to another loading shoe at the opposing bottom corner using two high-strength steel bars that were placed along each wallette face. Diagonal displacements were measured using two perpendicular portal gauges that were aligned along the wallette diagonals on the unretrofitted wall face. The wallettes were loaded continuously up to 50% of the expected maximum force, and in small increments (10–20% of the

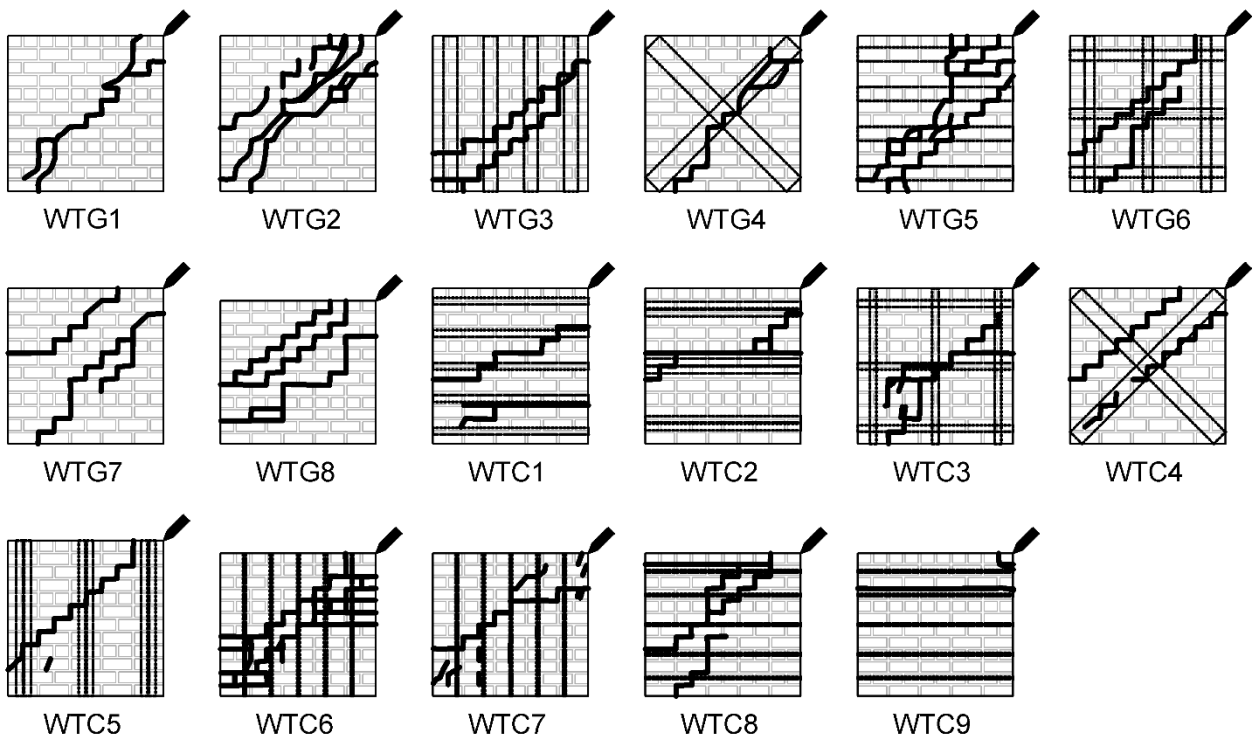
Figure 6: Cracking patterns of FRP-retrofitted walls.

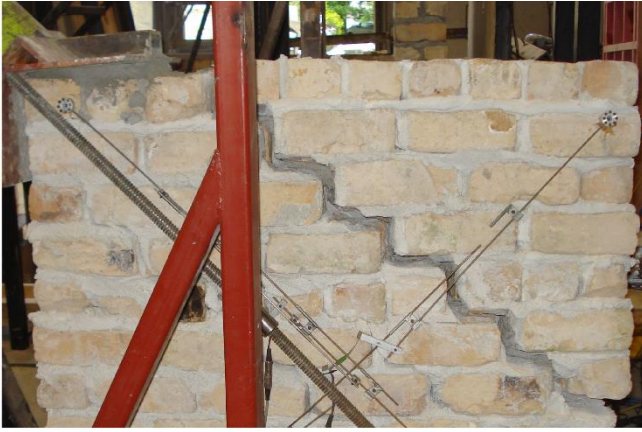
Figure 7: Diagonal crack in a wallette.

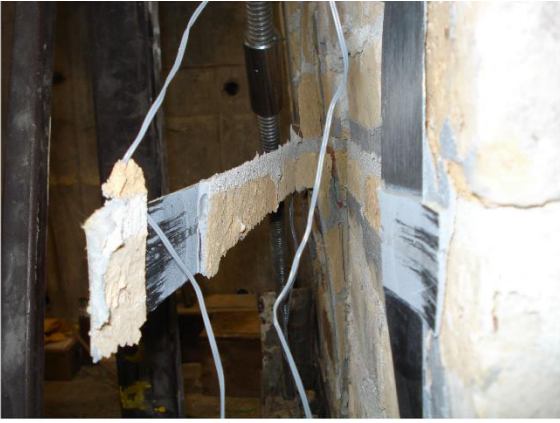
Figure 8: Debonding of CFRP plate.

Debonding of FRP was observed in the wallettes that were retrofitted with CFRP plates. The presence of overlapped CFRP plates in some wallettes also resulted in lower bond strength at the interface of the two plates (Figure 8), and contributed to low shear strength resulting from premature debonding of CFRP.

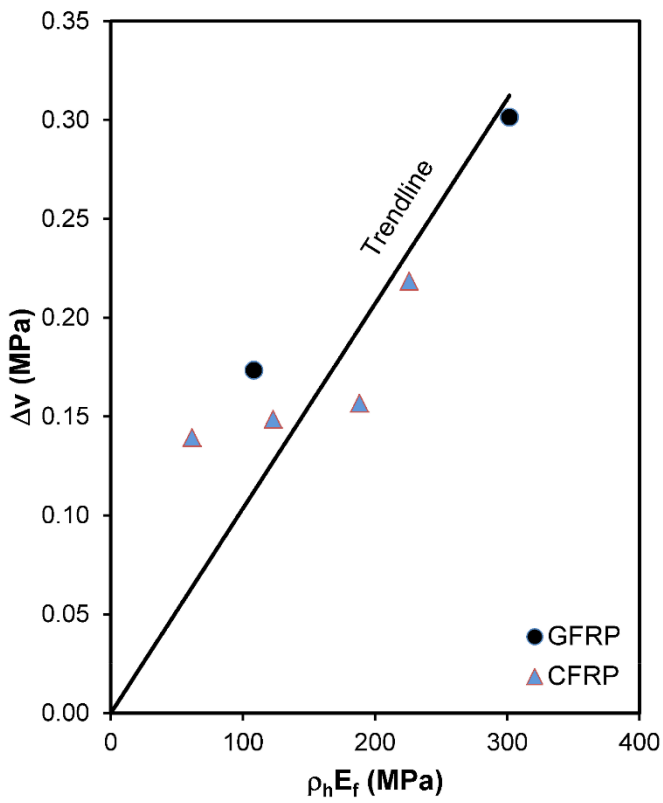
Figure 9: Increase in shear strength versus product of horizontal reinforcement ratio and FRP modulus of elasticity plot for horizontally-reinforced wallettes.

The increase in shear strength, Δv , has a linear relationship with the product $(\rho_h)(E_f)$ (ICC Evaluation Service 2007). This relationship was explored in Figure 9 by plotting Δv for horizontally-retrofitted wallettes only against $(\rho_h)(E_f)$, and a good linear fit was obtained, which was in agreement with the previous research findings.

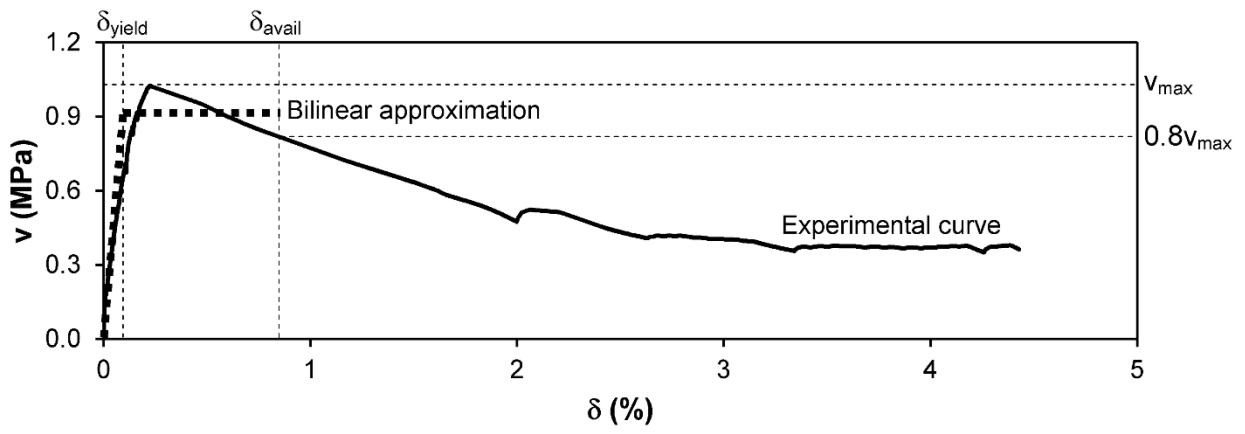
Figure 10: Bilinear approximation of experimental curve for wallette WTG2.

Ductility is the ability of a material to deform beyond the elastic range without fracturing or breaking and is an important parameter in seismic design. For materials without a distinct yield point, such as masonry, the concept of pseudo-ductility can be used. The yield drift, δ_{yield} , was determined from a bilinear equivalent elasto-plastic system (Fig. 10) with the same energy absorption as that of the wallette up to 80% of the strength in the post-peak region. The maximum available drift, δ_{avail} , is the post-peak drift at 80% of the strength. The available pseudo-ductility, μ , was hence calculated as the ratio of δ_{avail} to δ_{yield} . A similar concept has been used elsewhere (Marcari et al. 2007). The FRP retrofit interventions resulted in a large increase in pseudo-ductility (for values, see Table 4) for wallettes that failed by diagonal shear cracking, with large increases being achieved for two wallettes with only horizontal retrofits (WTG1 and WTC1), for the wallette with the grid of GFRP fabric strips (WTG6), and for the wallette with CFRP diagonal plates (WTC4). Relatively smaller pseudo-ductility values were achieved for the wallettes with NSM retrofits.
