International Journal of Food Engineering

Article 6

Fouling of Milk on Heat Transfer Surface with and without the Addition of *Bacillus stearothermophilus* – A Laboratory Study

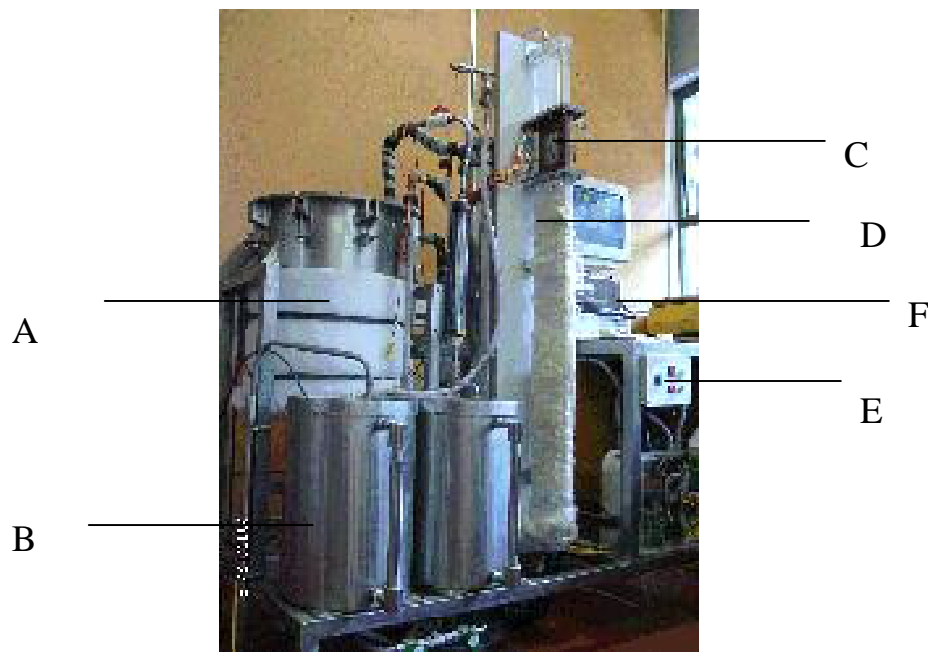
The fouling rig is shown in Figure 1. It is mainly made up of milk tank (A), cleaning solution tank (B), tank heaters (inside of A and B), test section (C), reference section (D), control equipment (E), and recording equipment (F). A data logging system is used to record heater temperature (T_s), milk temperatures at the inlet (T_{in}) and the outlet (T_{out}) of the test section, and milk temperature in the heated zone (T_{bulk}).

Figure 1: The photo of fouling apparatus: milk tank (A), cleaning solution tank (B), fouling test section (C), reference section (D), control equipment (E) and data recording equipment (F).

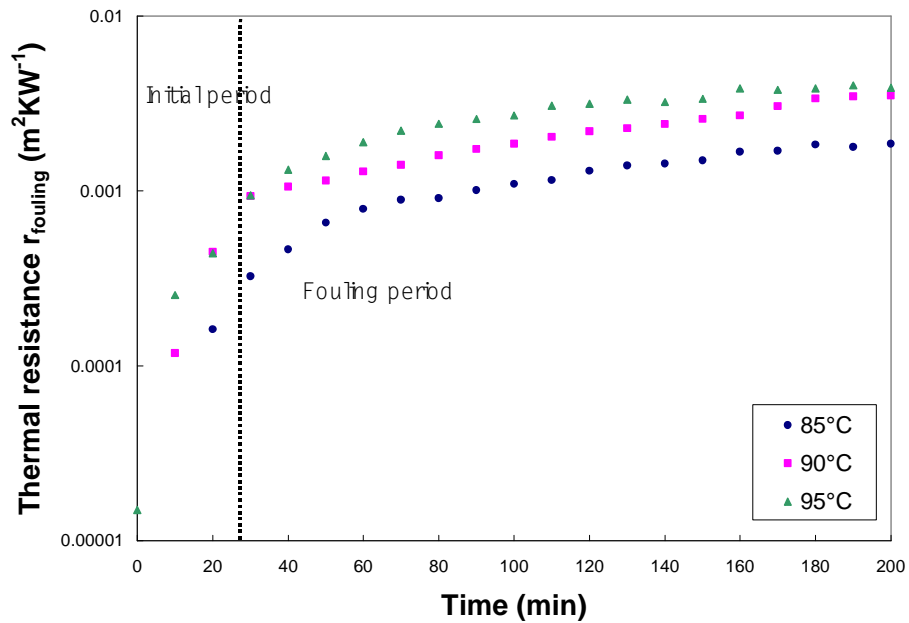
Figures 5 and 6 show the electrical resistance and thermal resistance respectively measured during the experiments. It can be seen that fouling took place in a typical pattern. A distinctive period was observed at the start of the fouling process where no fouling took place. This is induction period and is illustrated by almost little changes in both resistances. This is in line with the findings of Fryer (1997). This induction period may be a result of the time it required to develop suitable conditions for fouling. Figures 5b and 6b show the logarithmic plots to highlight the induction period. Longer induction period was observed at the lower wall temperature as expected.

Figure 6: Milk fouling without the addition of *Bacillus stearothermophilus* for 3.3 hours using thermal resistance: (a) general overview, (b) logarithmic view to highlight the initial period.

As observed with the electrical resistance and thermal resistance curves (see Figures 5 and 6) fouling was enhanced when the heater surface temperature was higher. The effect of temperature was much more evident in these early stages of the fouling process. The fouling resistance curves settled to similar asymptotic values near the end (see Figure 7). Hence similar values of deposit thickness were observed after 7 hours of operation.

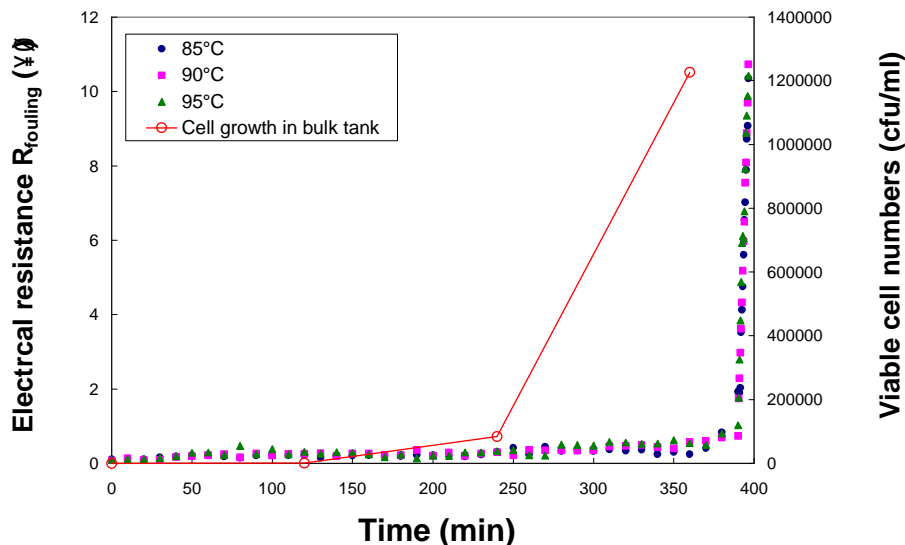
Figure 8 shows that the fouling pattern changed significantly with the addition of *Bacillus stearothermophilus*. Minimal fouling was observed for up to 6.4 hours at 85°C (electrical resistance $\approx 0.5\Omega$). Similar results were observed at 90°C and 95°C. In comparison, the electrical resistance values were significantly higher without the bacteria ($\approx 6\Omega$, see Figure 7).

Figure 8: Growth of *Bacillus stearothermophilus* in bulk tank and milk fouling with the addition of *Bacillus stearothermophilus* for 7 hours using electrical resistance.

The possible explanation for the mitigation of fouling by the bacteria is that the overall deposit strength reduced in the presence of *Bacillus stearothermophilus* and as a result the deposits were removed more easily by the hydrodynamic forces exerted by the process stream. The deposit removal process was confirmed by visual observations.

The concentration of the bacteria in the feed tank increased continuously from the initial value of 10^2 cfu/ml through out the fouling process. At 6 hours of operation, the concentration in the feed tank was measured to be 1.2×10^6 cfu/ml as shown in Figure 8. This was a result of the nutrients supplied by in the feed liquid. Interestingly, the electrical resistance of fouling did not changed much until the bacteria concentration in the feed tank was reached to 1.2×10^6 cfu/ml. The previous experience suggested that the bacteria concentration would increase more considerably after that (to the order of 10^7 cfu/ml) (Yoo et al, 2004). At such high concentrations, significant biologically induced fouling took place. The enhancement in the fouling rate was so significant after 6.4 hours of operation that the electrical resistance increased from 0.5Ω to 10Ω within around 0.5 hours. After the experiment, the deposit thickness was measured to be over 8 mm thick, which was about 2.5 times thicker than the deposit layer observed without the addition of *Bacillus stearothermophilus* (see Table 3).

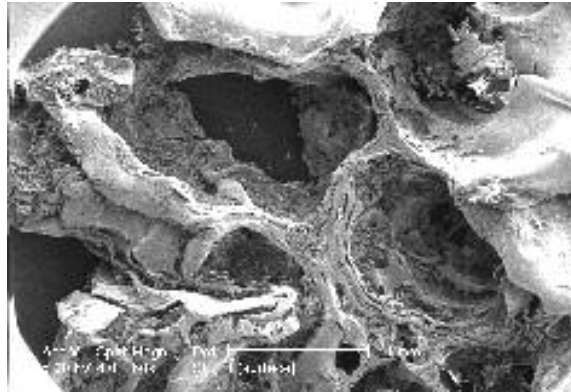
The SEM micrographs in Figure 13 show the surface structure of the milk fouling generated without the addition of *Bacillus stearothermophilus* after 3.3 hours of operation. At 85°C, the deposits seemed to be highly porous and were merely set (Figure 13a). At 90°C, the deposits were more compact with a lower porosity (Figure 13b). At 95°C, the deposits were dense (Figure 13c).

Figure 13: SEM micrographs of the deposits formed at deposit/solution interface at 3.3 hours (without the addition of *Bacillus stearothermophilus*): (a) at 85°C (mag. x 60), (b) at 90°C (mag. x 65), (c) at 95°C (mag. x 66).
