# Full-Scale Experimental Pushover Testing of an Existing URM

## Building

**Abstract:** Due to the large number of existing unreinforced masonry (URM) buildings worldwide, and the significant seismic risk that this building stock represents, it is important to quantify the seismic behaviour of such buildings in order to provide assessment guidance to practicing structural engineers. Current assessment guidelines have received little benchmarking against the results of large scale lateral testing of typical URM buildings. In response, field testing was performed on a decommissioned vintage URM building to investigate the in-situ behaviour of URM piers and compare actual behaviour to that predicted by existing assessment frameworks. The tested building was a prototypical, three-storey, 1930s fired clay brick URM building located in Auckland, New Zealand. A pushover test was performed by applying a load to the roof level of the building with a 22 tonne excavator, resulting in the formation of a pier rocking mechanism consistent with the predicted modes determined using current assessment guidelines for URM piers. Finite element modelling was able to replicate the results of the expe

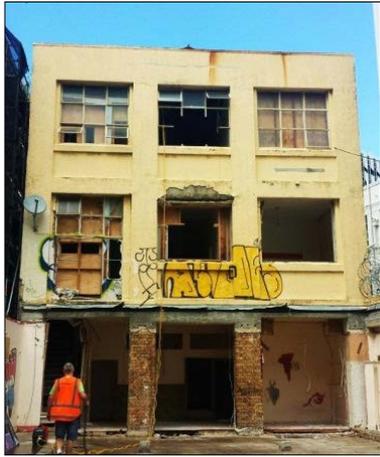
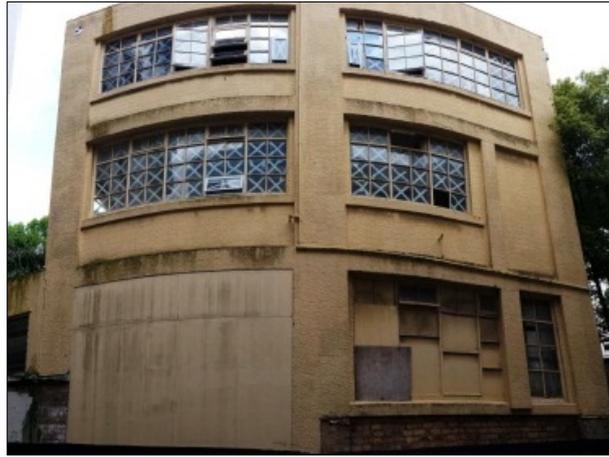
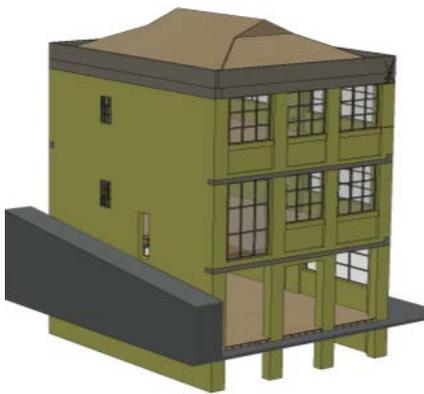
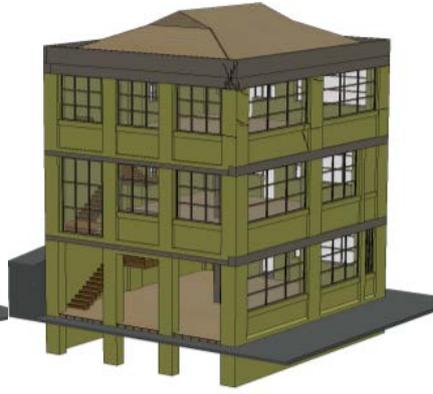
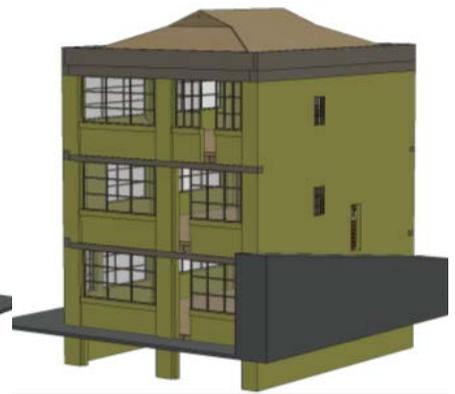
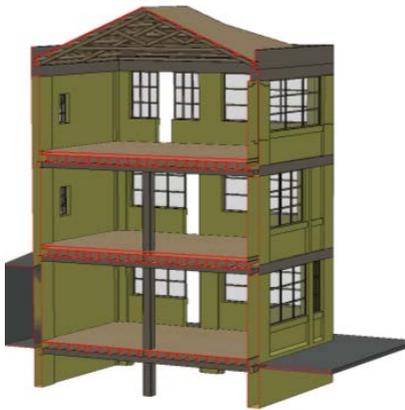
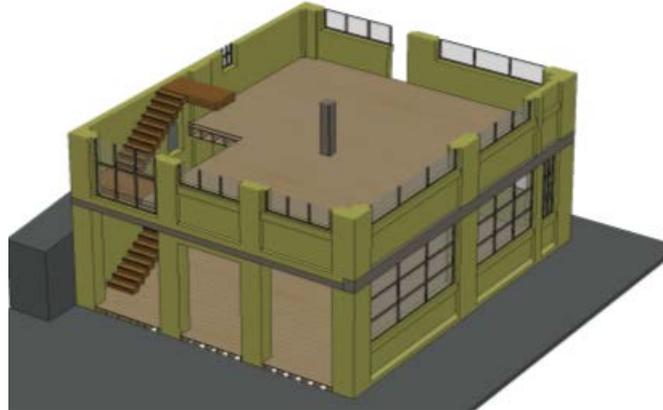
Figure 1. The tested building located at 27 Rutland Street, Auckland CBD

(a) North elevation

(b) West elevation

(c) N-E corner

(d) N-W corner

(e) S-E corner

(f) Elevation cross-section

(g) Floor-plan cross-section

The test building, located at 27 Rutland Street in the Auckland central business district (CBD), was a prototypical unreinforced clay brick masonry building [8 – 9] constructed in 1931. The building had floor dimensions of approximately 10 m in the E-W direction and 12 m in the N-S direction (see Figure 1). The

building consisted of four storeys, with three storeys above grade (approximately 11.3 m from grade to the top of the reinforced concrete (RC) parapet at the north elevation) and a basement level. The primary gravity loadbearing elements of the building consisted of URM piers and walls. A continuous RC bond beam extended around the perimeter of the building at the roof level, on which timber roof trusses were supported. RC bond beams at all other storey levels extended around the perimeter of the building (excluding the east elevation), where the RC beams acted as window lintels. The concrete bond beam on the east elevation lacked any reinforcement, and steel angle lintels were used over the few small openings on the east URM wall.

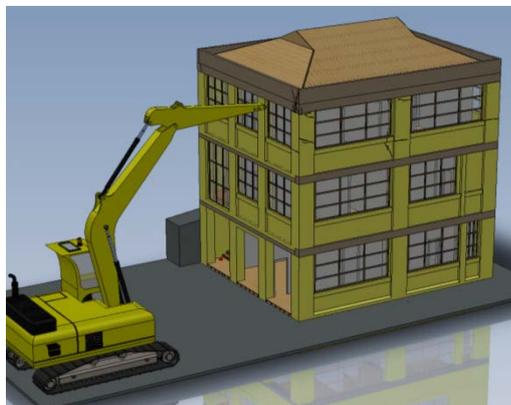
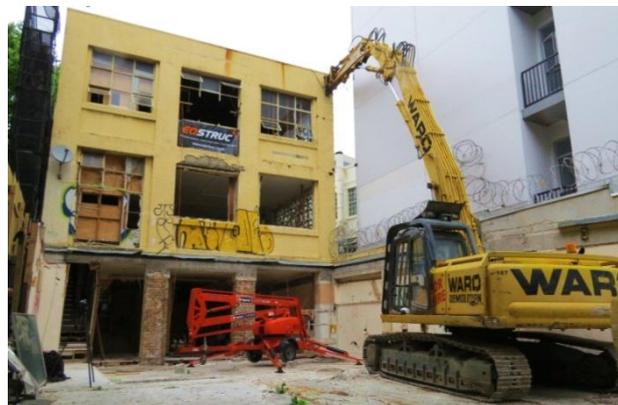
Figure 2. Excavator preparing to apply load for pushover testing

(a) Schematic showing loading of N-W corner (b) Photograph of north elevation prior to load application

Pushover testing of the subject building was simulated using a 22 tonne excavator (see Figure 2). The west elevation of the subject building was selected for testing due to the presence of large window openings on the elevation which formed three load-resisting URM piers that were estimated to have combined capacities less than that of the excavator (see Figure 1 and Figure 2), and for accessibility on site and reduced risk to public spaces. The failure mode and load capacity of the top storey piers was estimated with the current seismic assessment guidelines for URM buildings developed by the New Zealand Society for Earthquake Engineering (NZSEE) [11] and from ASCE 41 [27]. The ultimate capacities for the potential failure mechanisms are shown in Table 2 in which  $V_r$  relates to rocking failure,  $V_{tc}$  relates to toe crushing of the pier,  $V_{dt}$  relates to diagonal tension failure,  $V_s$  relates to bed-joint sliding failure of the piers, and  $V_{r,flanged}$  relates to the rocking failure of the piers while accounting for the flanged geometry of the North and South Piers (see Figure 1). The values for  $V_r$  and  $V_{tc}$  were calculated for two different boundary conditions including: fixity at the top and bottom of the piers ( $\alpha = 1.0$ ); and fixity at the pier base but free to rotate at the top of the pier ( $\alpha = 0.5$ ). While it is common practice to assume fixity at the top and bottom of these piers, the fixed-free case was investigated as a lower bound strength and was used to benchmark against the realistic boundary conditions found in the test building. It was predicted that the URM piers would be subjected to a rocking type failure occurring at a load of 73 kN if the piers exhibited fixity at both their top and base ( $\alpha = 1.0$ ) or at 41 kN if the piers exhibited fixity only at their base ( $\alpha = 0.5$ ) (Table 2).

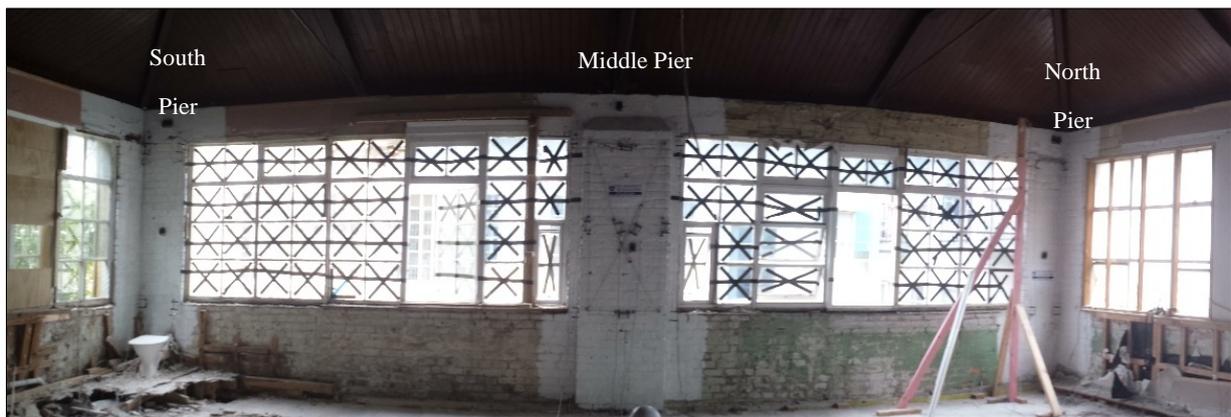
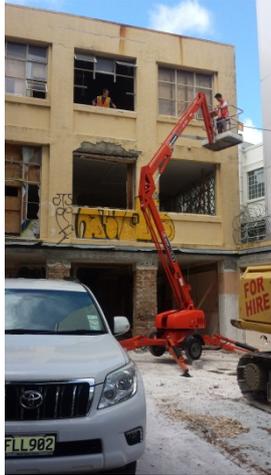
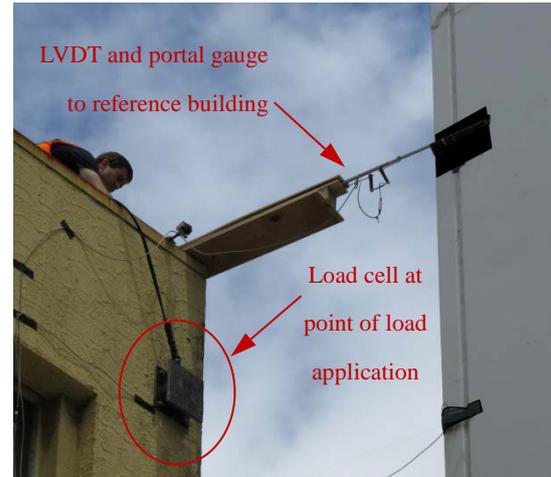
Figure 3. Test instrumentation

(a) West-facing interior view of second storey test wall showing instrumentation. Push loading was applied to the North pier

(b) Installation of external instrumentation

(c) Load cell with loading plate and LVDT mounted to adjacent reference building

The overall load deformation response was measured with a load cell fixed at the roof level at the point of load

application. A steel plate attached to the load cell was used for the excavator to apply loads to the building without inducing damage to the load cell (see Figure 3c). Due to the anticipated rocking mechanism of the second storey piers, insignificant lateral load was expected to be transferred to the lower storey URM piers. This limited force transfer, limited site access, and tight time restraints resulted in only the second storey URM piers being heavily instrumented (see Figure 3a). Vertical deformations at the ends of each URM pier were measured to quantify pier uplift and rotation. The overall displacement of the building near to the point of load application was measured with an exterior LVDT mounted to the roof and by measuring displacements relative to the adjacent “reference” building (see Figure 3d).

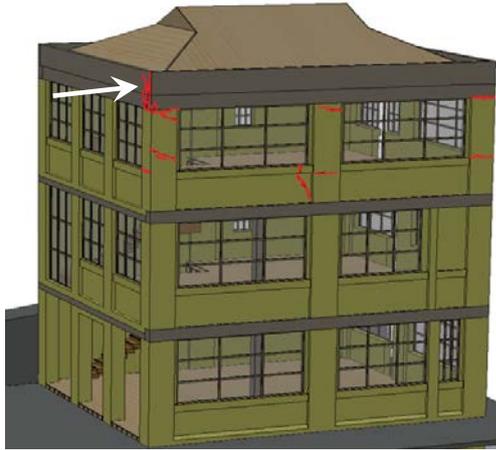
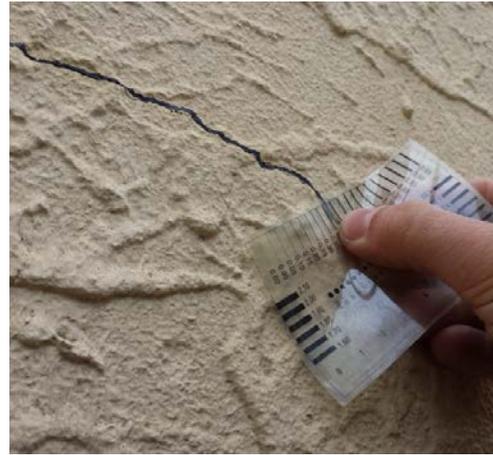
Figure 4. Observed cracking damage

(a) Observed crack damage (marked in red). Arrow indicates direction and location of load application

(b) Observed cracks widths (0.1 mm to 2.0 mm)

Following the completion of eight loading cycles, horizontal cracking was observed at the top and bottom of each of the second storey URM piers (see Figure 4). The observed crack pattern was consistent with the predicted rocking response of the second storey URM piers. No cracking was observed on either the first or ground storeys, suggesting that as expected, the pier rocking limited the shear demands to the lower storeys. Multiple cracks radiating away and around the load cell were observed that appeared to be local effects of masonry damage at the point of load application.

were approximately four times greater than at the bottom, which is consistent with the large cracks observed at the pier tops after testing (see Figure 4a), suggesting that flexural deformation occurred in the piers, rather than pure rigid body rotation of the piers.

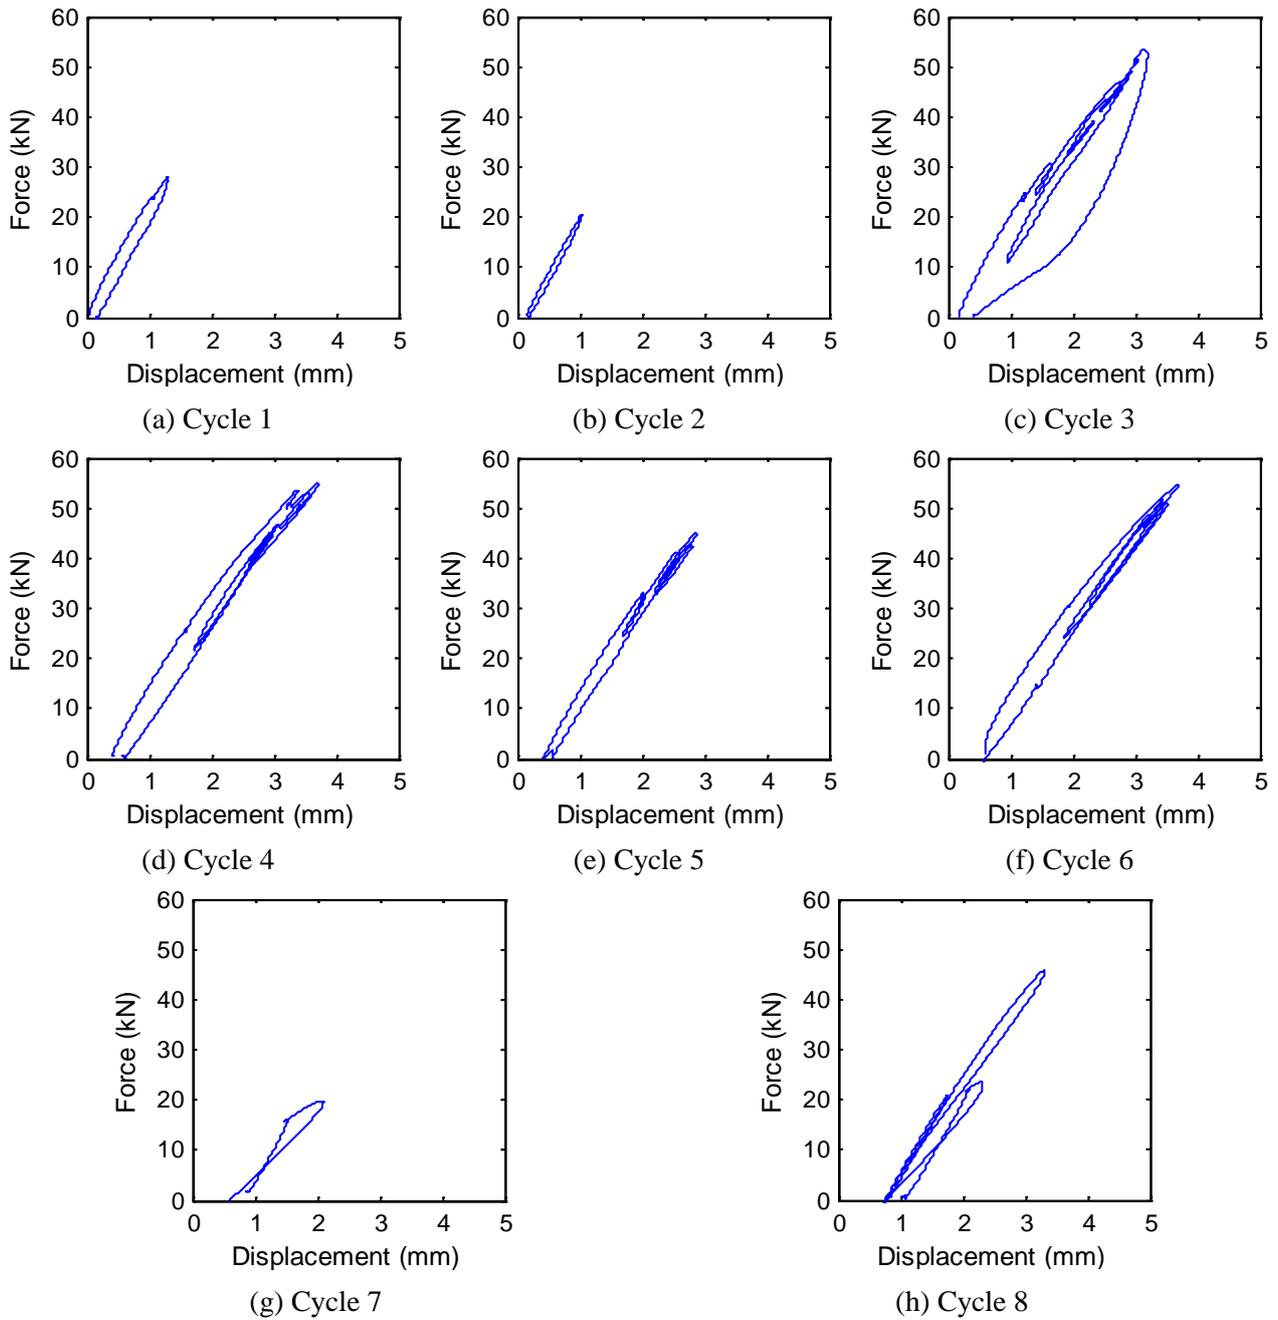
Figure 5. Force-displacement cycles of test wall at roof level. Note: displacement measured from exterior LVDT

The force-displacement behaviour of the west elevation is shown in Figure 5. Overall, the west elevation of the test building behaved in an elastic manner over the range of applied loading, with a consistent secant stiffness of approximately 16 kN/mm for each cycle. It should be noted that due to data acquisition complications, the hysteretic response of the initial (uncracked) stages of the test were not captured, including the initiation of cracking, and as such the force-displacement response shown in Figure 5 represents the cracked section behaviour for each cycle. The consistent secant stiffness observed is likely to be a result of all cycles representing the cracked section behaviour. Approximately 1 mm of residual displacement was observed during the portion of testing for which data acquisition was available. While the total residual displacement (defined with respect to the pre-test datum) was not measured, post-test observations of the top storey during crack mapping of the wall exterior indicated that any residual displacement was small. This small amount of residual displacement was attributed to local damage to the masonry in the area surrounding the applied load. The lack of significant residual displacement also suggested that there was no sliding of the concrete bond

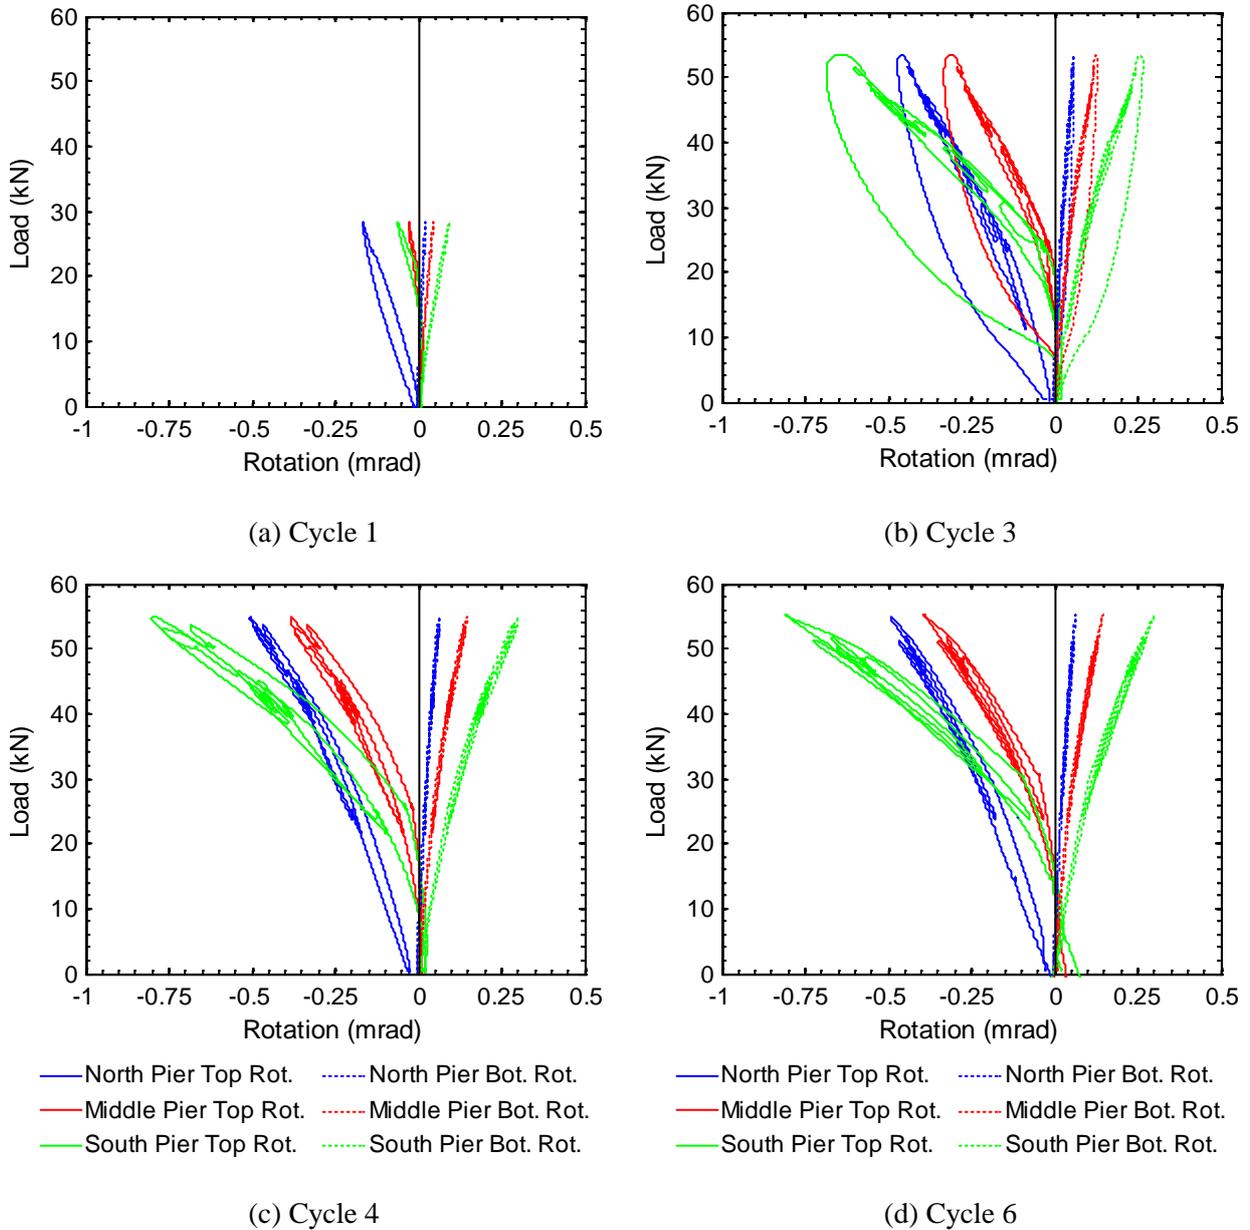
Figure 6. Selected experimentally measured pier rotation cycles of the test building at the second storey west façade

While the overall rotations for the north and middle piers were similar, the south pier experienced rotations of approximately twice the magnitude of the other piers at cycles with loading above 30 kN (see Figure 6). This increased rotation was most likely a result of the flange orientation at the north and south piers and the unidirectional loading (see Figure 3a for pier flange characteristics). Because the load was applied in only one direction, the north and south piers would be expected to have different lateral behaviour due to the opposite flange orientation between piers (see Figure 7). In the south pier, the flange was located on the compression face. When rocking initiated, the in-plane portion of the south pier cracked and the flange resisted the compression force. Because the flange was rocking out-of-plane, the moment of inertia and pier self-weight resisting the lateral load in the south pier was smaller than for the other two piers. Conversely, the north pier flange was located on the tension side of the section (see Figure 7). When cracking initiated through the flange, the north pier still had the majority of the in-plane portion to resist load, which had a much larger moment of inertia than the cracked section of the south pier. Also, the self-weight and roof load were located such that they acted to resist overturning and as a result worked to supplement the larger moment of inertia of the north pier to reduce the overall rotations. This discrepancy in stiffness between the North and South piers is consistent with the variation in strength between these two piers as predicted by the NZSEE assessment

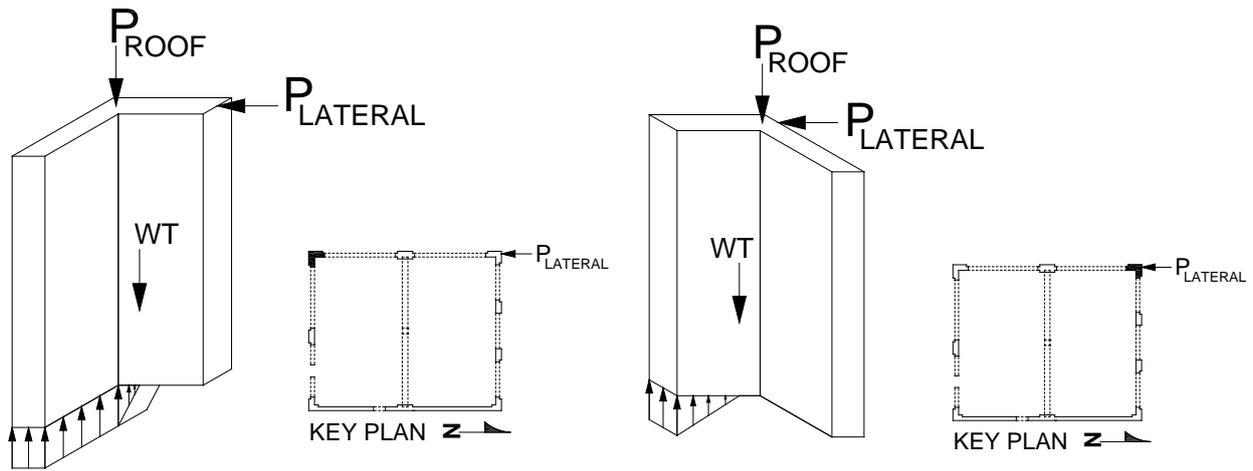
(a) Load distribution on South Pier

(b) Load distribution on North Pier

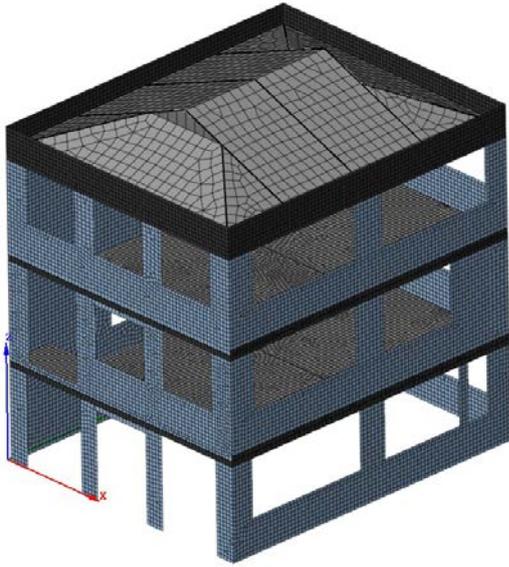
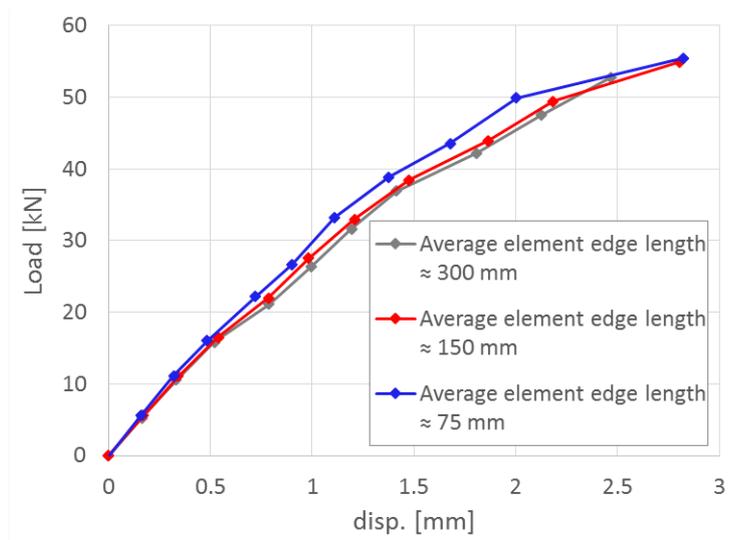
Figure 8. Sensitivity of the building model to the mesh size (nonlinear analysis with smeared cracking)

(a) Average masonry/concrete element size:  
150x150 mm<sup>2</sup> (quadrilateral)

(b) Capacity curve comparison of different model mesh sizes (loading scheme as per experimental pushover)

The smeared crack approach is known to be mesh sensitive as the energy dissipated during the cracking process is dependent on the size of the finite elements. This dependency can be effectively mitigated by referring to a crack bandwidth as proposed by Bazant and Oh [30]. When specific input values for the crack bandwidth are absent, the default length for quadratic elements in DIANA is equal to the square root of the element area. In order to investigate the model sensitivity to element mesh size, a nonlinear pushover was performed on the model with three different mesh sizes for the nonlinear masonry and concrete elements (Figure 8). The crack bandwidth was determined as described by Bazant and Oh [30], and the maximum element size was limited by the geometry of the structural elements. Mesh quality was checked by referring to the utilities embedded in the software package. As can be seen in Figure 8b, the model had limited sensitivity to mesh size, with the same secant stiffness at 2.5 mm displacement and only slightly higher tangent stiffness when a mesh of 75 mm average element length was used. Given the limited sensitivity of the model to mesh size, a mesh of 150 mm was used for all subsequent analyses.

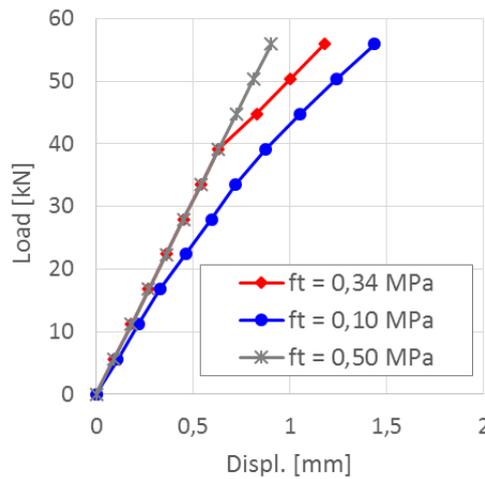
Figure 9. Pushover response with different masonry flexural tensile strengths

behaviour initiating at a load level of approximately 40 kN and resulting in a reduction of stiffness to approximately 45%, which is contrary to experimental observations (Figure 9). Due to the variation in the experimental value of the flexural bond strength ( $CoV = 0.58$ ), sensitivity analyses on masonry tensile strength were performed. A reduction of the tensile strength value resulted in a smoother pushover response curve, with crack formation occurring as soon as the lateral load was applied. The lower bound value (mean value minus one standard deviation,  $f_{t,lower\ bound} = f'_{fb} - \sigma_{f'_{fb}}$ ) of  $f_{t,l} = 0.1\ MPa$  was considered a reasonable choice (Figure 9) as this selection corresponded to a crack pattern in the model that was compatible with the damage observed during the testing (Figure 10). Values of  $f_t$  smaller than 0.075 MPa lead to an excessively large amount of cracking when compared to field observations and shifted the pier failure mechanism from rocking to shear failure. For values of  $f_t$  larger than the mean of  $f'_{fb}$ , the model responded elastically up to the loading corresponding to the maximum experimentally applied force (Figure 9). It should be noted that the selected lower bound  $f_t$  value of 0.1 corresponds with the values suggested by Eurocode 6 [32] in which for masonry prisms where the mortar compressive strength is less than 5 MPa (cf 4.3 MPa as reported in Table 1), the characteristic values of flexural tensile strength range from 0.05 MPa to 0.10 MPa.

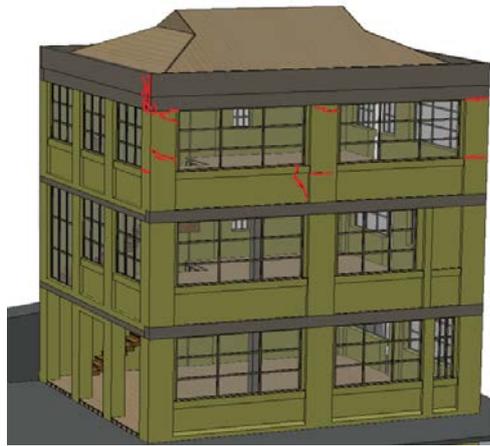
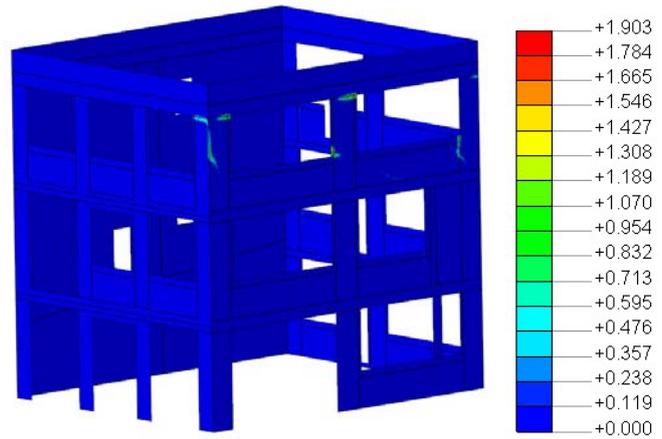
Figure 10. Crack pattern from pushover testing on Rutland St Building

(a) experimentally observed cracks

(b) numerical results for last pushover cycle displacement (maximum crack width in mm)

The FE model of the building was subjected to a point load at the northwest corner of the roof level to simulate the loading during experimental testing. As shown in Figure 10 the crack pattern obtained from the numerical model was compared to that observed from the tested building. Consistent with the experimental behaviour,

pier-rocking at the building top level (west) dominated the numerical response, with the formation of horizontal cracks at the top and at the bottom of the masonry panels. No cracking greater than 0.05 mm was observed elsewhere in the building.

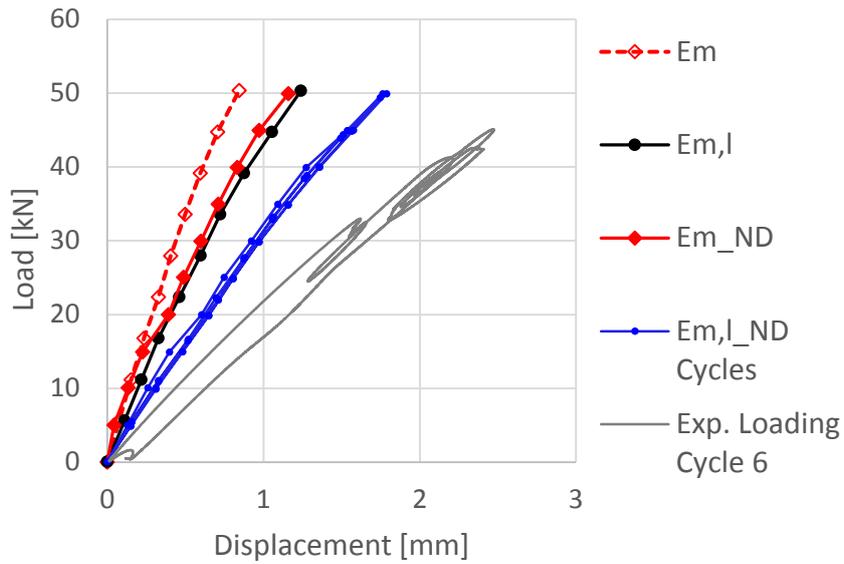
Figure 11. Pushover curve comparison between experimental roof deformations and load vs. numerical results for different model stiffnesses

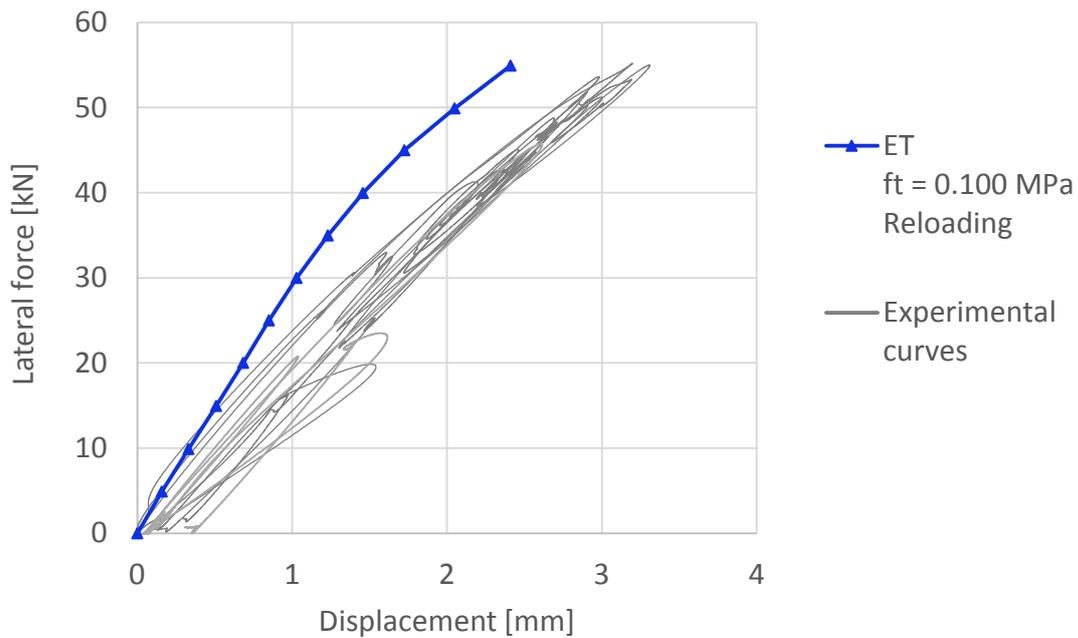
Figure 12. Pushover curve comparison between experimental results and numerical results with reduced masonry elastic modulus in tension at the third level

where  $h$  is the average length of the shell elements,  $m$  is the number of interface lines in a mesh set and  $n$  is the number of element rows in a mesh set. The resulting capacity curves, which are given in Figure 12, showed an improved agreement with the experimental data.

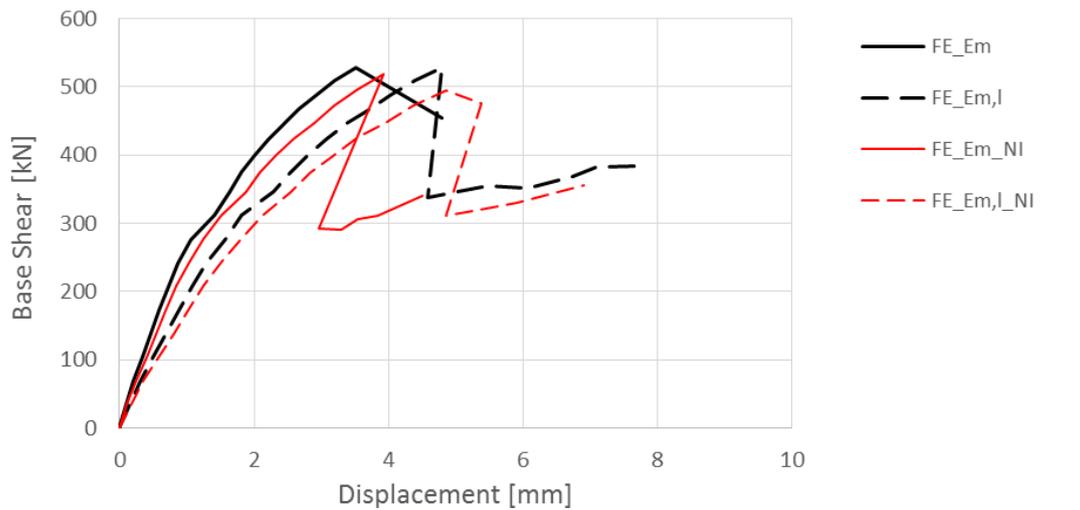
Figure 13 Building capacity curves of the finite element (FE) model for mass proportional loading in the North-South direction. (The subscripts Em = mean modulus of elasticity of masonry, Em,I = lower bound modulus of elasticity of masonry, and NI = ineffective connection between orthogonal walls).

Figure 13 shows the pushover curves obtained from the finite element model when subjected to increasing lateral loading. Mass proportional loading was applied in the North-South loading direction, and the Northwest corner of the roof was used as the control point to maintain consistency with the experimental testing. As expected, the adoption of the lower bound value for the masonry MoE (dashed black line in Figure 13) in lieu of the mean value (solid black line in Figure 13) decreased the overall stiffness, with a negligible effect on the maximum shear capacity, which was approximately 520 kN. In order to provide a more direct comparison to the NZSEE/ASCE assessment methods and macro element model, the FEM was run with the connections between orthogonal intersecting walls are ineffective, such behaviour is inherent in the formulation of both the NZSEE/ASCE and ME models. The response of the ineffective wall connection FE model permutations are shown in red in Figure 13, and as expected, the lack of effective connection between the walls resulted in a further stiffness reduction.

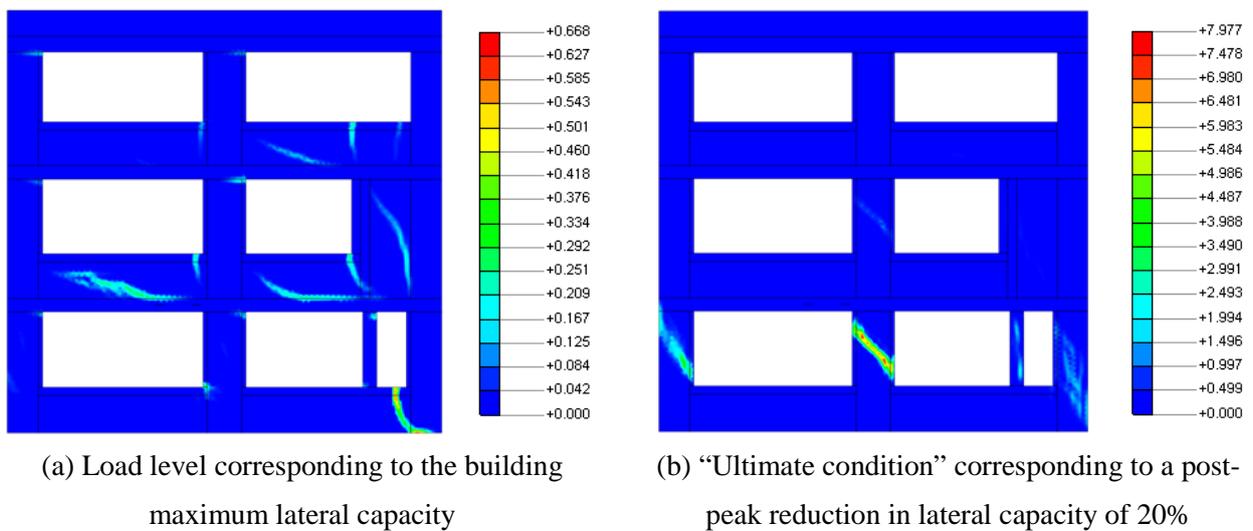
Figure 14 FE-model damage pattern evolution on West façade (scale shows principal crack width [mm]).

Analysis of the crack pattern evolution showed that damage mainly occurred on the West façade, with the onset of pier rocking mechanisms at all storey levels, diffused cracking in the spandrels at the second level (Figure 14a), followed by diagonal shear failure of the piers at the ground level (Figure 14b). In conjunction with shear failure developing in the piers on the West façade, diffused in-plane cracking simultaneously started to develop on the other building façades (Figure 15). It should be noted that the crack width maps shown in Figure 14b and Figure 15 are at different scales.

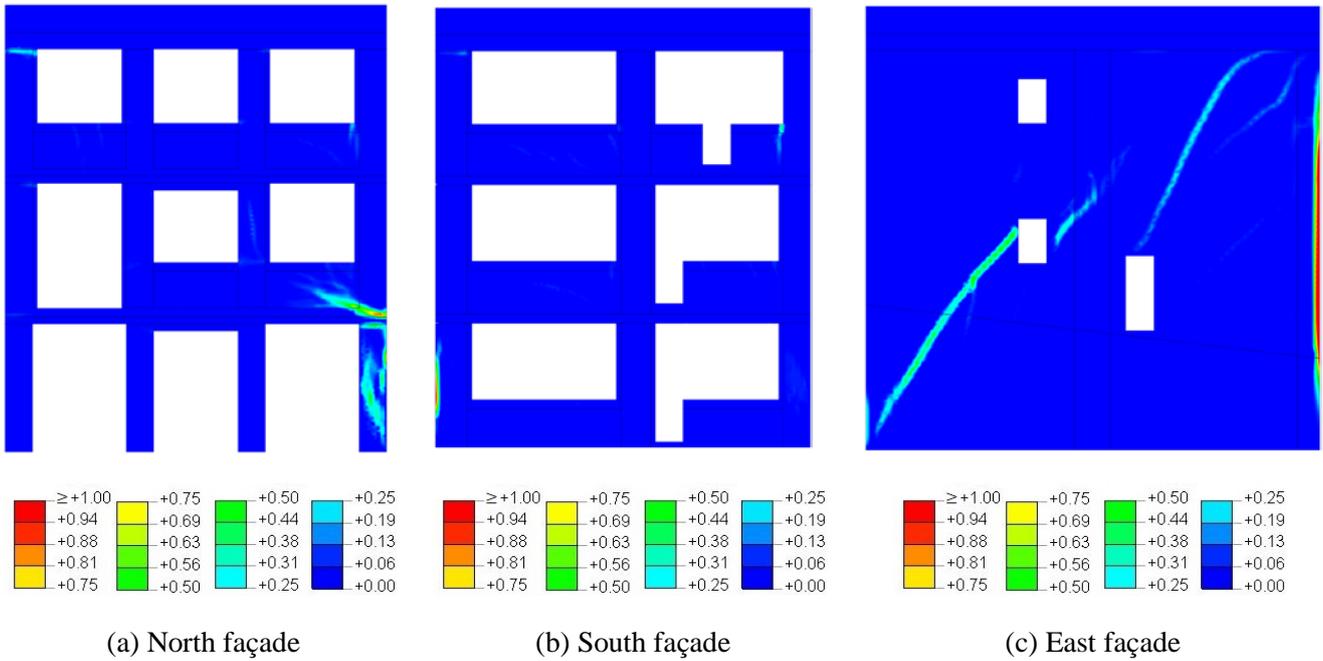
Figure 15 FE-model damage patterns on South and East facades at ultimate condition (scale shows principal crack width [mm])

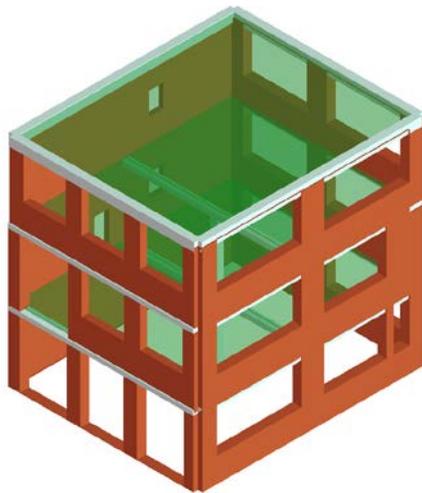
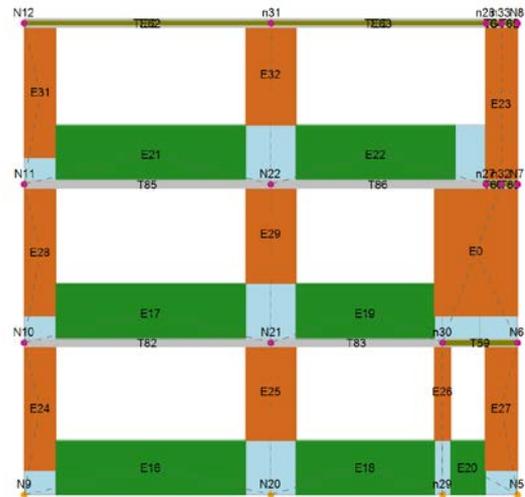
Figure 16 Macro-element model overview and West façade model components

(a) overview of building model

(b) mesh details of West façade (green = spandrel element; brown = pier element; light blue = rigid node; grey = concrete beam element)

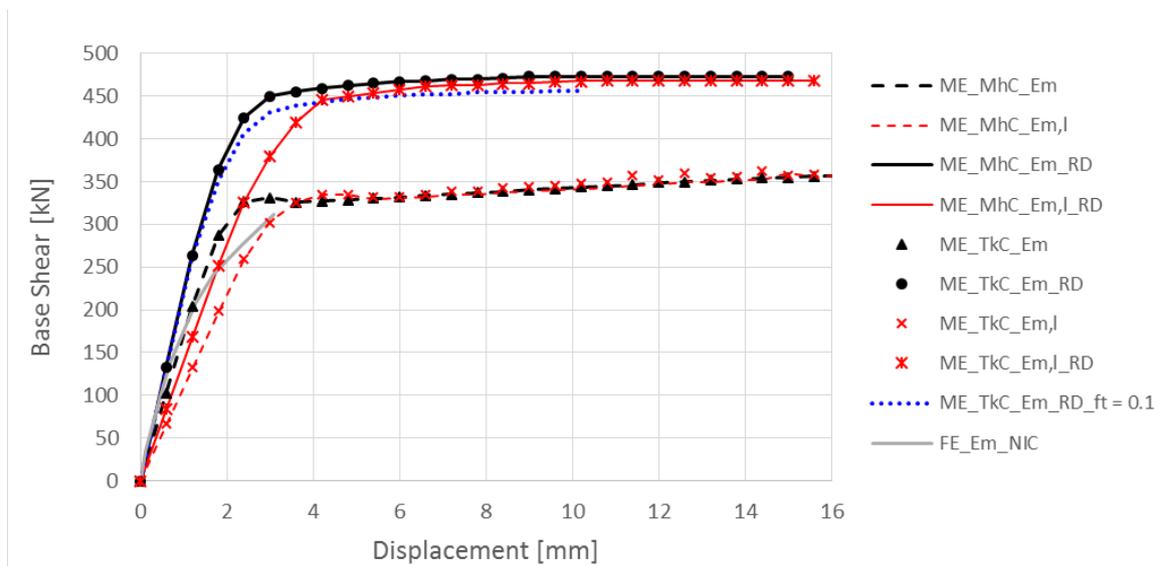
Figure 17 Macro-element (ME) model. Building capacity curves – North-South loading direction, load proportional to mass distribution (MhC = Mohr-Coulomb shear failure criterion, TkC = Turnšek & Cačovic [38] shear failure criterion, RD = rigid diaphragms, NIC = ineffective connection between orthogonal intersecting elements including concrete parapets and ring beams).

ringbeams, the maximum shear force sustained by the West façade ( $\approx 150$  kN) corresponded to the sum of the  $V_{rd}$  shear capacities of the piers determined from the shear-type building model assumption ( $\alpha = 1$ , Eq. 2). As already mentioned, unlike the FE model (Figure 19a), the ME model showed no damage in the other building façades, with the elements remaining well within their elastic phase throughout the entire analysis (Figure 19b). When the rigid diaphragm option was selected (Figure 19c) a significant increase in the building capacity was observed (Figure 17), with more load being transferred to the East façade and also the engagement of the rocking capacity of the piers on the North façade (Figure 19c, compare also Figure 19c with Figure 19a). The resulting capacity appears to be compatible with the capacity level exhibited by the FE model. This disparate behaviour shown by the two models was partially attributed to the stiffening effect on the diaphragms produced by the connections at the façade corners between concrete elements that ran perpendicular to each other in the FE model. When the concrete elements were prevented from transferring out-of-plane bending moments to the adjacent perpendicular elements, the FE response became closer to that of the ME model (see curve labelled as *FE\_Em\_NIC* in Figure 17).

The final ME model variation utilized a  $f_{t,cr}$  value equal to the value adopted for  $f_t$  in the FE modelling (i.e. 0.1 MPa). The initial stiffness and the base shear capacity of this model remained unaltered (see the curve labelled as *ME\_TkC\_Em\_RD\_ft = 0.1* in Figure 17) but the model experienced a change in failure mode. The new failure had the spandrels exceeding their plastic threshold, and the central pier at the ground level of West façade failing in shear (Figure 18b), similarly to what was observed from the FE model (Figure 14).

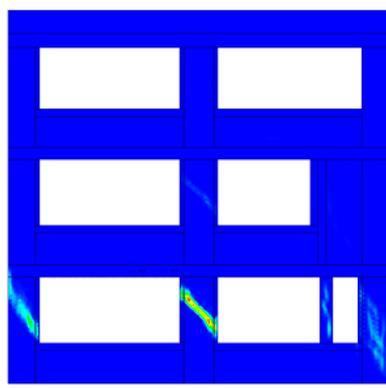
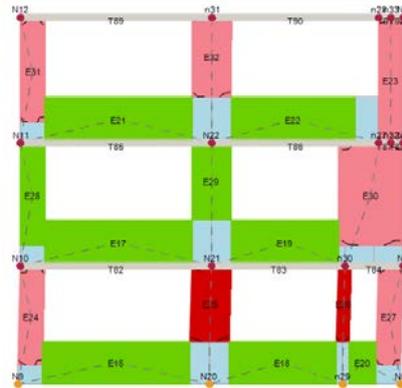
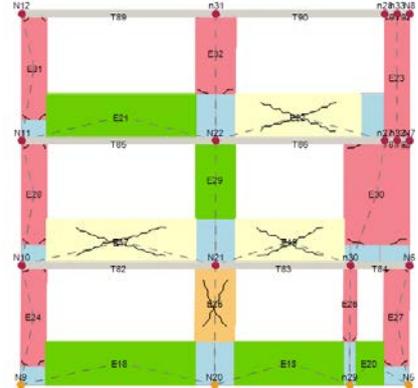
Figure 18 Damage pattern on West façade (perpendicular to the loading direction)

(a) FE model at ultimate capacity crack width [mm]

(b) Mohr-Coulomb and Turnšek & Cačovic shear failure criteria ( $f_{t,cr} = 1.5 \times \tau_0$ )

(c) Turnšek & Cačovic shear failure criterion ( $f_{t,cr} = f_t = 0.1 \text{ MPa}$ )

Multiple model formulations were investigated to determine the change in response of the model to different shear failure criterion, masonry stiffness, masonry tensile strength, and diaphragm type, and how these parameters altered the response with respect to the calibrated FE model pushover response. These different model permutations are summarised in Table 6. Shown in Figure 17 are the resulting capacity curves obtained from the pushover analysis performed with the ME model. Irrespective of the shear failure criterion or the masonry MoE value selected, the model showed a maximum capacity of approximately 350 kN (33% smaller than the capacity from the FE model), with failure characterized by rocking of the piers at the ground level of the West façade (Figure 18). Because of the spandrel geometry and the presence of the concrete

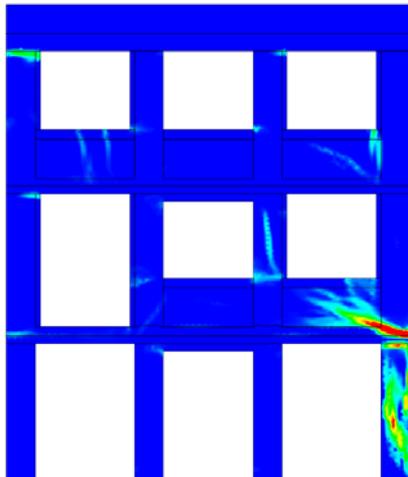
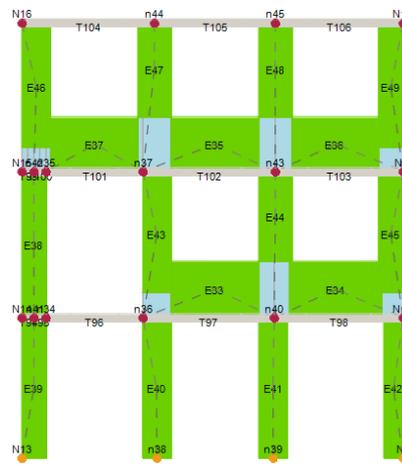
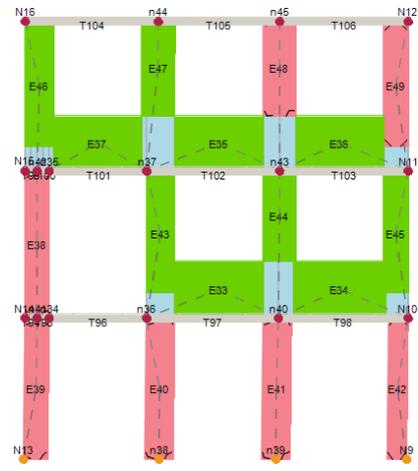
Figure 19 Damage pattern on North façade (perpendicular to the loading direction)

(a) FE model crack width [mm]

(b) ME model

(c) ME model (rigid diaphragms)

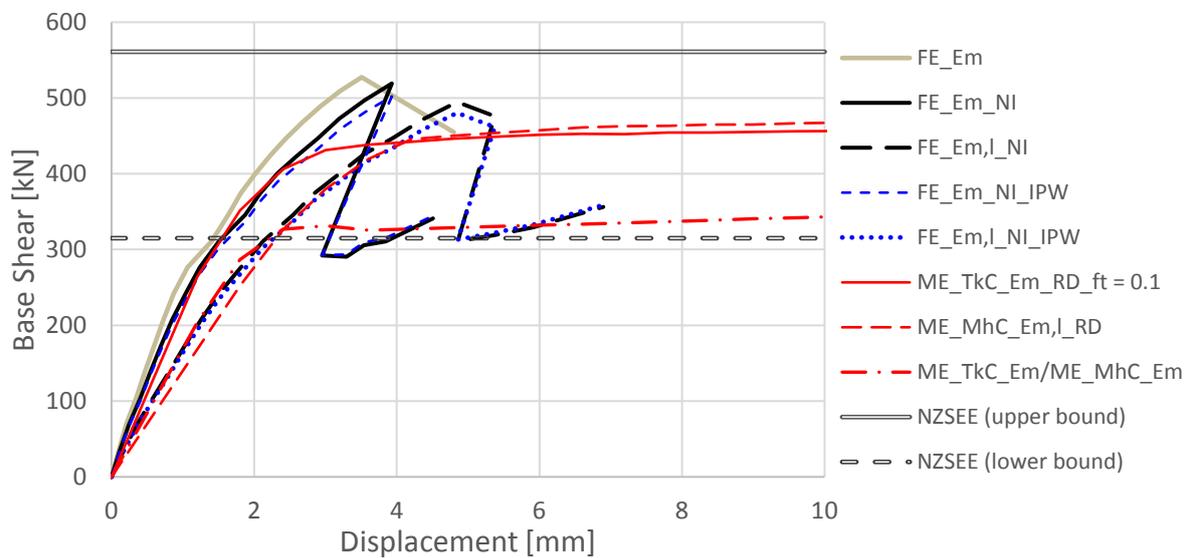
Figure 20 Capacity curve comparison (IPW = capacity contribution from the out-of-plane loaded wall is neglected).
