# INVESTIGATION OF COOLING WATER CHEMICAL DOSING: THE OHAAKI GEOTHERMAL POWER STATION COOLING TOWER

Morris Young<sup>1,2\*</sup> and Sadiq J. Zarrouk<sup>2</sup>

<sup>1</sup>Contact Energy Ltd, Wairakei Power Station, Taupo, New Zealand

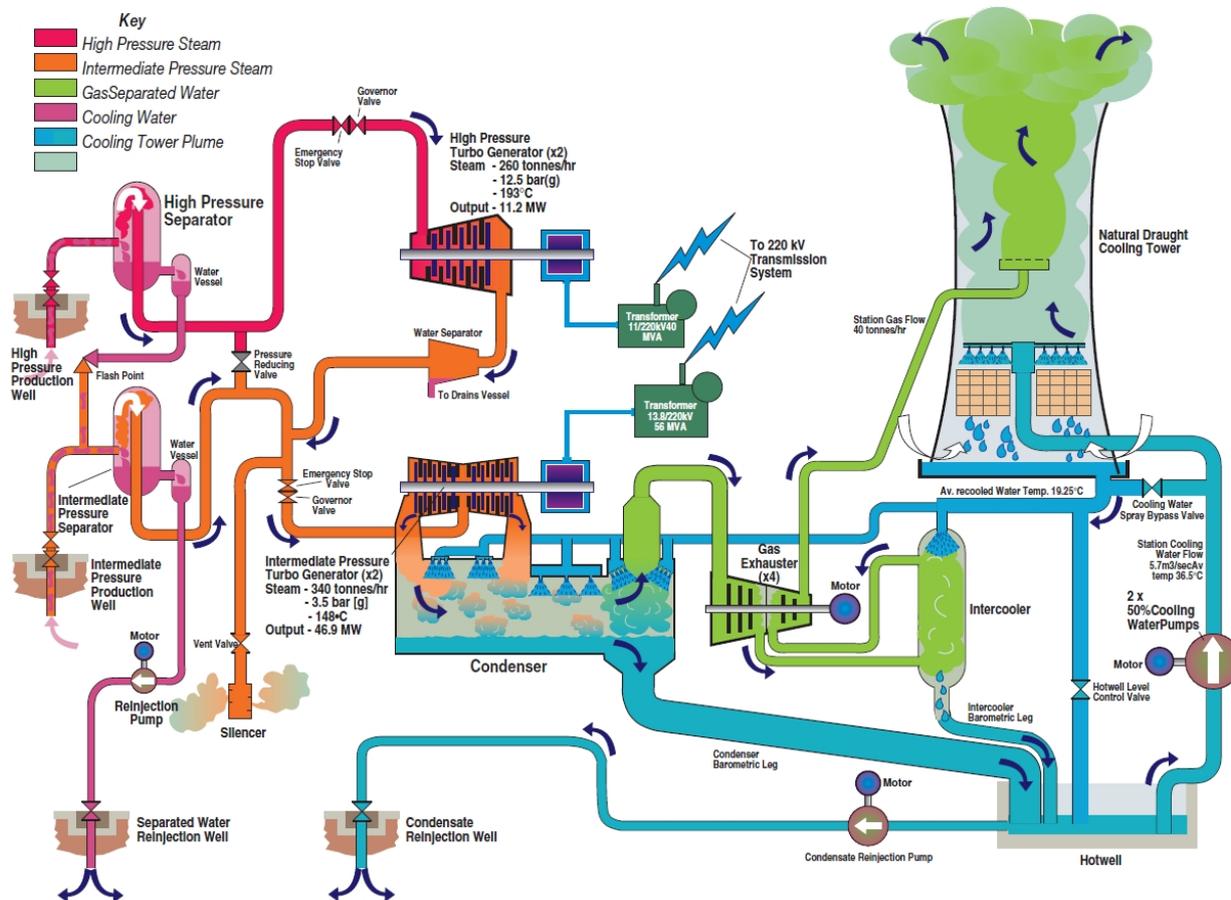
Figure 1: Schematic diagram of Ohaaki power station

Cooling water flows from the cooling tower basin via a set of screens to either the TG1 or TG2 direct-contact condenser by suction, then from the condenser through a barometric leg to the common hot well where 2 x 50% cooling water circulation pumps transports water/condensate back at 10,764 T/h to the cooling tower where it is sprayed overfill material to maximise surface area for cooling. Some of the cooling water can bypass the cooling tower if required to prevent ice from forming on the fill material during winter and potential collapse from the extra weight (Figure 1).

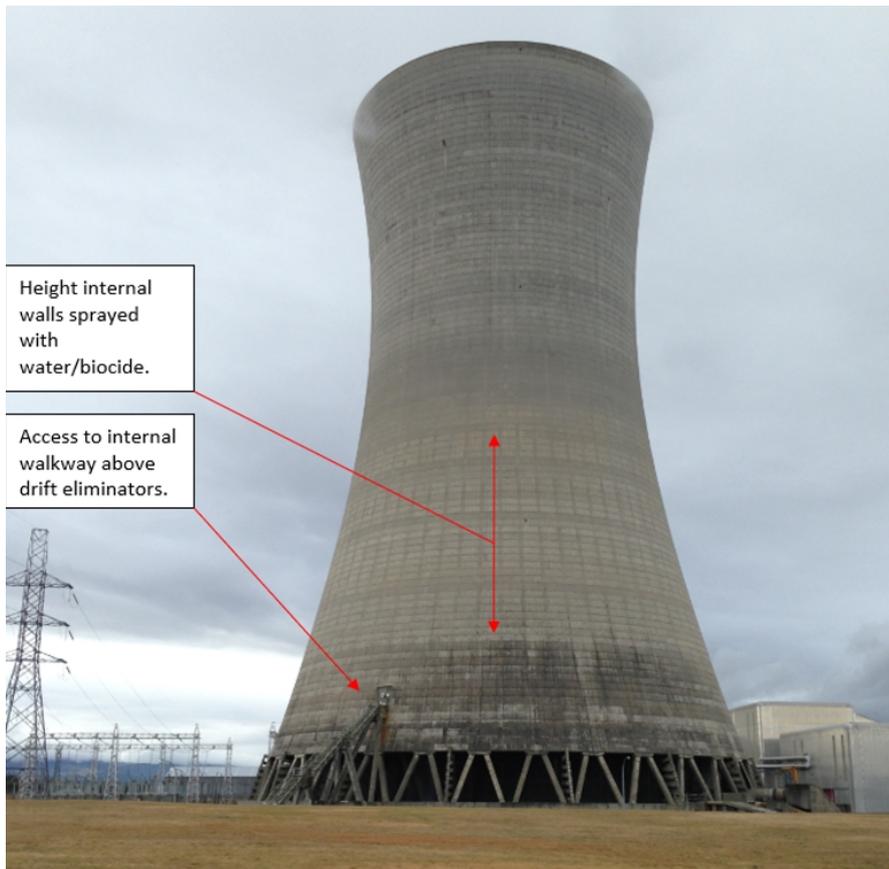
**Figure 2: Ohaaki cooling tower**

The stations’ most distinctive feature is its natural-draft cooling tower at 106 m high, 74.5 m at its base, 40.6 m at its throat and 53.2 m at the top (Figure 2). The shell thickness is 160 mm except at the bottom, where it is 660 mm and the top, where it is 236 mm (Bruce et al., 2020). Although at the time of construction, there was no clear economic advantage between natural-draft and mechanical draft cooling towers, the former was chosen to reduce the contribution to the fog that occurred in the Waikato River valley at Broadlands. The natural draft design also aided the dispersion of non-condensable gases (NCG). For the removal of NCG from the condenser, rotary gas exhausters were chosen over steam ejectors because of the economics of the relatively high percentages of gas to be removed (Brown et al., 1989).

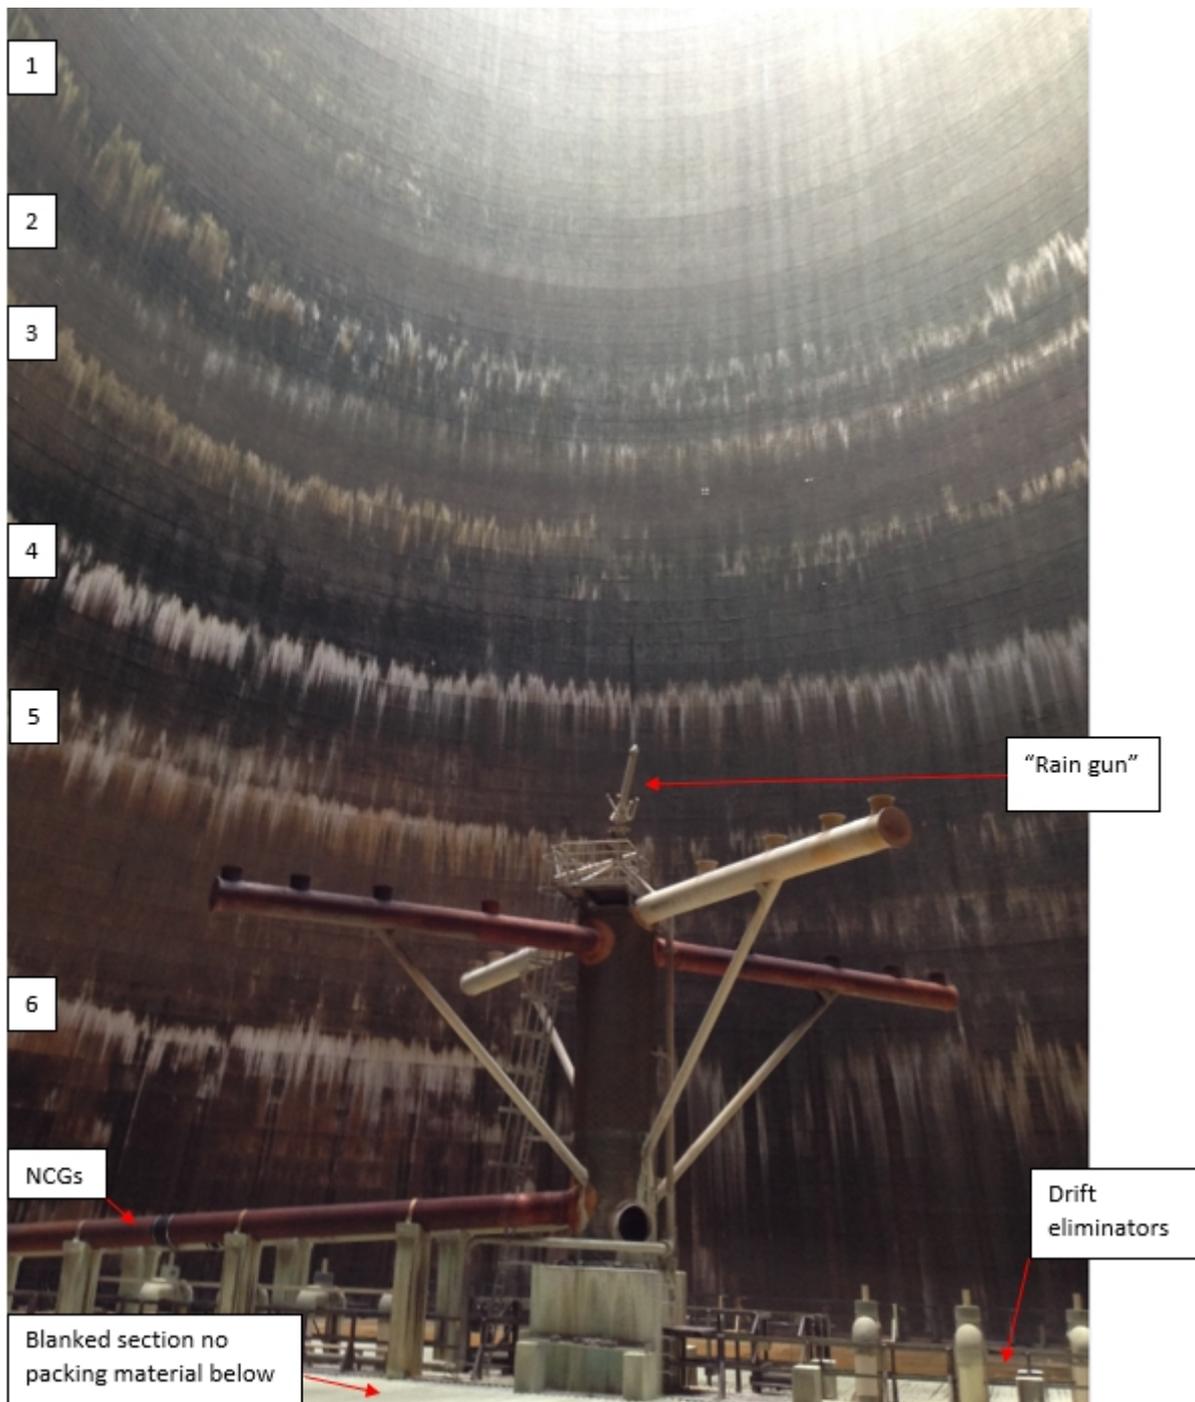
**Figure 3: Inside Ohaaki cooling tower. “Rain gun” water/biocide six jet impact locations visible on the shell (labelled).**

Concrete corrosion in the Ohaaki cooling tower was observed in 1991 with the erosion of surfaces on the inside of the cooling tower and associated concrete structures – only two years after commissioning. The corrosion was sufficient to be of immediate concern only in areas within the vapour zone of the tower, i.e., at the tidal zone of the basin wall, to the pack support beams and the roof of the return water channel that supplies the distribution pipework for the spray nozzles. An epoxy coating was applied to these areas. The corrosion was attributed to acid produced from the activity of SOB. A similar corrosion mechanism, although less severe, was also observed on the internal surface of the tower shell (Bacon et al., 1995). Applying a protective coating on the inner tower shell was not economical nor practical, so a “rain gun” was installed and commissioned in June 1996 to distribute biocide periodically on the interior tower shell as a means of algae and SOB control – this sprayed at six fixed elevations and rotated horizontally 360° up to approximately the height of the throat of the tower (Figures 2 to 3).

1. The cooling water itself, where the basin is dosed with chemicals that are intended to treat all the fully immersed/wetted cooling water surfaces around the cooling water circuit, including the film-fill packing in the tower.
2. The interior concrete shell within the vapour space of the cooling tower between the drift eliminators and the throat of the tower (Figure 3).

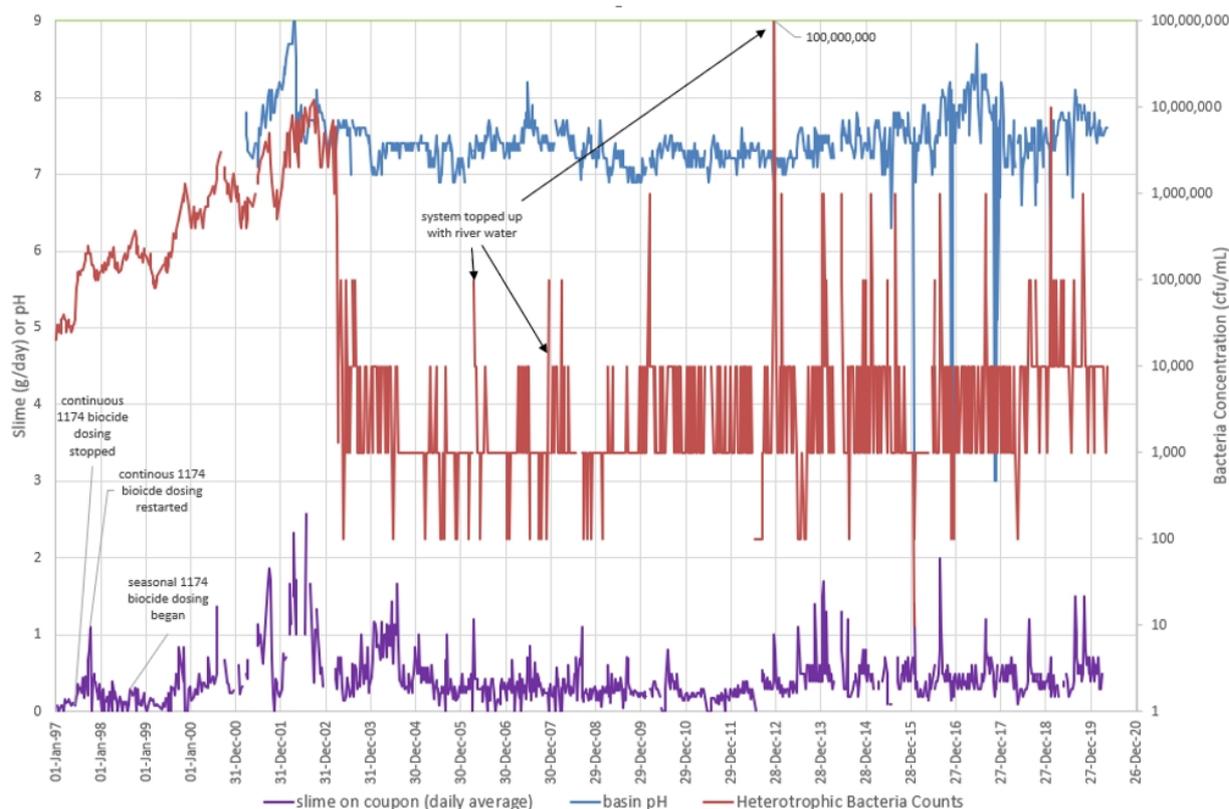
**Figure 4: Historical trends of pH, heterotrophic bacteria, and slime of Ohaaki cooling water.**

Historic weekly grab sample measurements of pH and heterotrophic bacteria from water in the cooling tower basin and slime from a coupon immersed in the return water line to the tower are shown from 1997 to 2020 (Figure 4). Looking over such a long period helps to put some previously reported comments (Section 2.2) in perspective.

It had been stated that both slime and bacteria levels “soared” after continuous biocide dosing of the cooling water stopped in June 1997. While there was an apparently significant increase in slime and bacteria numbers compared to earlier months of 1997, when viewed over many years, it can be seen that the normal variability of these readings is more significant than this one event (Figure 4). Hence these results are not conclusive as to the benefits or not of dosing the Busan 1174 biocide. It also questions the suitability and reliance on these monitoring parameters to indicate adequate biofilm control. The general “heterotrophic” bacteria numbers were overall trending continually higher between 1997 to March 2003, then appeared to drop significantly from April 2003. This drop corresponds to when dip slides were used to replace the agar-coated plates (Figure 4). This was most likely due to the difference in the agar growth media composition being more specific for heterotrophic bacteria in the procured dip slides, whereas the “home-made” agar-coated plate tests may have promoted other types of bacteria or microorganism growth, or their use was simply not conjunctive to reliably monitoring. The significance of the increase in the agar plate tests is unexplained but is not considered to be reliable data in terms of biofilm monitoring.

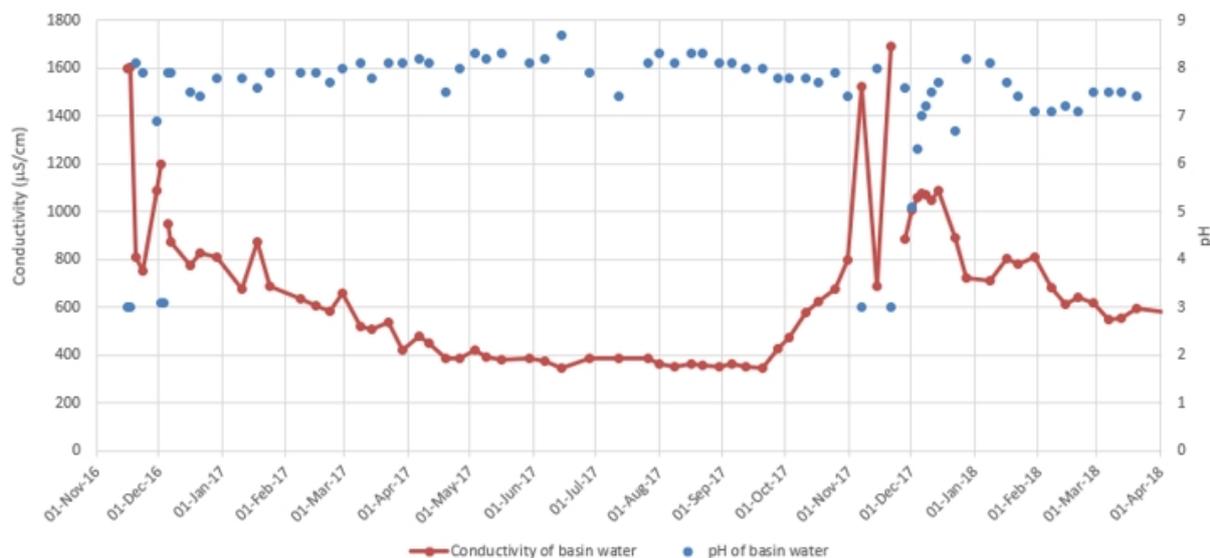
Figure 5: Weekly pH and conductivity measurements of basin water

During the second pH excursion event on 16th November 2016, conductivity measurement of the basin water was added to the routine weekly grab sampling after early optimisation work being done at Te Mihi (Young, 2018). Here the conductivity was 1,600  $\mu$ S/cm at pH 3. After dosing 6,000 L of sodium hypochlorite and 1,000 L of Busan 1009 into the basin on 17th November, the pH recovered briefly, and the conductivity dropped to 800  $\mu$ S/cm. However, by 2nd December, the pH had dropped again to 3 with a conductivity of 1,200  $\mu$ S/cm (Figure 5). The conductivity had increased to 1090  $\mu$ S/cm on 30th November, with the pH only dropping to 6.9, indicating that the biocide dose was insufficient to regain control over the SOB. On 3rd December, 4,000 L of sodium hypochlorite and 1000 L of Busan 1009 were dosed, the pH recovered, and importantly, the conductivity began to decline – although very slowly (Figure 5).

The fourth and fifth pH excursion events on 7th and 21st November 2017 appear very similar to the ones a year earlier. Although, this time it can be seen that the conductivity began to steadily increase from 27th September and exceeded 600  $\mu$ S/cm over two weeks before the pH dropped to 3. Shock-dosing of 4,000 L of sodium hypochlorite and 1,000 L Busan 1009 was performed on 7th and again on 21st November after the pH dropped again. The pH recovered, and the conductivity slowly trended down (over three months) to below 600  $\mu$ S/cm. (Figure 5).

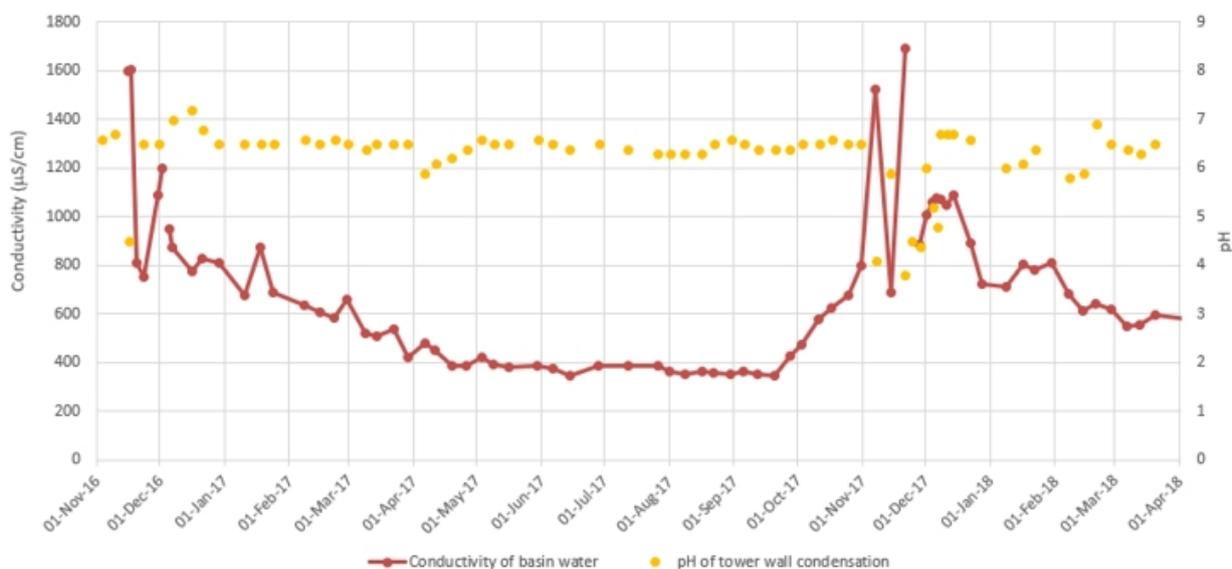
Figure 6: Weekly pH of tower shell condensation and conductivity of basin water

It had previously been thought that if SOB numbers got too high on the tower shell, sufficient acid would be produced to not only lower the pH of the tower shell surface but also the pH of the cooling water (or at least by allowing SOB to “seed” the surfaces below). It had been reported that as the pH of the concrete surface declines to about 5, SOB begin to proliferate and produce high concentrations of sulphuric acid, dropping the pH to 2 or less (Rowe, 1991). The tower condensation pH measurements are plotted with the conductivity of the basin water to test this hypothesis. Low pH readings from the tower shell do seem to correlate with high conductivity and low pH of the basin water, but the pH values on the shell are not as low as in the basin (Figures 5 and 6). Also, the shell pH readings do not provide any advance warning (from these weekly measurements) of a pending drop in the basin water’s pH,

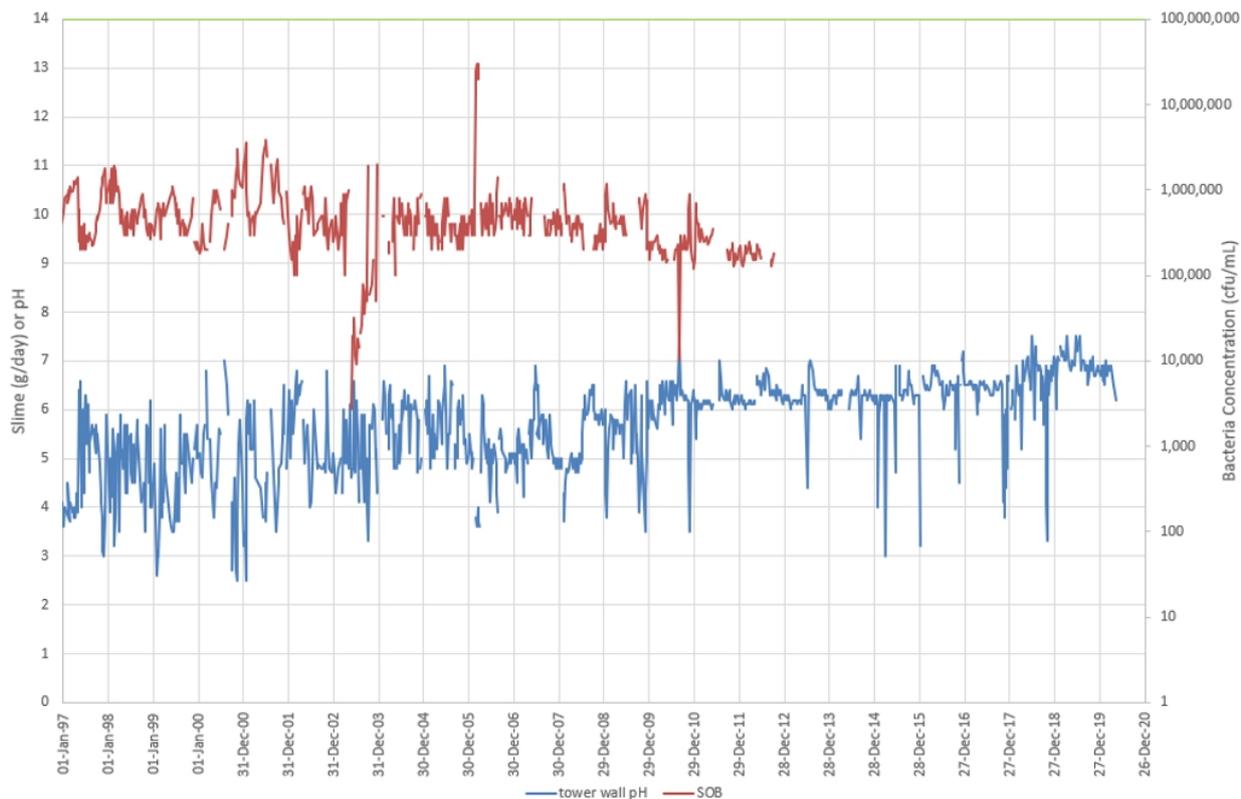
Figure 7: Historic trends of SOB and pH of condensation on cooling tower interior shell

unlike the basin conductivity readings do. There have been over a dozen similar low pH readings from the tower shell in previous years (Figure 8) that did not result in low pH of the basin water. SOB enumeration culturing was being done by the chemical provider but was stopped in 2011 as it was not providing any useful information (Figure 7).

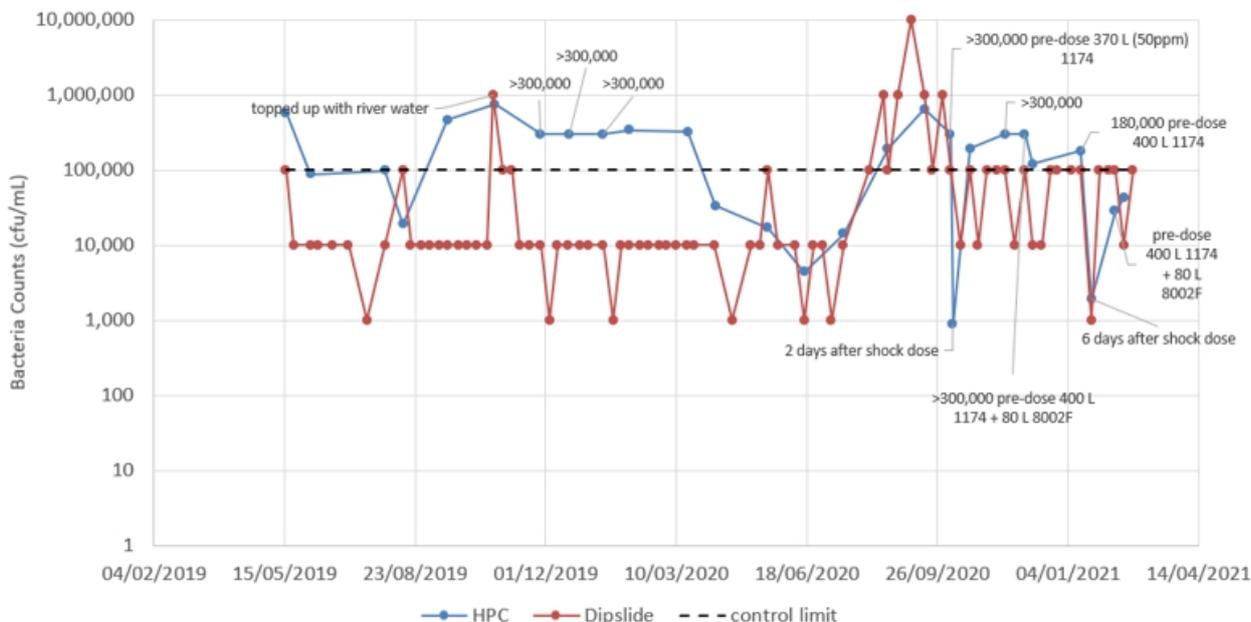
Figure 8: Basin water heterotrophic bacteria

The dosing application to the basin was changed from a 5 mg/L 1174 continuous dose over August to December (last done in 2019) to a periodic 50 mg/L shock-dose of 1174 and bio-dispersant from 2020 (Figure 8). HPC samples were also taken immediately before and a few days after shock-dosing. Although the dip slide results appear to be higher with shock-dosing than before, their accuracy is questionable and are better suited for monitoring heterotrophic bacteria once good microbiological control has been established – which certainly is not the case here. The HPC counts were no worse under the shock-dosing method but were often higher than ideal.

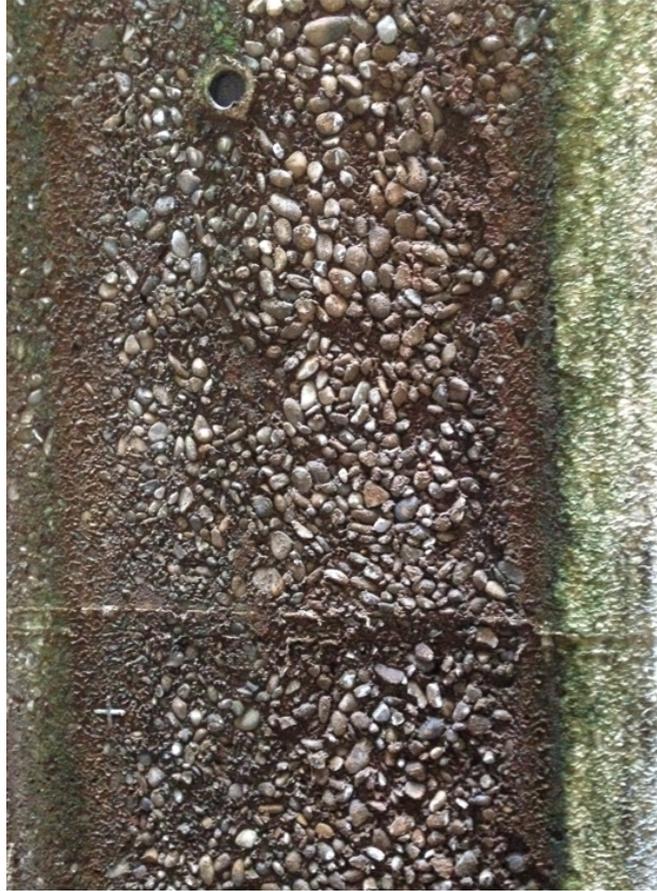
During the May 2018 maintenance outage, there was an opportunity to inspect the inside of the cooling tower. With respect to the concrete tower shell, it appeared to be in good condition from what was visible from the walkway around the circumference, with some “greener” areas but of no discernible thickness. However, there were several localised vertical channels where condensation appeared to have flowed down the shell and severely attacked the cement to the extent aggregate (stones) were being dislodged

(Figure 9). The heights of these attacked channels were not discernible from the walkway, and were concerned that the damage may be more severe higher up on the shell.

**Figure 9: Example of more severely attacked vertical area of tower shell, approximately 300 mm wide (2018 outage inspection)**

- Reduce the frequency of biocide dosing of the tower shell. Initially trial once per week, review, then consider monthly dosing.
- Automatically record and trend the “rain gun” operational parameters (flowrate, biocide and wash steps).
- Select and trial alternative types of biocides for the “rain gun” (one that is less toxic to people) and cooling water (one that does not react with sulphide).

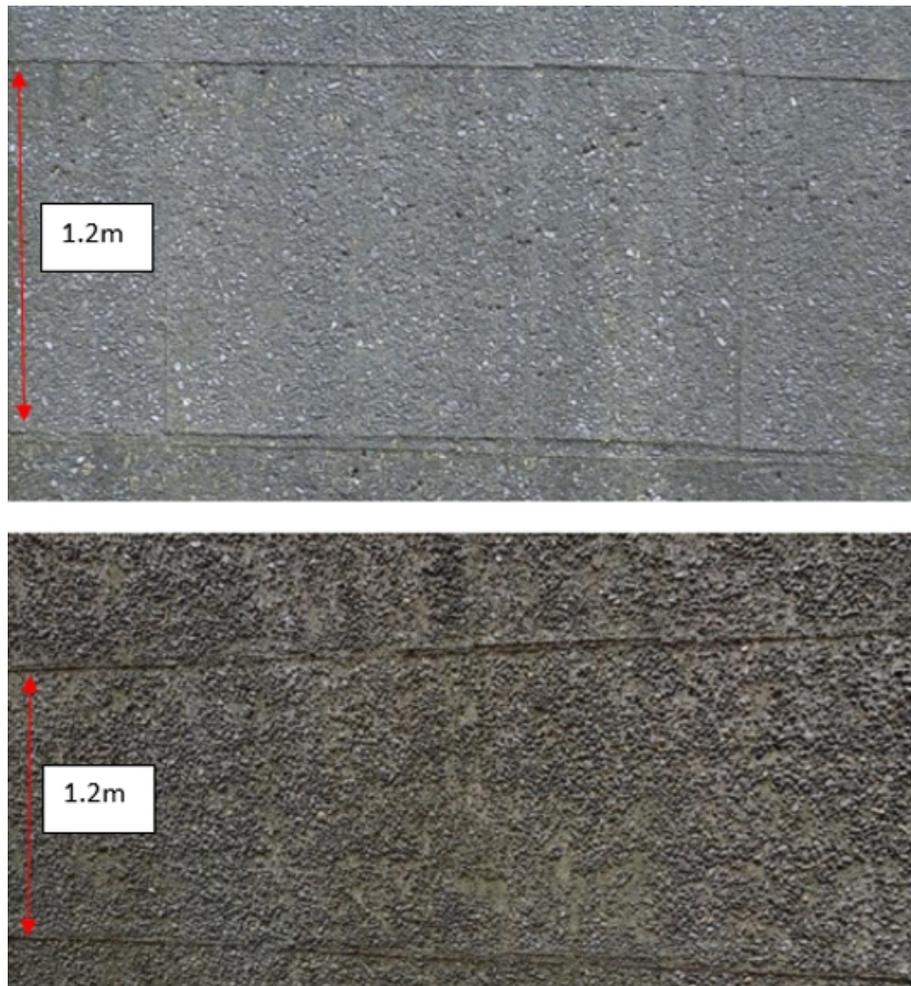
At the next maintenance outage in August 2020, a drone inspection was performed for the first time to better confirm the condition of the tower shell. This was carried out while concrete condition experts were also present and revealed useful information that had not been previously available. Fortunately, the only attack on the tower shell of note were the few previously observed vertical channels, but these only extended several meters above the walkway and would be accessible with scaffolding to repair at a future outage. Typical examples of the internal shell condition are shown (Figure 10) with apparently better concrete near the top of the tower. There was no difference in surface texture between areas impacted by the “rain gun” jet and the adjacent regions above and below these.

**Figure 10: Typical examples of internal shell condition, generally better higher up the tower (Bruce et al., 2020)**
