Jaimin Patel¹, Bipan Bansal², Mark I Jones¹, Margaret Hyland¹

Dairy fouling

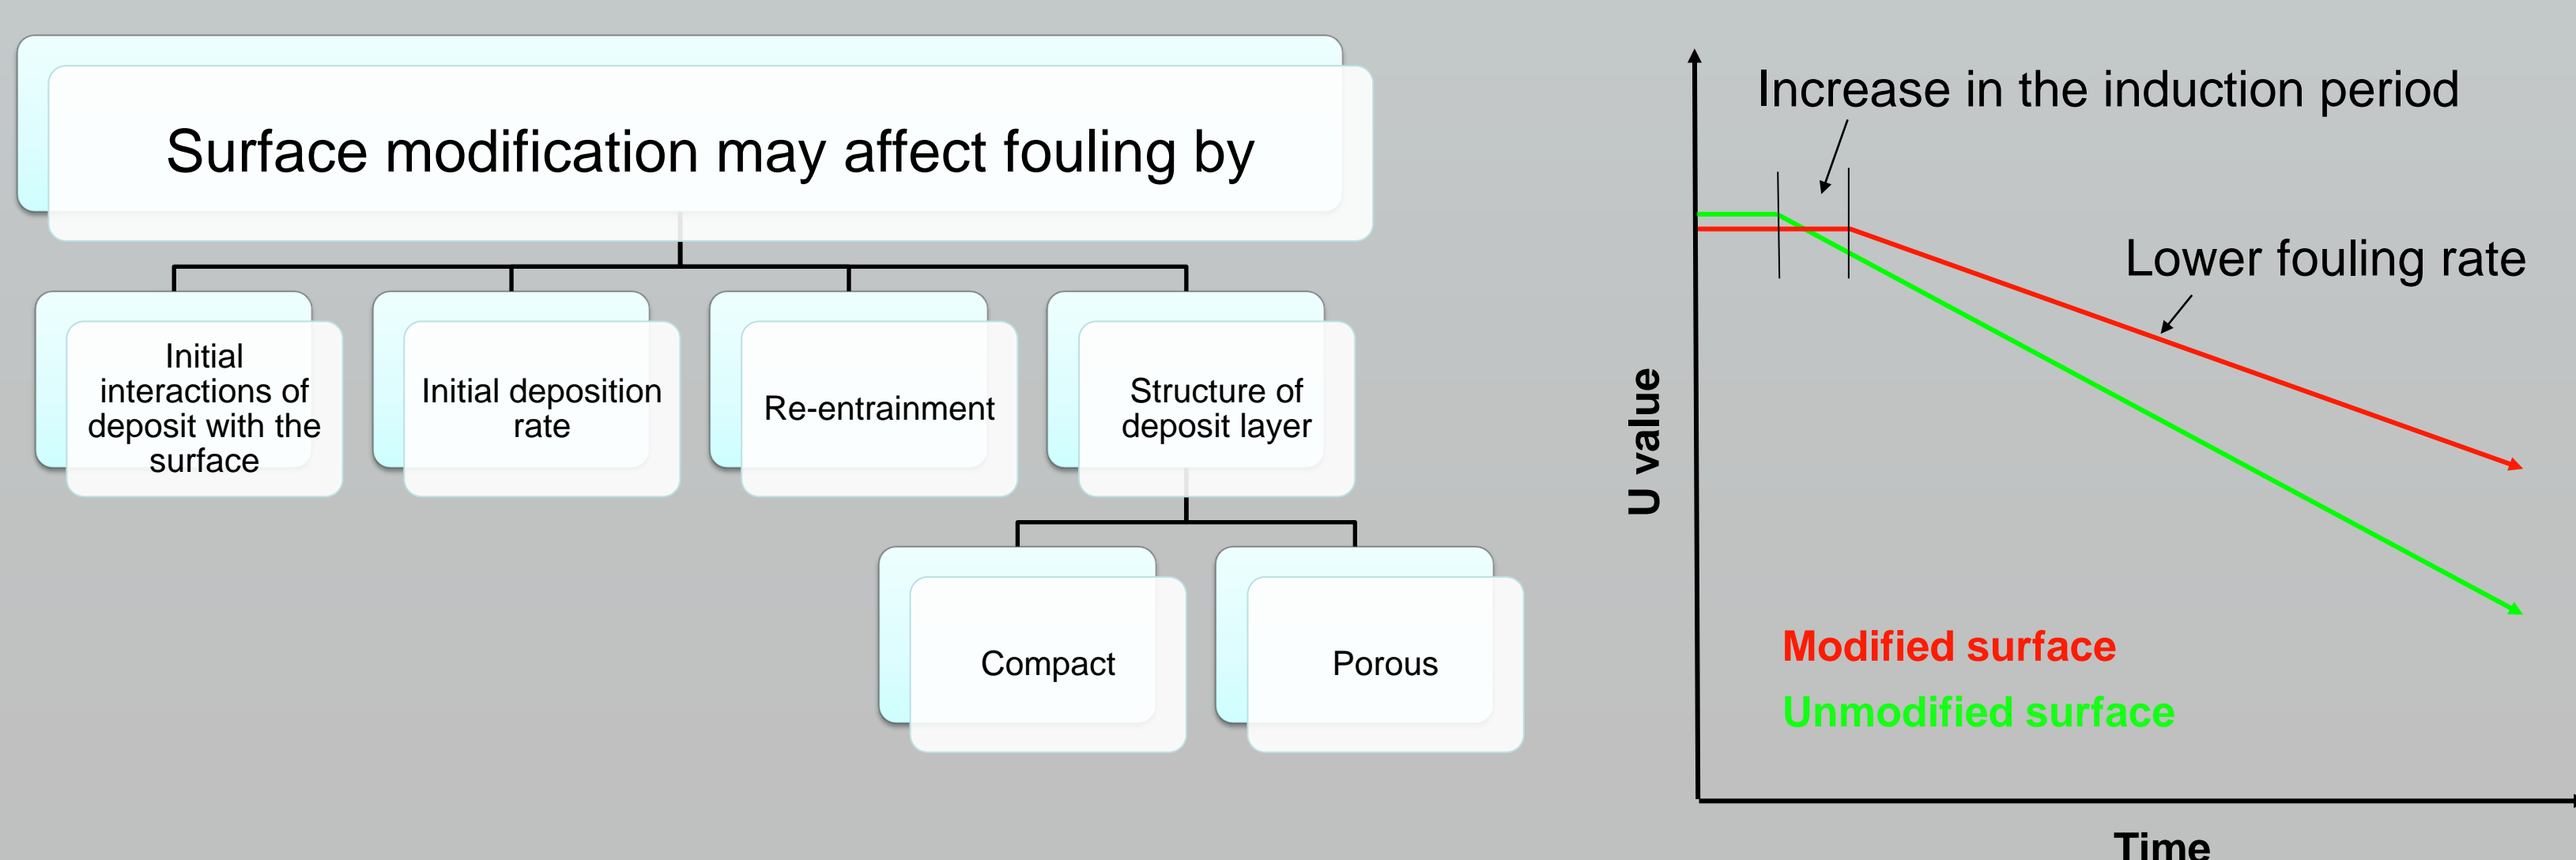
Figure 4 Probable theory for fouling mitigation by modified surface

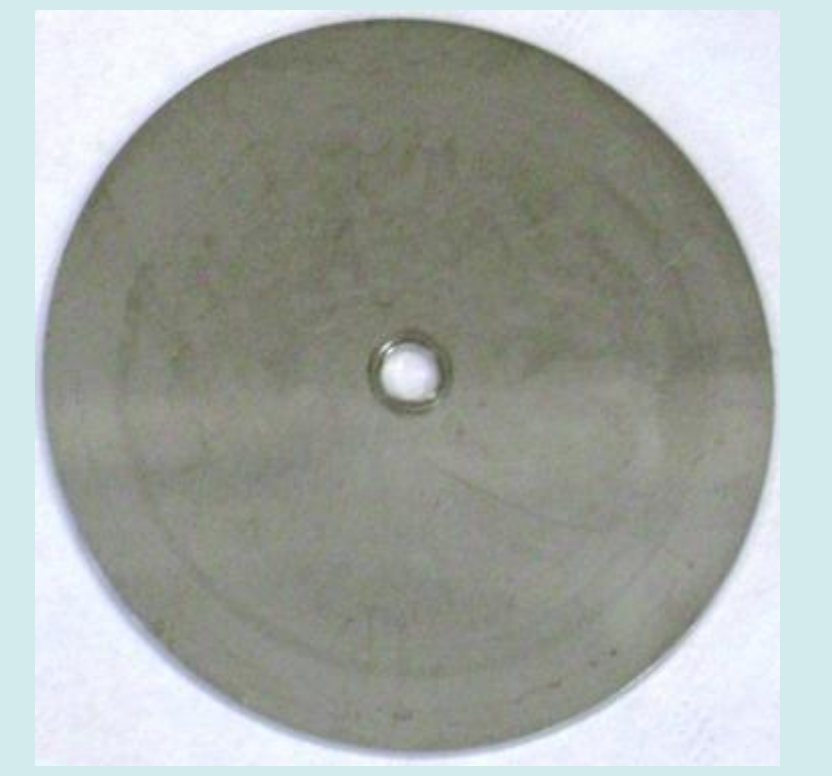
Figure 5 Lab scale set up (four parallel flow streams)

Experimental disk

Parallel design

- To overcome the effect of "daily variation in milk composition"
- To overcome the effect of "ageing of milk"

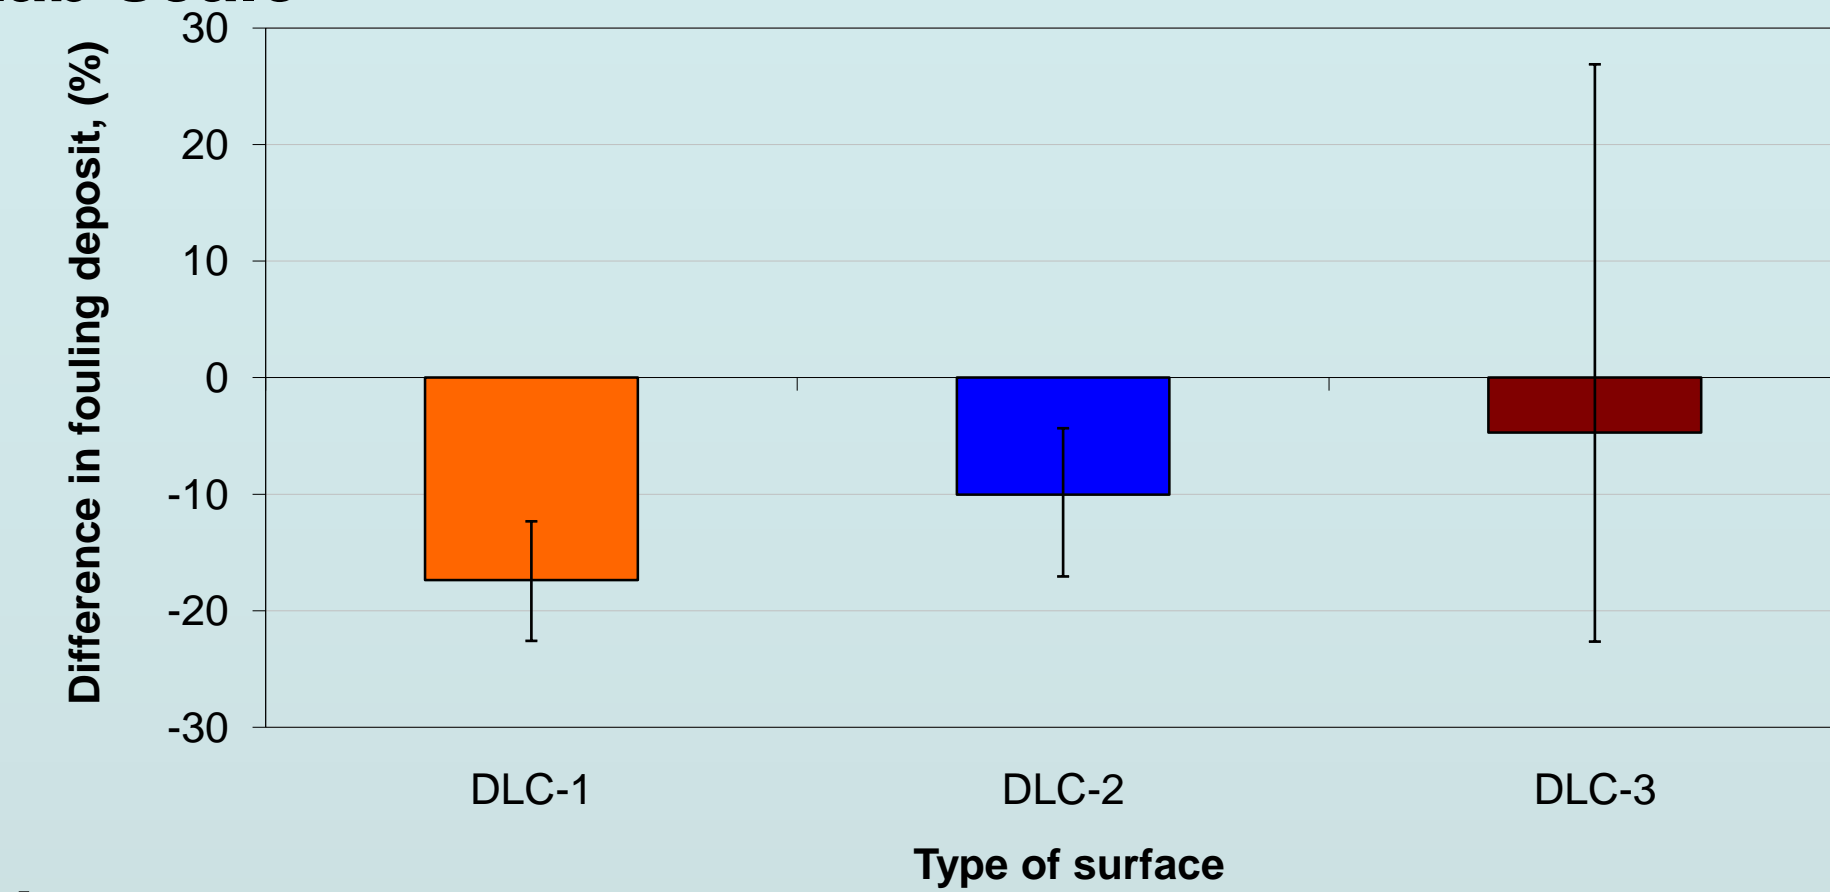
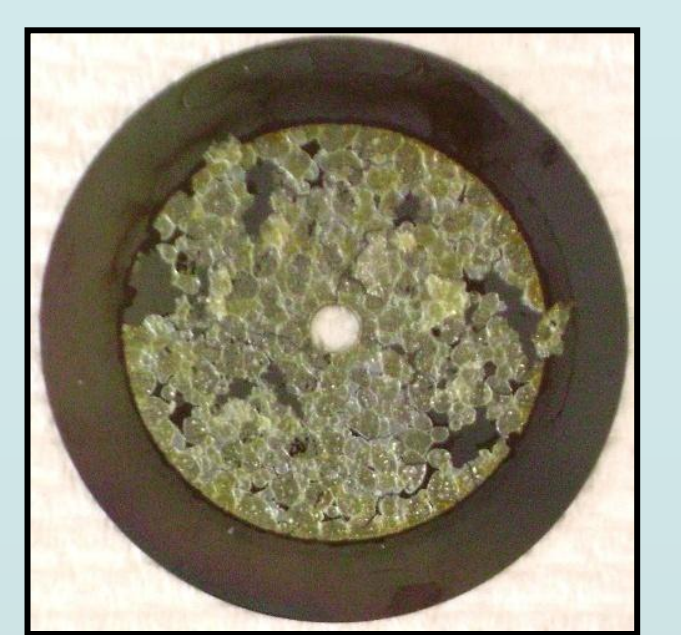
(a) Lab scale

Fouled disk

Figure 7 Effect of doped DLC coating on fouling deposition with milk

- About 5 - 15 % less fouling deposits were observed on all three DLC coated surfaces at lab scale (Fig. 7a). **The difference between control and DLC-1 was statistically significant.**

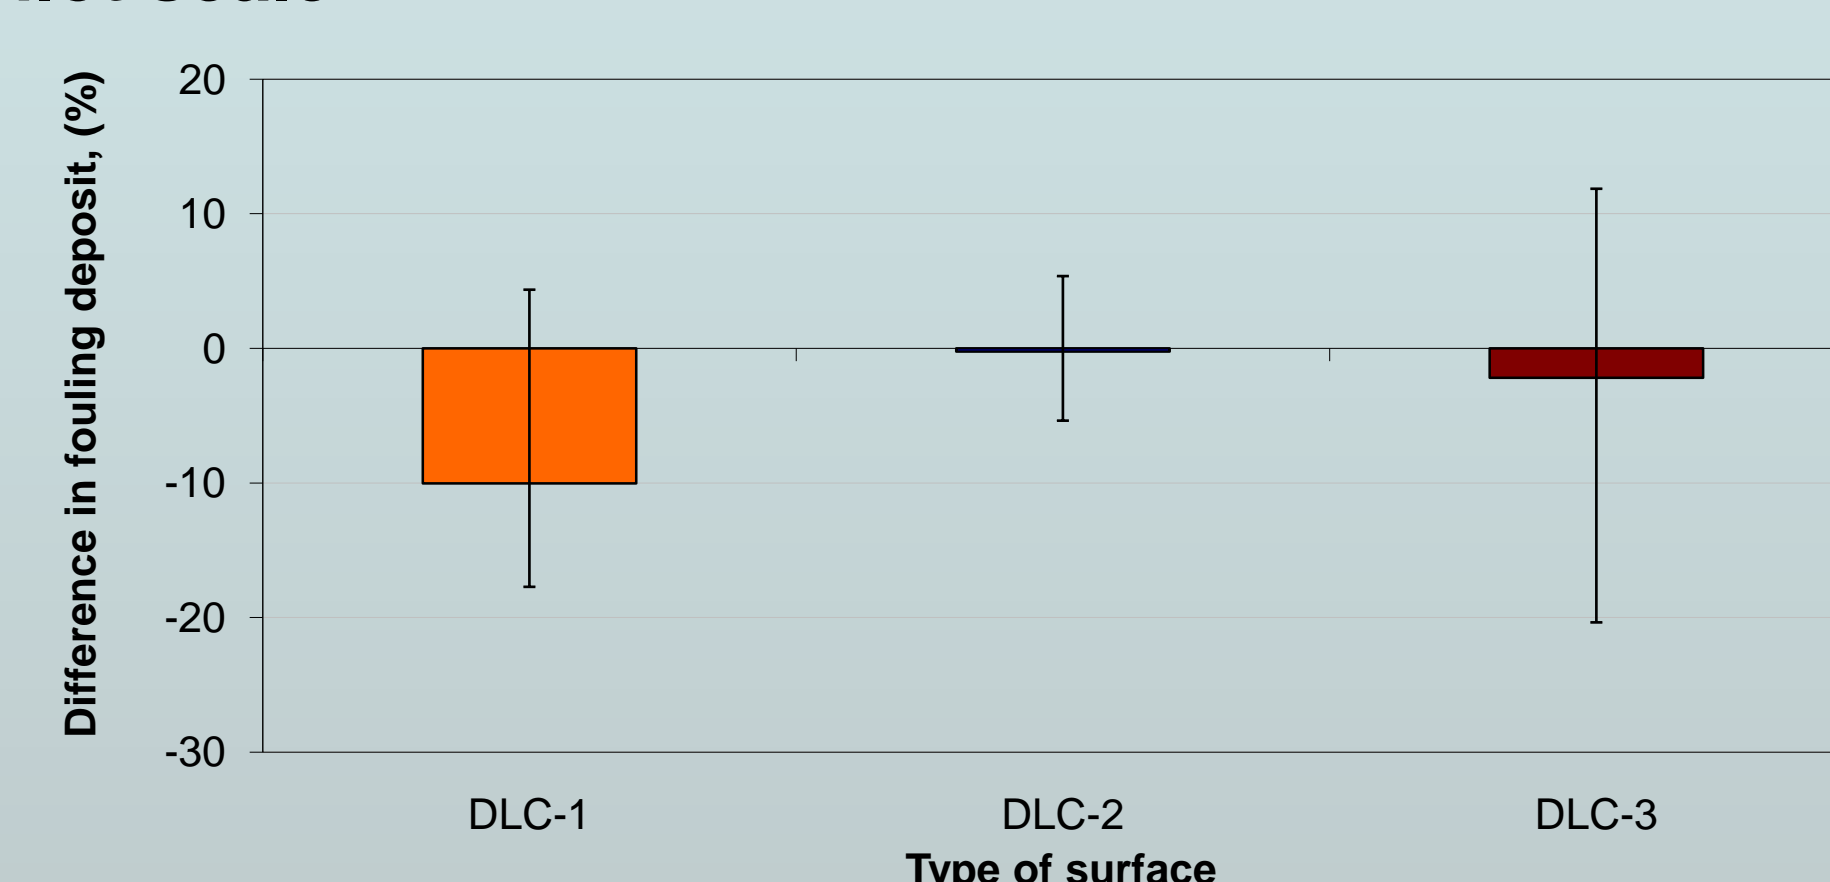
(b) Pilot scale

Fouled plate

- However, **no statistical difference in fouling deposition was noticed between control and coatings at pilot scale** (Fig. 7b). The difference between control and DLC-1 at pilot scale (~10%) was not statistically significant.

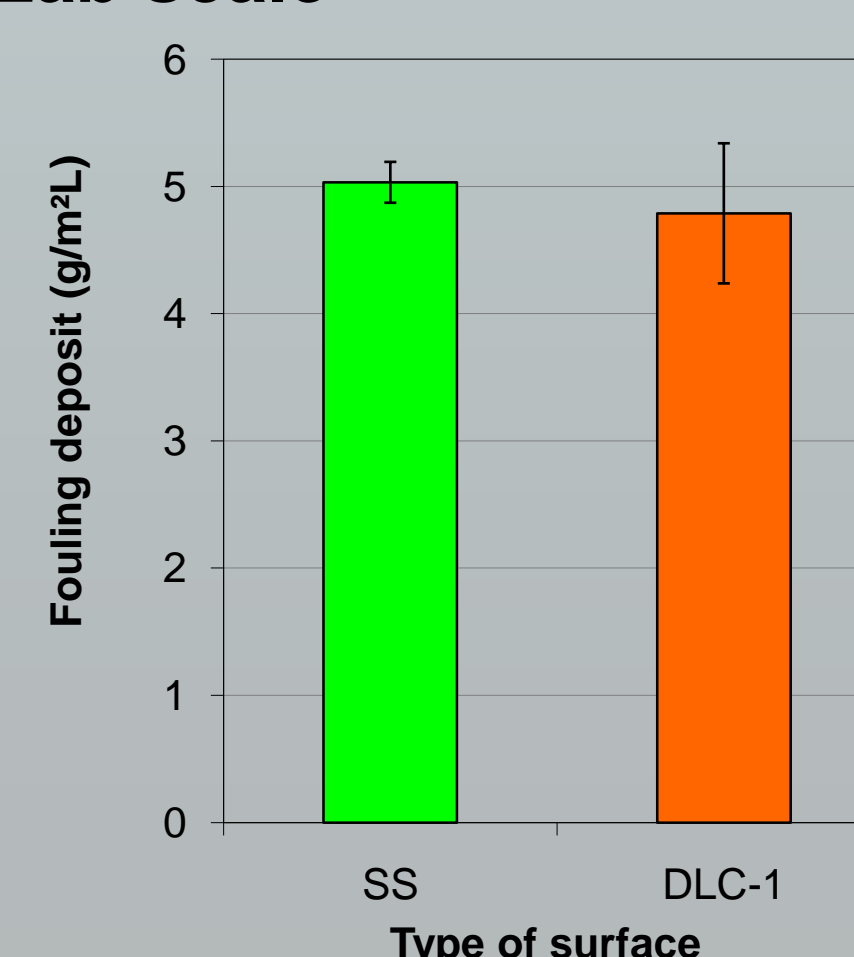
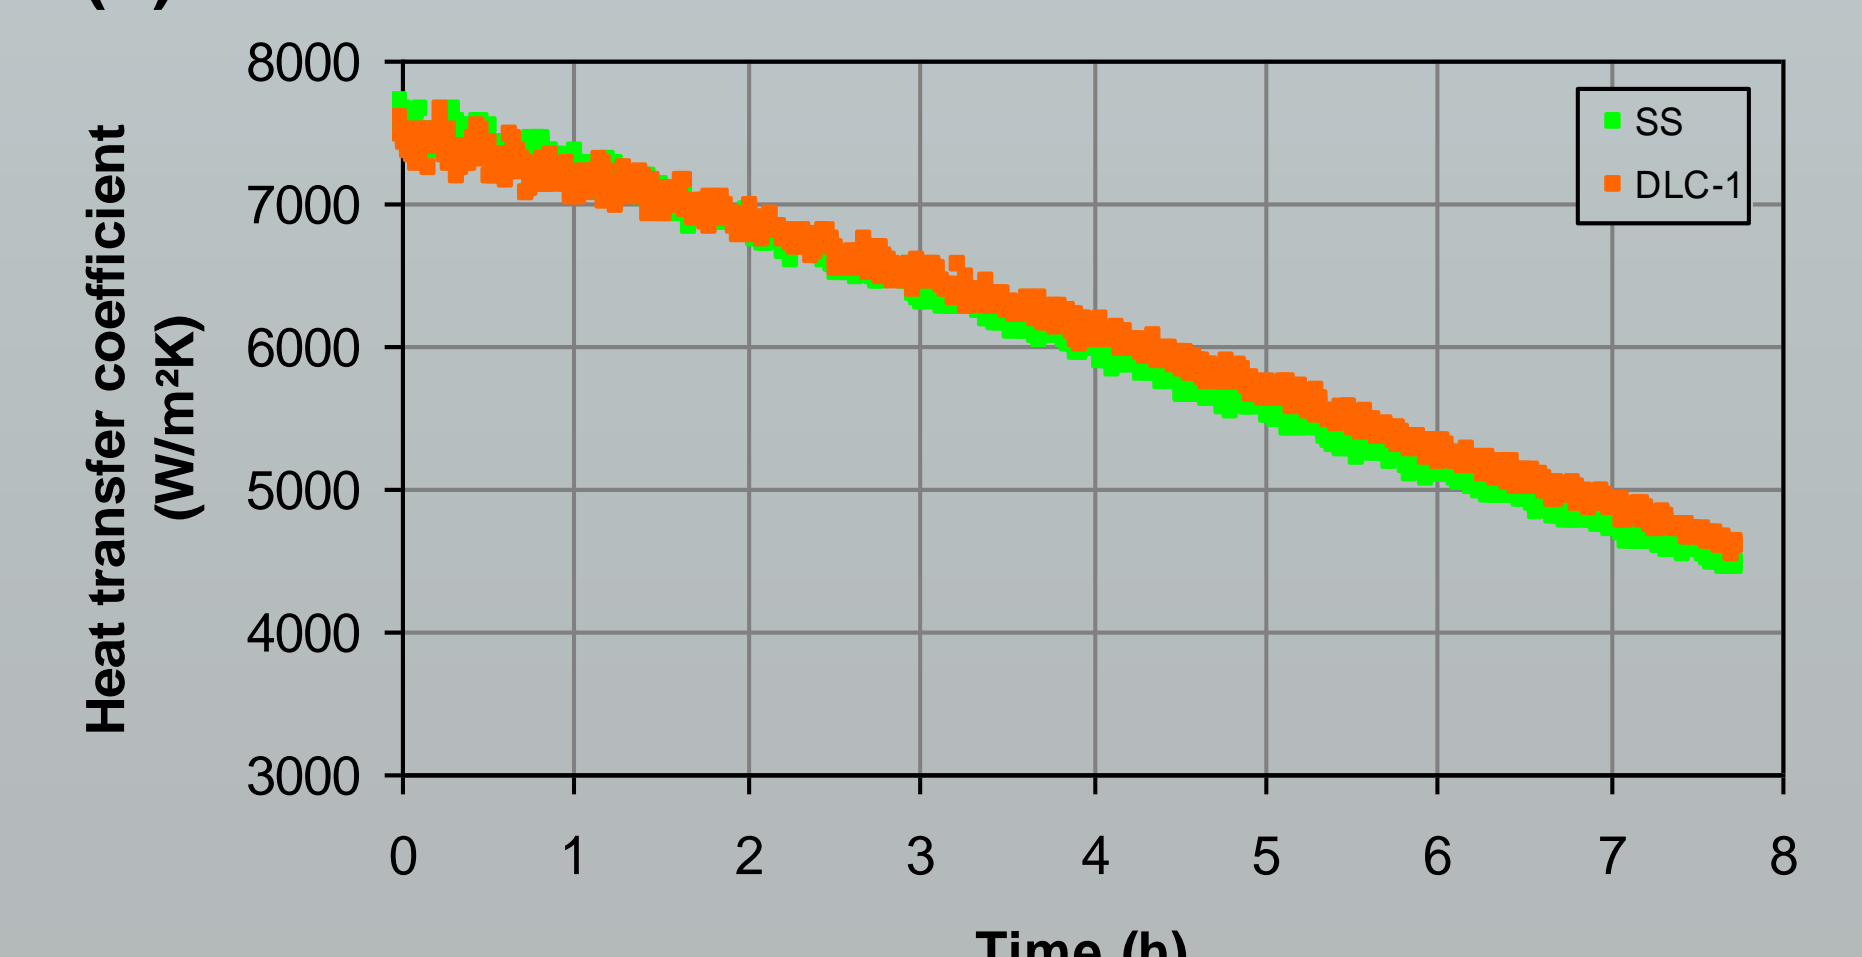
Figure 8 Fouling deposition with Whey Protein Isolate (WPI) solution

- No reported literature of milk fouling on DLC coating.
- Much lower levels of fouling was observed when using WPI instead of raw milk. The small amount of fouling observed with WPI mean that no difference was found between control and DLC coatings, at either lab or pilot scale.
