## Experimental testing of full-scale timber floor diaphragms in unreinforced masonry buildings

A.W. Wilson, P.J.H Quenneville, & J.M. Ingham

*The University of Auckland, Auckland, New Zealand.*

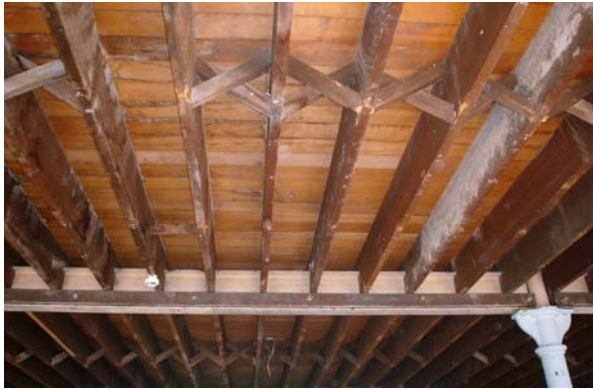
(a) Underside showing joists, sheathing and cross-bracing

**Figure 1 – Typical timber diaphragm configuration (Australis House, Britomart, Auckland)**

URM buildings in New Zealand are typically constructed with rigid clay brick perimeter walls and comparatively light timber floor diaphragms. These floors are generally made up of either straight-edge or tongue & groove floorboards nailed perpendicular to joists that span between the URM walls. When perimeter walls are close enough (approximately less than 6 m) joists sometimes span continuously between these elements. For larger spans, joists are typically lapped or butted, with or without a mechanical connection, over intermediate steel or timber cross-beams supported on columns. Diaphragm blocking and chord elements are almost never present, and timber cross-bracing is typically fitted intermittently between joists to prevent out-of-plane buckling. Joist ends are typically either simply supported on a brick ledge resulting from the perimeter walls reducing in width at each storey height, or pocketed into the wall to a depth equal to one brick width. Examples of timber floor configurations are given in Figure 1.

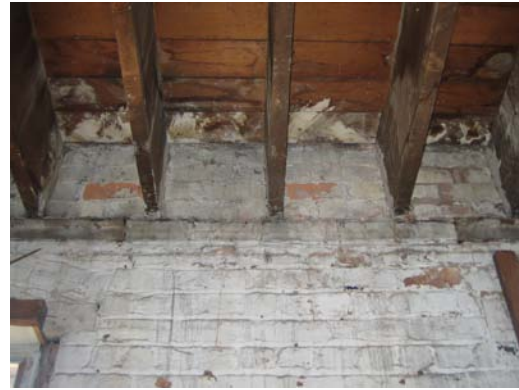
(b) Joists pocketed into URM perimeter wall

Diaphragms FS3a and FS4a were tested in the direction perpendicular to joists so that the diaphragm span to depth ratio was 1 to 1.88. Realistic conditions were created for this set-up by constructing URM walls on each side of the diaphragm for the joists to pocket into (Fig. 2d), similar to that illustrated in Figure 1b. Sliding of the brick walls was prevented by post-tensioning the walls with threaded rods epoxied into the warehouse concrete slab. Loading was introduced into the diaphragm using the same hinged steel frame as for the previous set-up but with only two points of loading. Diaphragms FS3a and FS4a were equivalent in construction except that diaphragm FS3a had continuous joists spanning between the brick walls while diaphragm FS4a had discontinuous joists with a two-bolt lapped central connection.

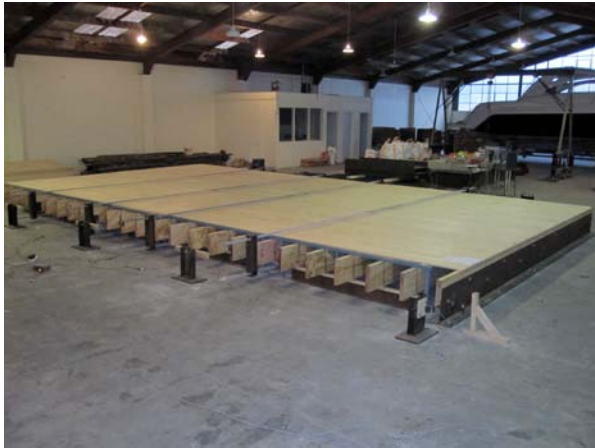
(a) Diaphragm FS1a

**Figure 2 – Experimental program**

A total of four diaphragm specimens labelled FS1a to FS4a, constructed with new pine timber, were tested. Each specimen measured 10.4 m x 5.535 m and was comprised of 135 mm x 18 mm straight edge floorboards nailed perpendicular to 45 mm x 290 mm joists spaced at 400 mm centres. Joists were orientated in the 5.535 m dimension. Cross-bracing was fitted between the joists at 1/3 joist length locations using 45 mm x 75 mm framing. Every floorboard-to-joist connection was fastened using two 75 mm x 3.15 mm bright power driven nails spaced at approximately 95 mm.

Diaphragms FS1a and FS2a were tested in the direction parallel to joists so that the diaphragm span to depth ratio was 1.88 to 1. In this direction the two side joists were bolted to steel frames that were fastened to the warehouse concrete slab, replicating in-situ boundary conditions where the edge joists would simply be bolted intermittently to the perimeter URM walls (Fig. 2a). Lateral loading was introduced into the diaphragm using a hinged steel frame on castors that distributed the hydraulic actuator point load into four equal point loads. Figure 2b shows that the loading frame comprised a main truss and two secondary beams that were capable of rotating with the deforming diaphragm. Reversed cyclic loading was achieved by positioning loaders on both ends of the loaded joists, and post-tensioning these together using threaded rods that spanned the depth of the diaphragm. The diaphragm was supported vertically on Teflon pads that allowed the diaphragm to deform laterally without measurable friction. Diaphragm FS1a (Fig. 2a) was a homogenous diaphragm while diaphragm FS2a (Fig. 2c) included a corner penetration measuring 3.2 m x 1.08 m that represented a typical stairwell present in many timber diaphragms.

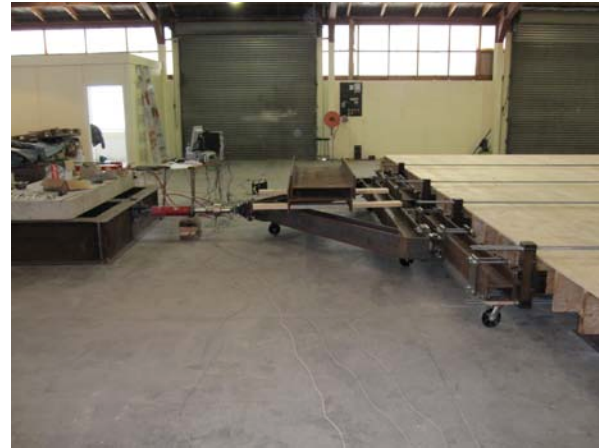
(b) Loading frame set-up

During each test, total load was recorded using a load cell attached to the actuator, while the diaphragm deformation profile was measured at three locations using string potentiometers. In addition, the in-plane and out-of-plane displacement of the steel side frames was monitored during testing parallel to joists using strain ‘portal’ gauges. Each diaphragm was subjected to pseudo-static reversed-cyclic loading to midspan displacement amplitudes of 2.5 mm, 5 mm, 10 mm, 15 mm, 25 mm, 50 mm, 75 mm, 100 mm, and 150 mm. Each displacement amplitude was repeated three times to investigate the cyclic degradation of diaphragm performance.

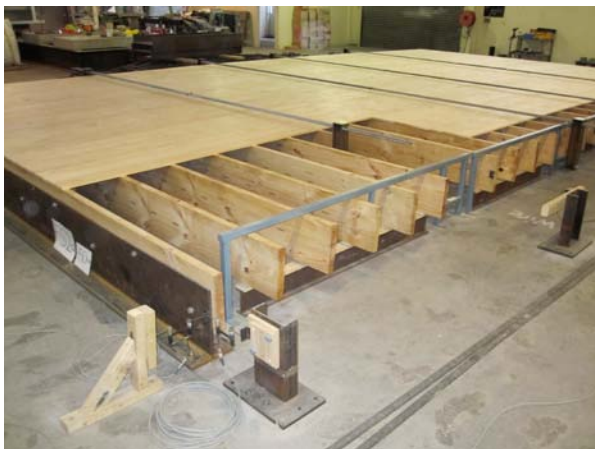
(c) Penetration in Diaphragm FS2a

A comparison of the force-displacement responses of specimens FS2a and FS1a suggests that a small diaphragm opening such as a stairwell does not significantly affect diaphragm performance, with these responses being largely indistinguishable. It is appreciated that larger penetrations may worsen this effect however. Interestingly, FS4a was found to have higher initial stiffness than FS3a despite the

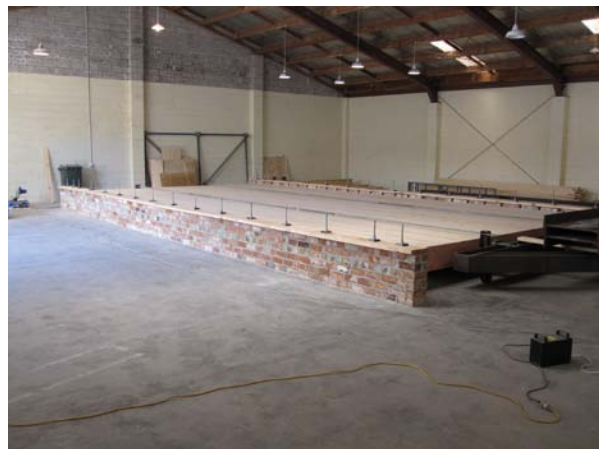
(d) Diaphragm FS3a/4a

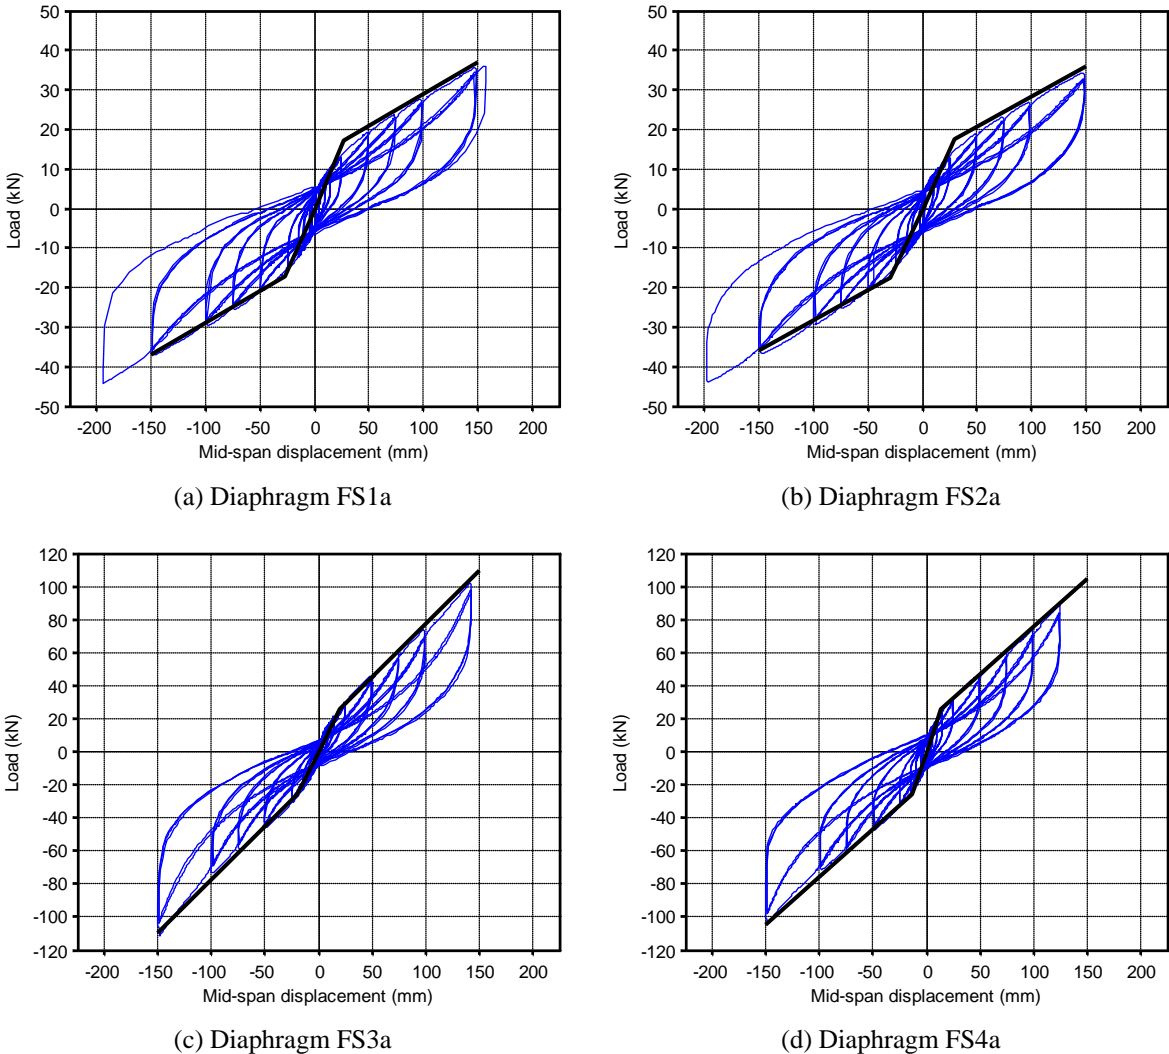
Figure 3 – Full-scale diaphragm test results with bilinear idealisations

Overall the diaphragms displayed flexible and highly nonlinear characteristics with low levels of hysteretic pinching, as illustrated in the force versus midspan displacement plots in Figure 3. The open hysteretic loops demonstrate that these diaphragms are capable of dissipating considerable amounts of energy when subject to lateral loading. No splitting of timber, nail tear-out or other failure mechanisms were observed during testing, even at displacements in excess of 150 mm, and all diaphragms appeared to remain completely serviceable at the conclusion of each test.

Figure 3 shows the bilinear curves produced for the tested diaphragms. The bilinear curves defined the yield force ( $F_y$ ), yield displacement ( $\Delta_y$ ), maximum force at  $\Delta = 150$  mm ( $F_{max}$ ), and initial and secondary stiffness ( $K_1$  and  $K_2$ ) values presented in Table 1 that were used to calculate the desired diaphragm performance parameters.

presence of joist discontinuities. Either the bolted connections added additional strength to the diaphragm or the effect of the joist discontinuities was minimised by zero shear force existing within the central region of the diaphragm, and the increased stiffness was a function of construction variation between tests. Further analysis of these results is currently being performed.

It is difficult to directly compare force-displacement response between the two principal loading directions due to the influence of diaphragm geometry. Diaphragms FS3a and FS4a demonstrated greater stiffness and strength than FS1a and FS2a, but this is clearly due to a considerably lower span to depth ratio. As a general observation, the hysteretic loops are larger in the direction parallel to joists which could result from greater engagement of the yielding nail couples in this direction as opposed to loading in the direction perpendicular to joists, where the nail couples are less engaged and the out-of-plane bending of the joists has greater influence on response.
