# **Low Voltage Arcing and Fire Testing: Experiments to Compare Arc Flash and Fire Hazard Between Faults Inside LVAC Enclosures and LVDC Enclosures**

A thesis submitted to

**MASTER OF ENGINEERING**

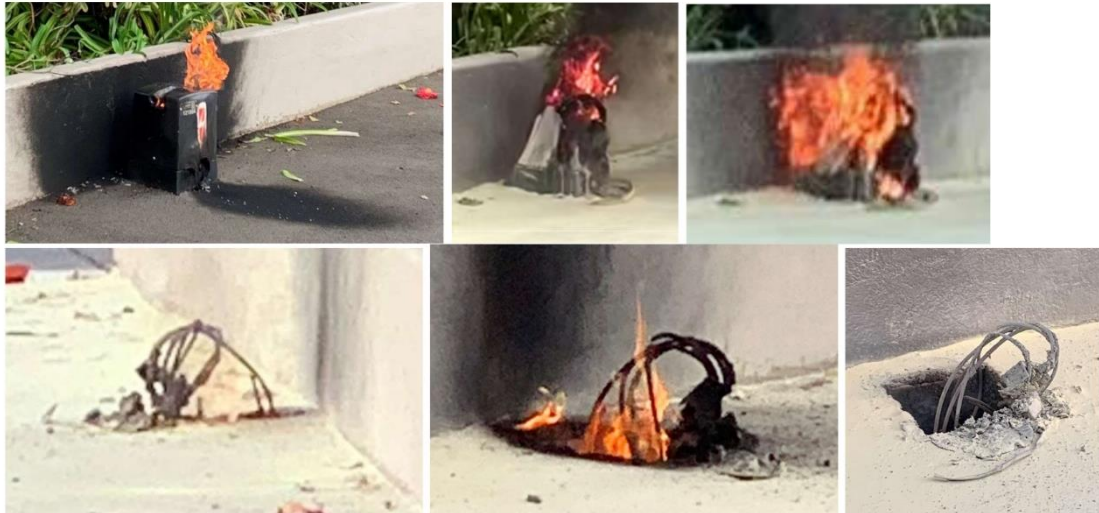
*Figure 2 LV Pillar Fire Progression Over 90 Minutes [1]*

Collaborative efforts between researchers, industry stakeholders, and electrical service providers like Powerco Ltd. are crucial for advancing our knowledge in this field and implementing effective preventive measures. In summary, the research on low-voltage arcing fire hazards is motivated by the pressing need to improve electrical safety in various settings and prevent potential devastating fires that can result in property damage, injuries, and even loss of life. Figure 2 illustrates the rapid combustion of these pillars, highlighting their potential as a fire hazard.

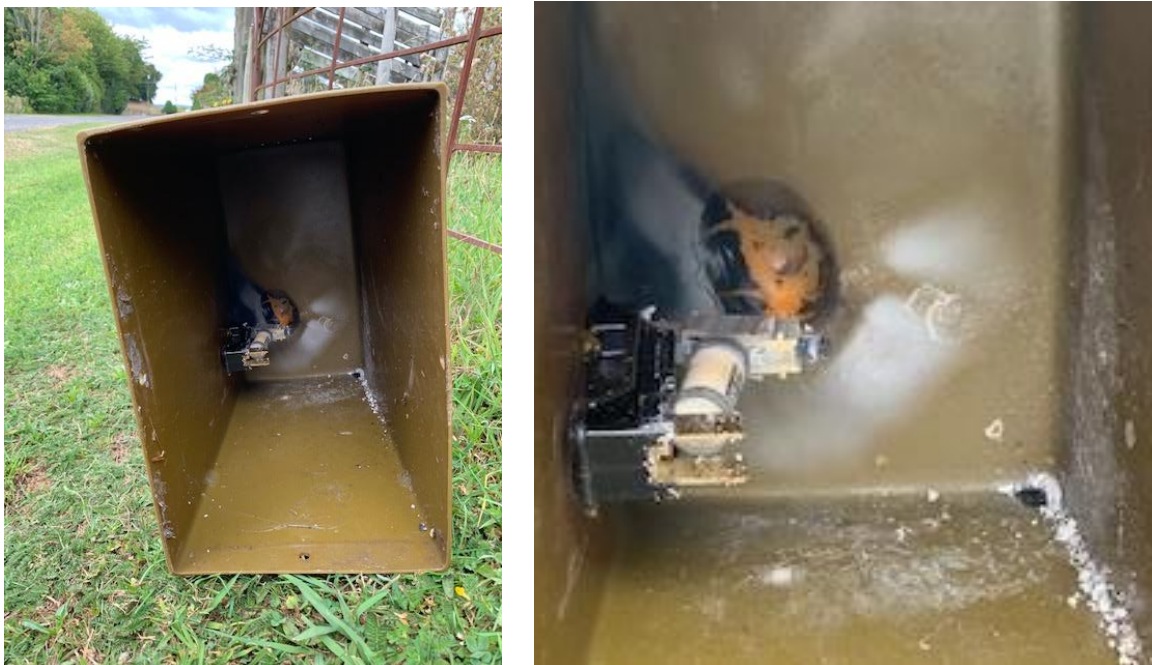
*Figure 5 The Fuse Holder Top is Stuck to the PE Pillar Lid and the Lid Shows Signs of Sooting and Melting. The Mounting Plate Shows that the Plastic Has Melted and Dripped Away Behind the Hot Connector.*

Photographs of actual pillars in the network, as shown in the Figure 5, reveal the harm caused by hot connections to the fuse holder, cables, and pillar housing. In [66], the data gathered from inspections, defect reports, and undisclosed reports to utilities are consistent with the results of laboratory testing on PVC and PE concerning decomposition and fire behaviour.

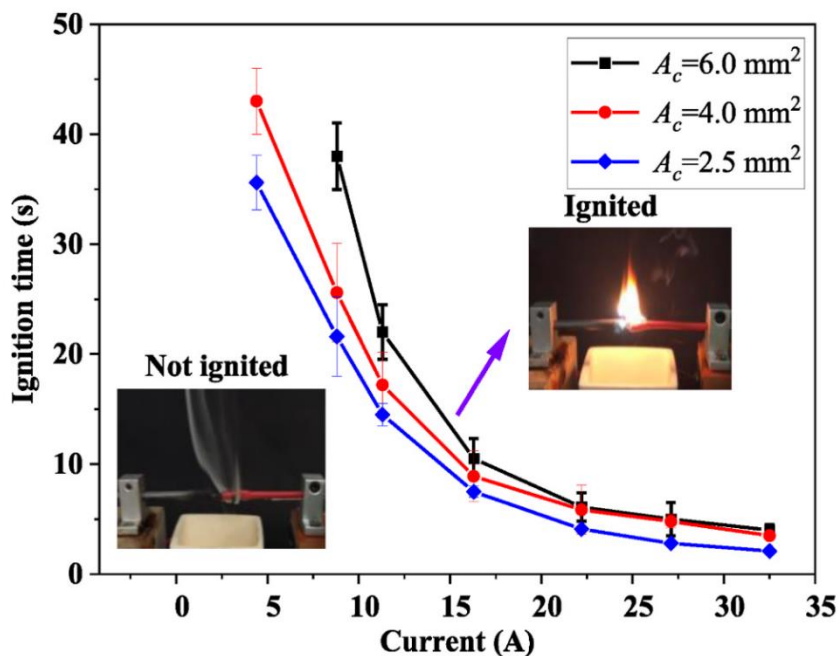
Figure 7 The Ignition Time of the at Different Currents [25]

The ignition time and current have an exponential function correlation as seen in the Figure 7 below. An exponential decrease in the ignition time of PVC insulated wire occurs as the arc current increases, attributed to the elevated temperature of the arc [25]. A wire with a bigger cross-sectional area takes longer to be lit with the same current in an arc. Flame spreading on an inclined electrical wire can be influenced by gravity's impact on the molten insulator and buoyancy-induced flow, affecting the heat transfer balance between the flame and the wire [50].

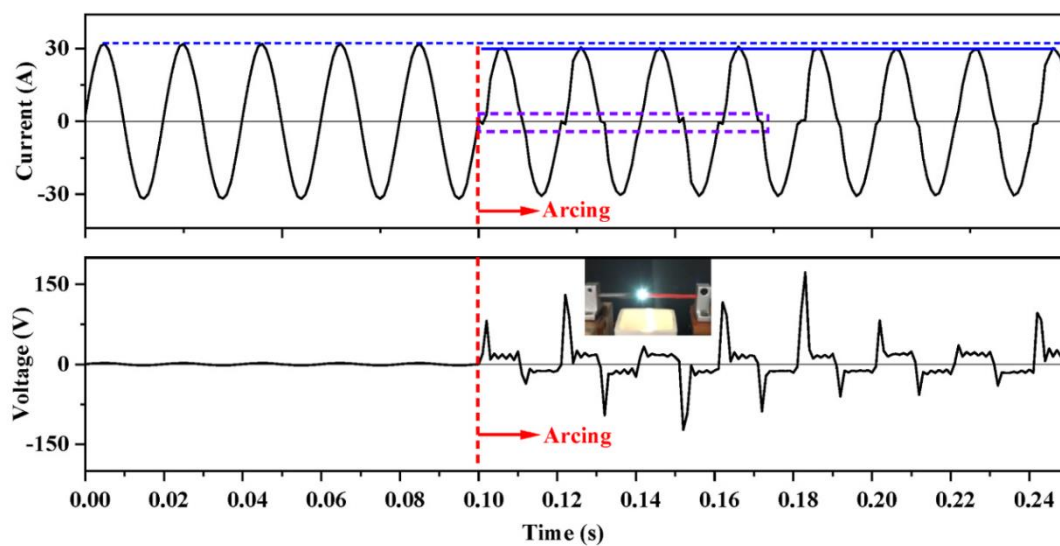
Figure 10 Example Waveforms of Current and Voltage for the Arc [71]

Current and voltage patterns may occur before such failures (Figure 10), resulting in fires, which are ideal for real-time detection [1], and can be well-suited for gaining a deeper insight into the failure-to-fire process. This research involves gathering data to evaluate the ignition patterns and failure features of electric fires in low-voltage pillars. By analysing the voltage and current waveforms, as well as monitoring internal and exterior temperature and gas development in low-voltage pillars, diagnostic procedures can be created to establish preventive measures to decrease the frequency of pillar fires. Diagnostic procedures may include the use of switchgear similar to that in Table 3.

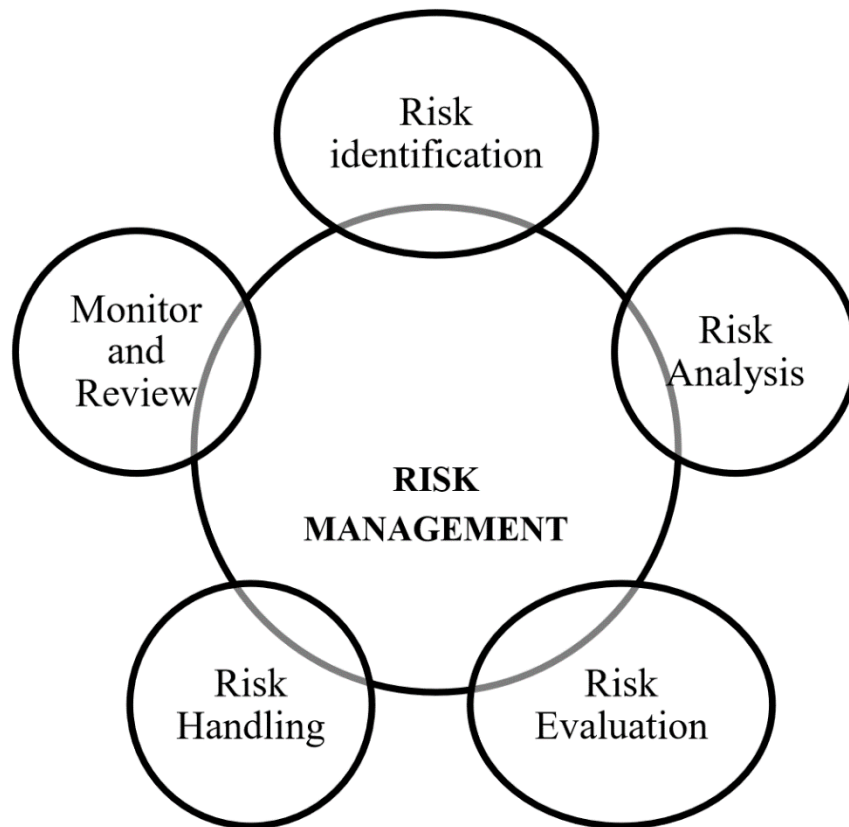
*Figure 13 Risk Management Factors [47]*

This method guarantees a systematic and impartial examination of possible risks, considering the unique circumstances of the experiment. A risk assessment should include all factors that contribute to operational safety, personal and equipment safety and account for accidents as seen in the Figure 14. It allows researchers and stakeholders to recognise, comprehend, and resolve potential hazards in an organised fashion, ultimately leading to a safer and more regulated experimental setting. Figure 15 shows the important risk management factors the researcher [47] has considered when exposed to arc flash.

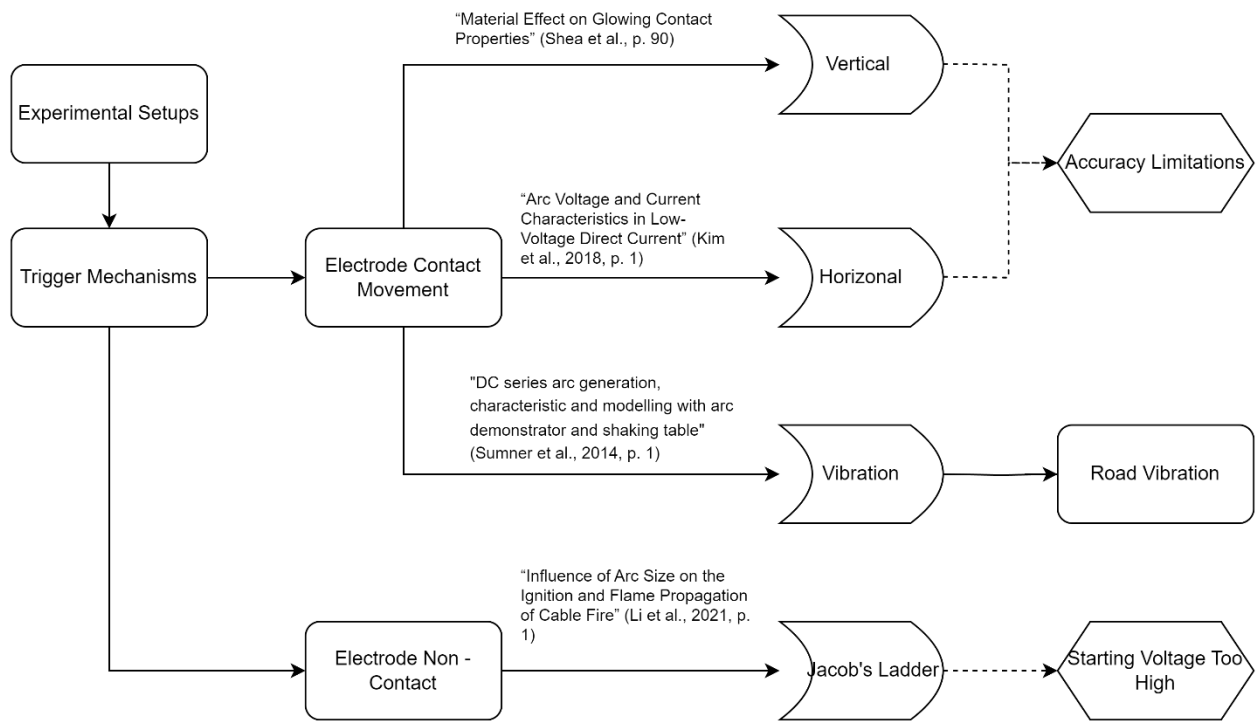
Figure 15 Typical Methods to Create an Arc in Laboratory Settings

The precision and dependability of arc creation rely on choosing the appropriate mechanical movement between electrodes. Three common types of arc generators use mechanically moving electrodes. 1) [68] utilised vertical movement, 2) [12] focused on horizontal movement, and 3) [21] researched vibration seen in this Figure 15. Vibration most accurately replicates the impact of traffic and seismic activity on LV pillars. One can replicate traffic-induced vibrations using a shaker table, as seen in Figure 16.

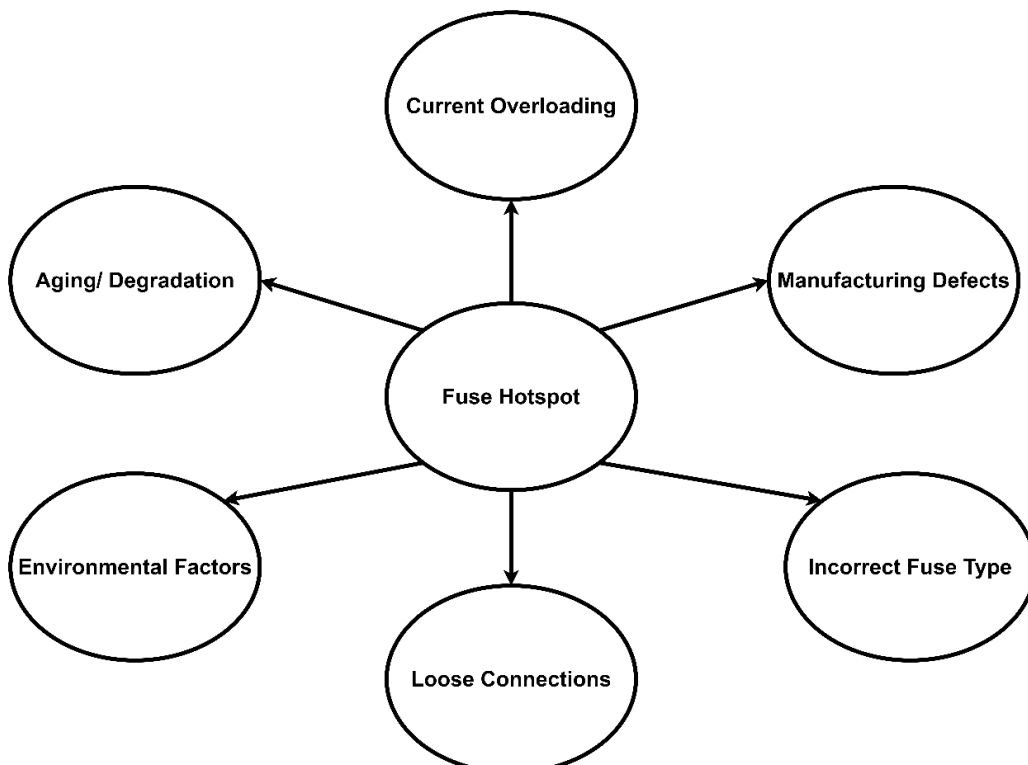
*Figure 20 Causes of Fuse Hotspots*

Figure 20 displays potential failure mechanisms that could lead to excessive heating of fuses, which might result in fire hazards. Two common failure scenarios, which are frequently encountered in practice, can be directly examined in an experimental setup and provide the most reliable indications of how pillar fires may originate from overcurrent fuses.

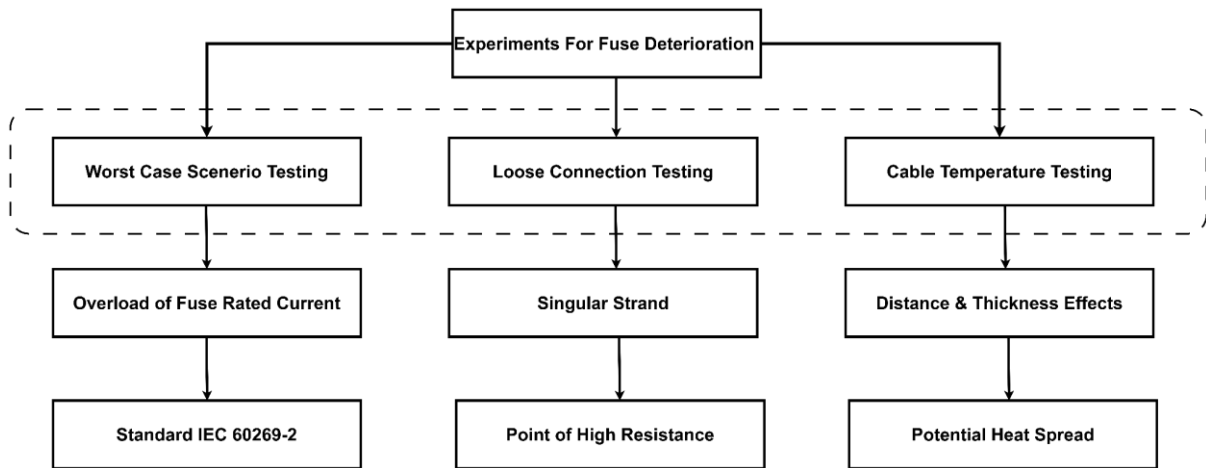
*Figure 21 Testing Flowchart*

Figure 21 displays the flowchart for the experiments, and the three configurations for testing, namely worst-case scenario, loose connection and cable temperature, are detailed below.

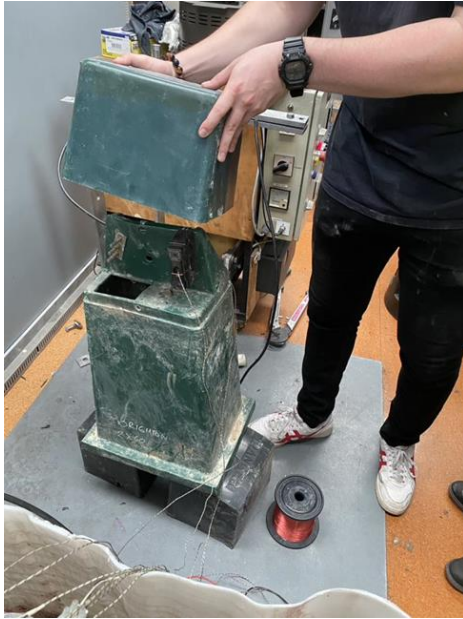
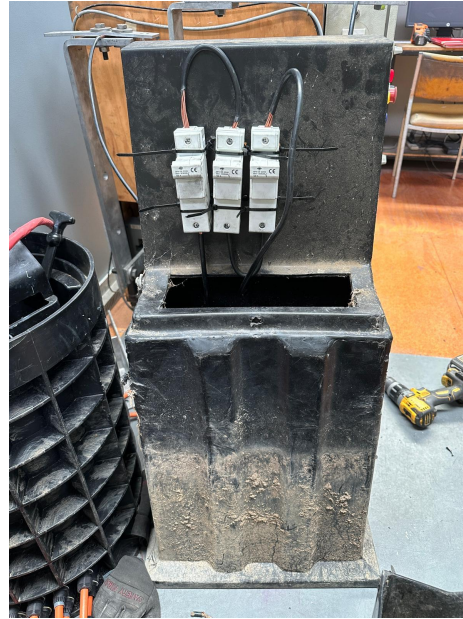
*Figure 22 Assembly Single Fuse Holder & Figure 23 Assembly Three Fuse Holders*

The Assembly Setups are shown below on Figure 22 and Figure 23:

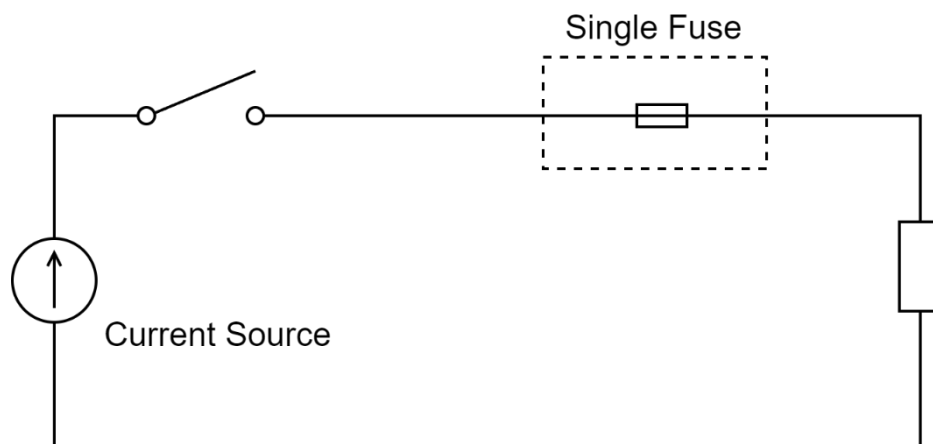
*Figure 24 Simplified Single Fuse Circuit Model*

The experimental configuration should be set up with a single 63A fuse in the circuit insulation as seen the Figure 24 below. These pillars are made of LDPE and the cables are made internally of copper with PVC.

This setup was utilised for Loose Cable Testing, presented Table 9.

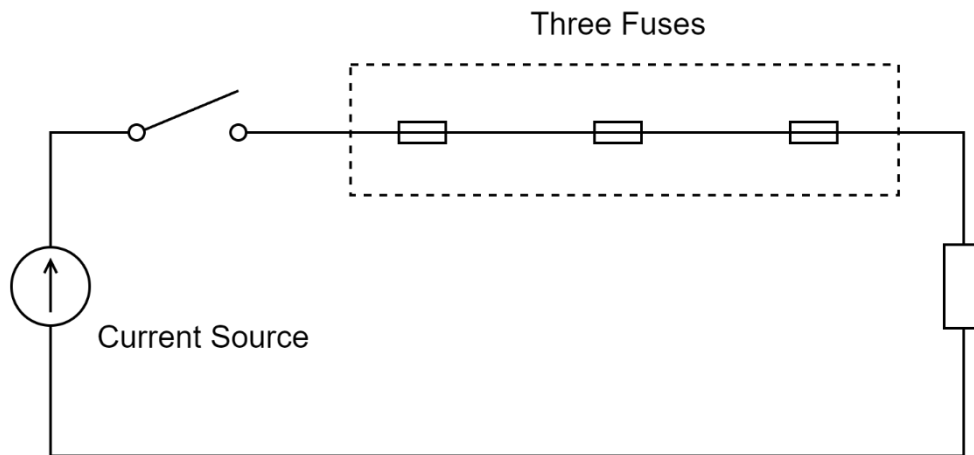
*Figure 25 Simplified Three Fuse Circuit Model*

The experimental configuration should be set up with a three 63A fuses in the circuit. The fuses should be connected in series to enable heating of all fuses at the same current level as seen in the Figure 25 below. These pillars are made of LDPE and the cables are made internally of copper with PVC insulation.

This setup was utilised for Worst Case Scenario Testing (Table 10).

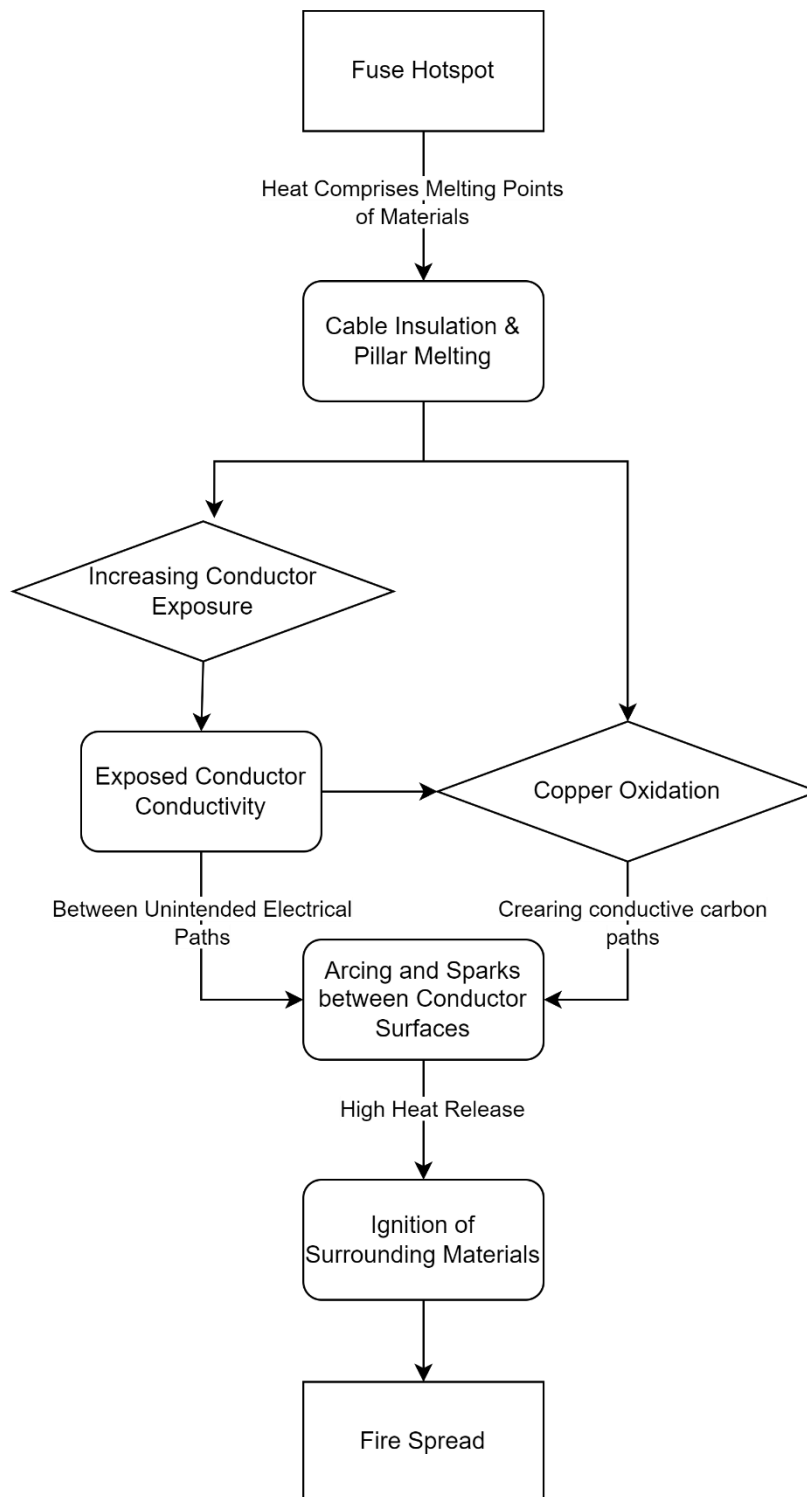
*Figure 27 The Relationship Between Fuse Hotspot and Pillar Fire*

The findings of this chapter and theory from the literature review has been summarised in Figure 27.

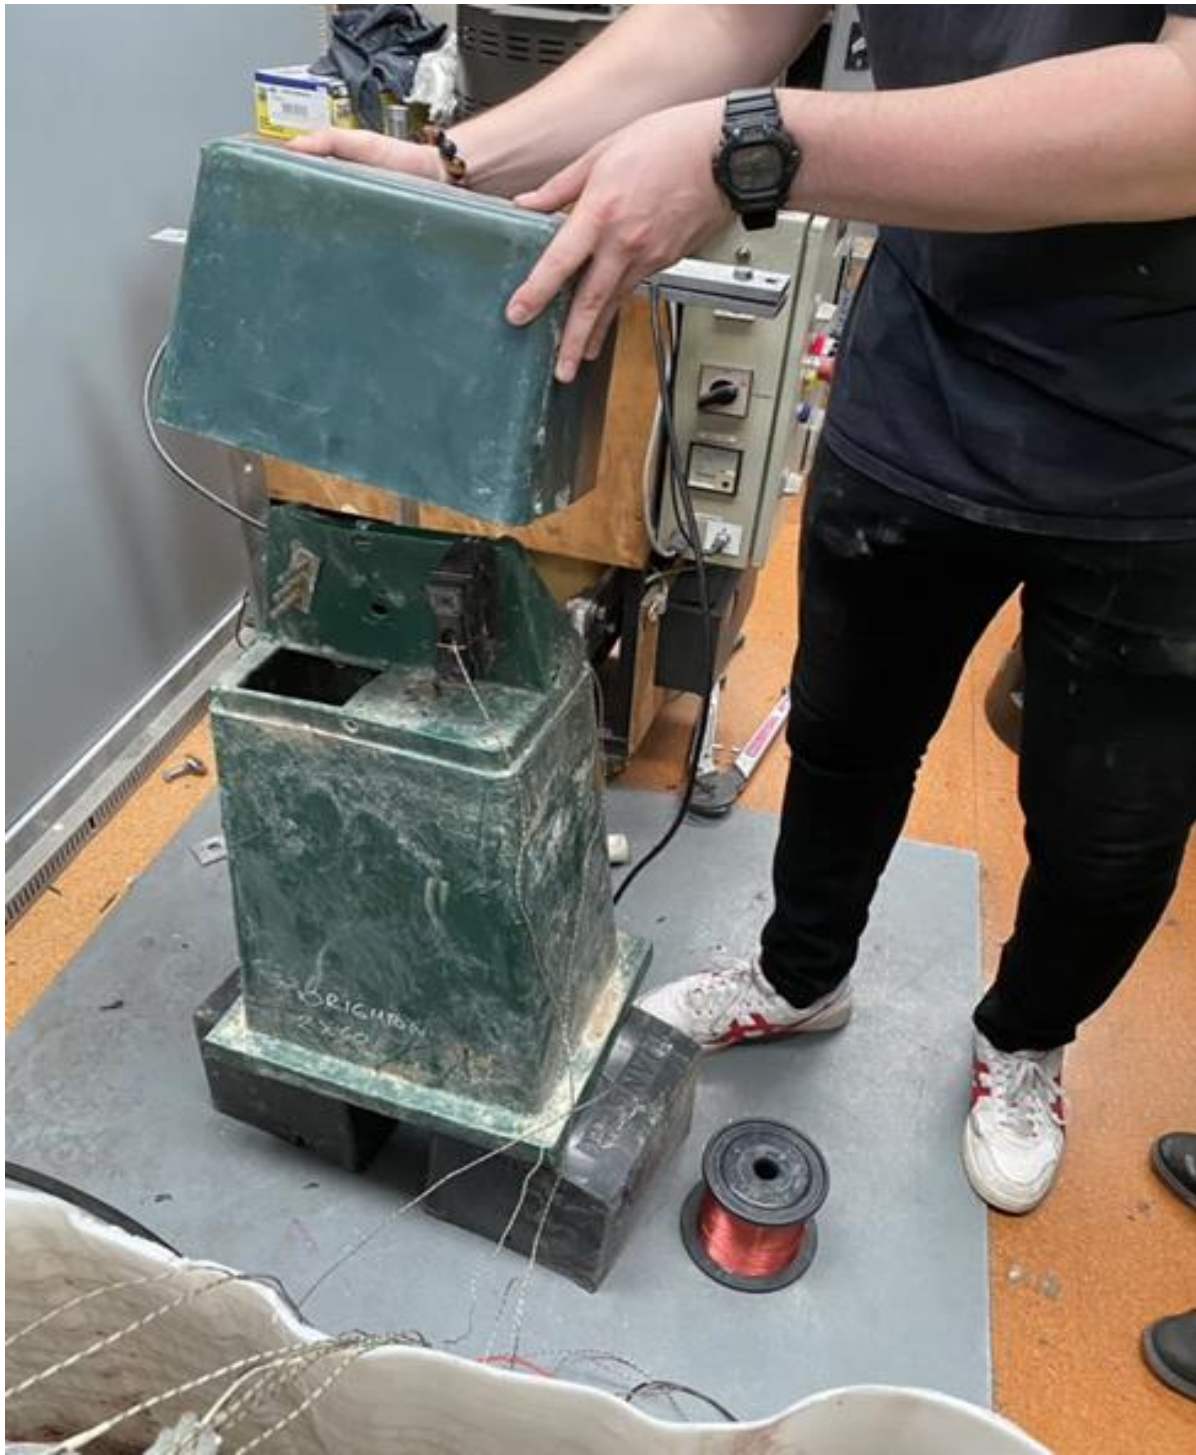
*Figure 2 Single Fuse Holder Setup*

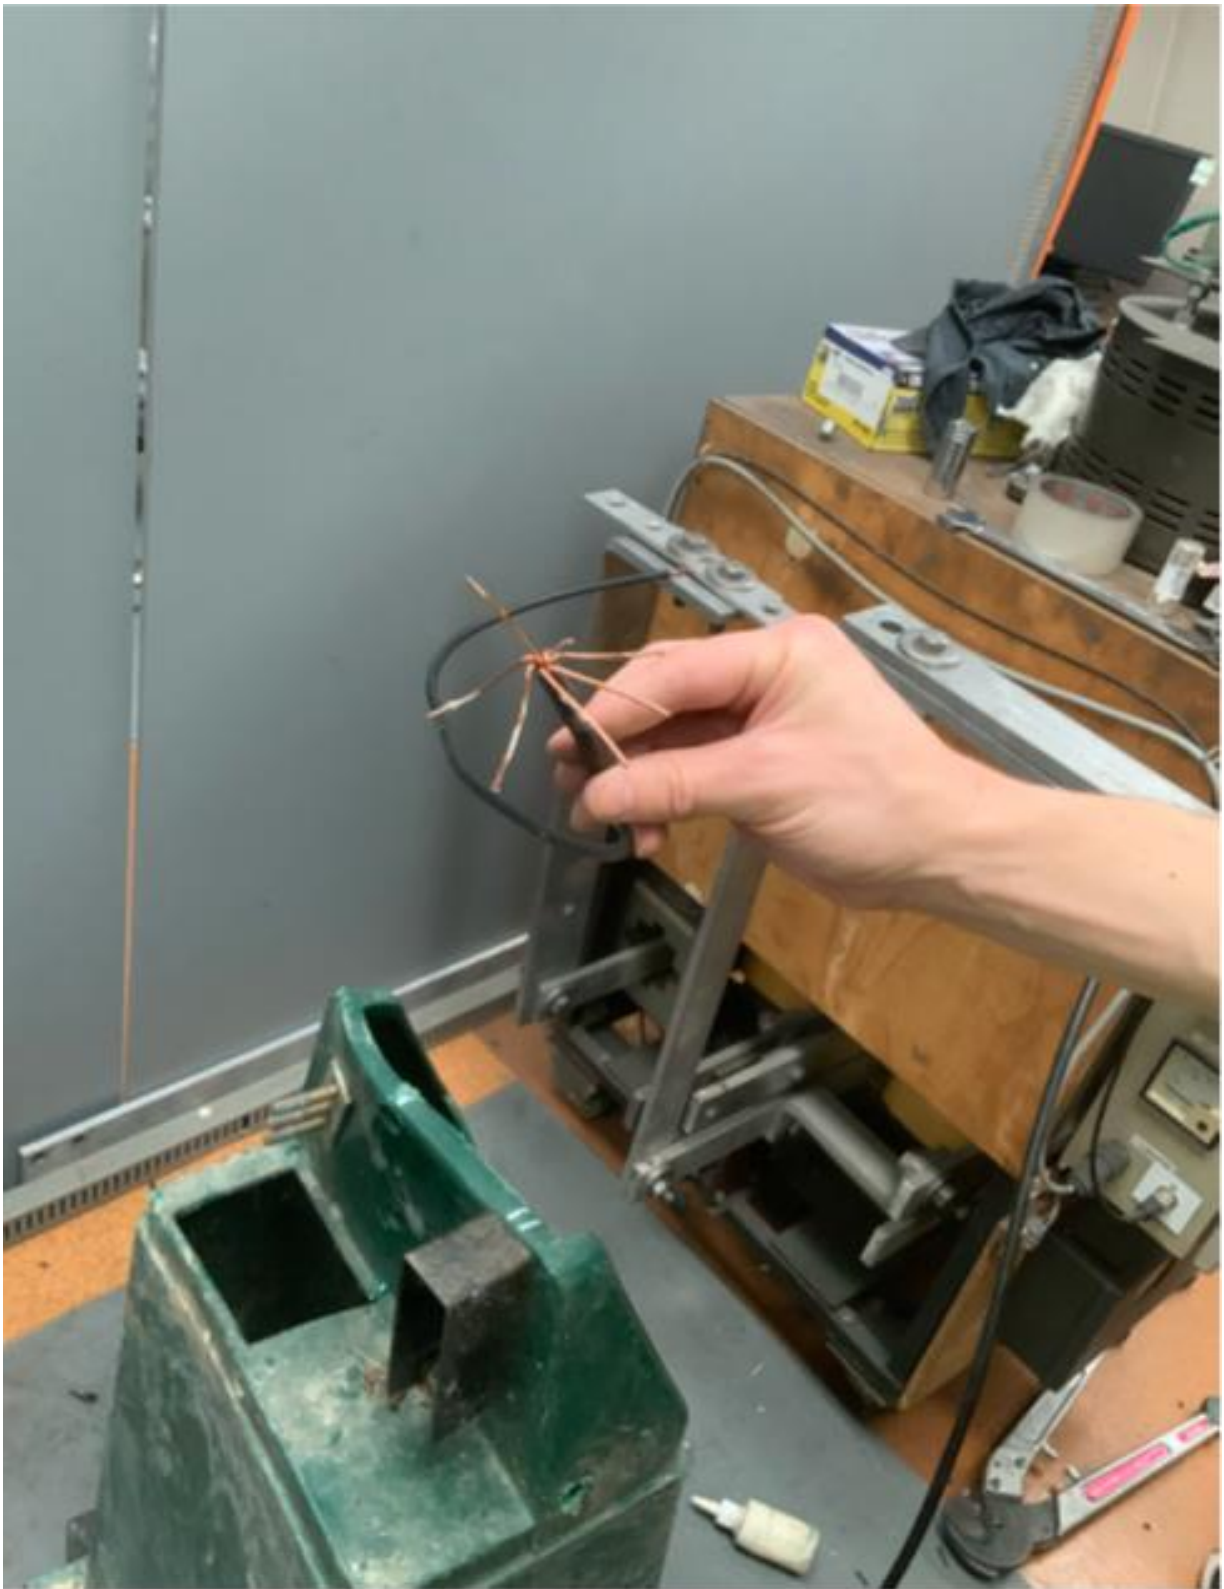
*Figure 4 Strand Separation of Copper Cable*
