# Assessment of timber floor diaphragms in historic unreinforced masonry buildings

Aaron Wilson<sup>1</sup>, Pierre Quenneville<sup>2</sup>, Jason Ingham<sup>3</sup>

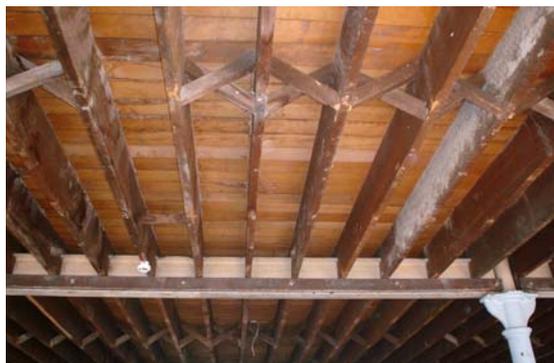
(a) Underside showing joists, sheathing and cross-bracing

While URM buildings outside of Europe typically comprise rigid clay brick perimeter walls, the floors are usually constructed of comparatively light timber framing. These floors are generally made up of either straight-edge or tongue & groove floorboards nailed perpendicular to joists that span between the URM walls. When perimeter walls are close enough (approximately less than 6 m) joists often span continuously between these elements. For larger spans, joists are typically lapped or butted over intermediate steel or timber cross-beams supported on columns. Diaphragm blocking and chord elements are almost never present, and timber cross-bracing is typically fitted intermittently between joists to prevent out-of-plane buckling. Joist ends are typically either simply supported on a brick ledge resulting from the perimeter walls reducing in width at each storey height, or pocketed into the wall to a depth equal to one brick width. Examples of timber floor configurations are given in Figure 1.

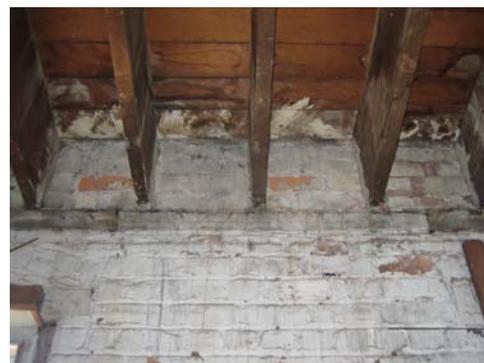
(b) Joists pocketed into URM perimeter wall

Diaphragms FS3a and FS4a were tested in the direction perpendicular to joists so that the diaphragm span to depth ratio was 1 to 1.88. Realistic conditions were created for this set-up by constructing URM walls on each side of the diaphragm for the joists to pocket into, similar to that illustrated in Figure 1 (b). Sliding of the brick walls was prevented by post-tensioning the walls with M16 rods epoxied into the warehouse concrete slab (measurement of wall position during testing showed that no wall displacement was observed). Loading was introduced into the diaphragm using the same hinged steel frame as for the previous set-up but with only two points of loading. Diaphragms FS3a and FS4a were equivalent in construction except that diaphragm FS3a had continuous joists spanning between the brick walls while diaphragm FS4a had discontinuous joists with a two-bolt lapped central connection.

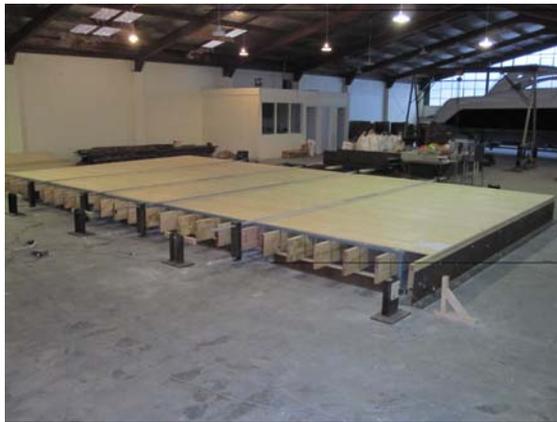
(a) Diaphragm FS1a

A total of four diaphragm specimens labeled FS1a to FS4a, constructed with new pine timber, were tested. Each specimen measured 10.4 m x 5.535 m and was comprised of 135 mm x 18 mm straight edge floorboards nailed perpendicular to 45 mm x 290 mm joists spaced at 400 mm centers. Joists were orientated in the 5.535 m dimension. Cross-bracing was fitted between the joists at 1/3 joist length locations using 45 mm x 75 mm framing. Every floorboard-joist connection was fastened using two 75 mm x 3.15 mm bright power driven nails spaced at approximately 95 mm.

Diaphragms FS1a and FS2a were tested in the direction parallel to joists so that the diaphragm span to depth ratio was 1.88 to 1. In this direction the two side joists were bolted to steel frames that were fastened to the warehouse concrete slab which replicated in-situ boundary conditions where the edge joists would simply be bolted intermittently to the perimeter URM walls (see Figure 2 (a)). Lateral loading was introduced into the diaphragm using a hinged steel frame ‘whiffle tree’ on castors that distributed the hydraulic actuator point load into four equal point loads. It can be observed in Figure 2 (b) that the loading frame was comprised of a main truss and two secondary beams that were capable of rotating with the deforming diaphragm. Reversed cyclic loading was achieved by positioning loaders on both ends of the loaded joists, and post-tensioning these loaders together using M16 threaded rods that spanned the depth of the diaphragm (Figure 2 (b)). The diaphragm was supported vertically by Teflon pads that allowed the diaphragm to deform laterally without measurable friction. Diaphragm FS1a shown in Figure 2 (a) was a homogenous diaphragm while diaphragm FS2a shown in Figure 2 (c) included a corner penetration measuring 3.2 m x 1.08 m that represented a typical stairwell present in many timber diaphragms.

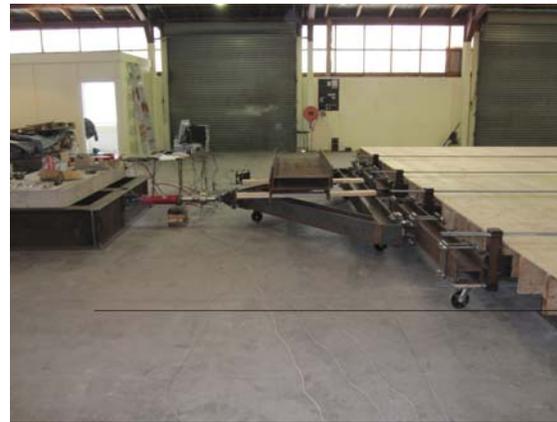
(b) Loading frame set-up

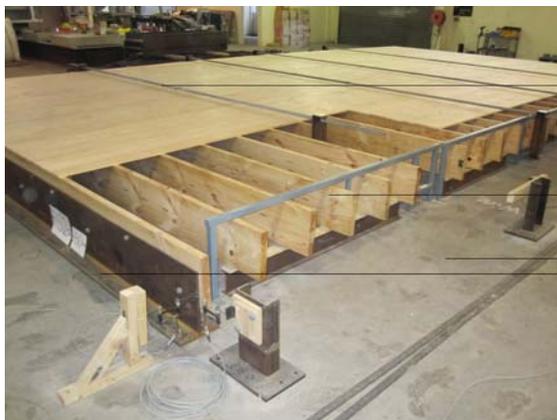
(c) Penetration in Diaphragm FS2a

A comparison of the force-displacement responses of specimens FS2a and FS1a suggests that a small diaphragm opening such as a stairwell does not significantly affect the diaphragm’s performance, with these responses being largely indistinguishable. It is appreciated that larger penetrations may worsen this effect however. Another interesting observation is that diaphragms FS3a and FS4a behaved analogously despite the presence of a central discontinuity in the joists in diaphragm FS4a. This could be explained by the deformation profile of the diaphragms displaying little amounts of relative displacement between the two point-load locations. With the majority of deformation occurring in the outer regions of the diaphragm, the curvature near the centralized joist connection was low and therefore considerably reduced its effect on diaphragm response.

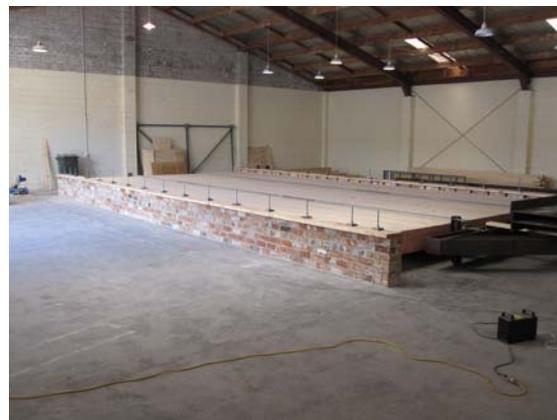
(d) Diaphragm FS3a/4a

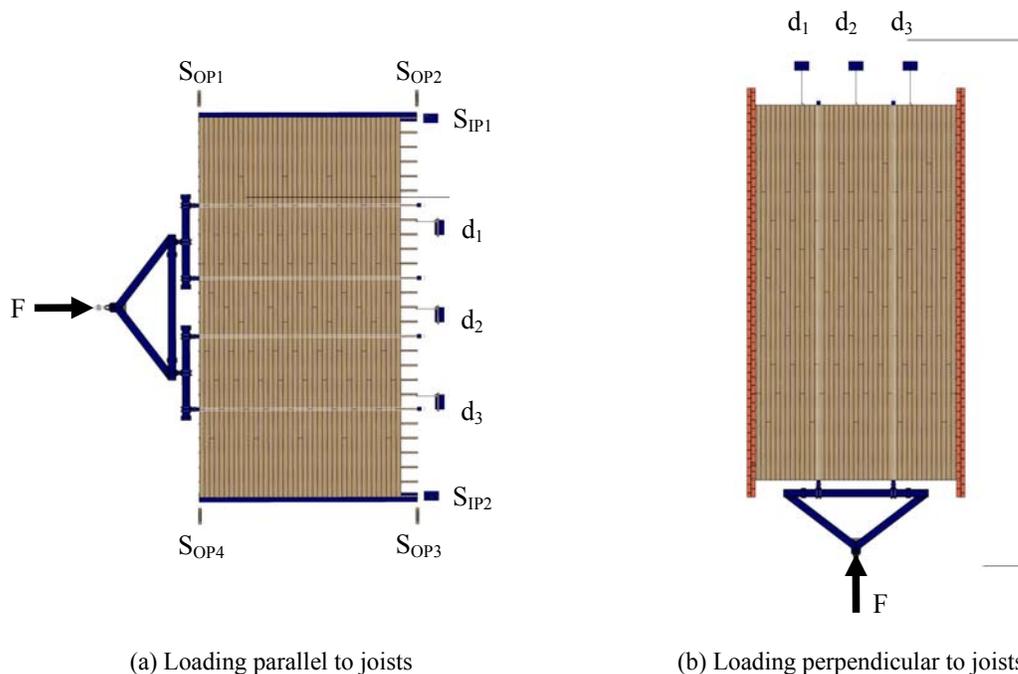
Figure 3 – Instrumentation locations

During each test, total load ( $F$ ) was recorded using a load cell attached to the actuator, while the diaphragm deformation profile was measured at three locations ( $d_1 - d_3$ ) using string potentiometers. In addition, the in-plane ( $S_{IP1}$  and  $S_{IP2}$ ) and out-of-plane ( $S_{OP1} - S_{OP4}$ ) displacement of the steel side frames was monitored during testing parallel to joists using ‘portal’ strain gauges. Figure 3 illustrates the location of test instrumentation.

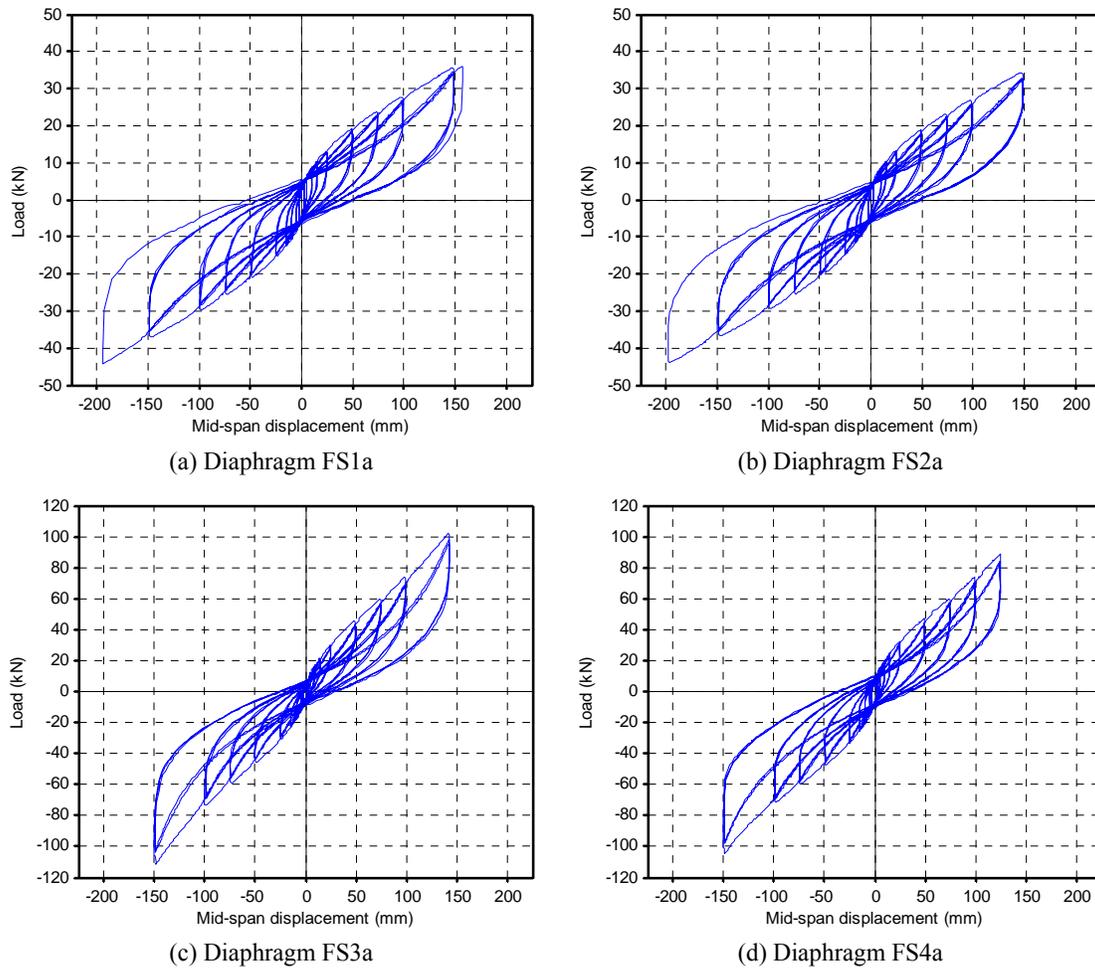
**Figure 4** – Full-scale diaphragm testing results

Overall the diaphragms displayed flexible and highly nonlinear characteristics with low levels of hysteretic pinching, as illustrated in the force versus midspan displacement plots in Figure 4. The open hysteretic loops demonstrate that these diaphragms are capable of dissipating considerable amounts of energy when subject to lateral loading. No splitting of timber, nail tear-out or other failure mechanisms were observed during testing, even at displacements in excess of 150 mm, and all diaphragms appeared to remain completely serviceable at the conclusion of each test.

It is difficult to directly compare force-displacement response between the two principal loading directions due to the influence of diaphragm geometry. Diaphragms FS3a and FS4a demonstrated greater stiffness and strength than FS1a and FS2a, but this is clearly due to a considerably lower span to depth ratio. As a general observation, the hysteretic loops are larger in the direction parallel to joists which could result from greater engagement of the yielding nail couples in this direction as opposed to loading in the direction perpendicular to joists, where the nail couples are less engaged and the out-of-plane bending of the joists has greater influence on response.

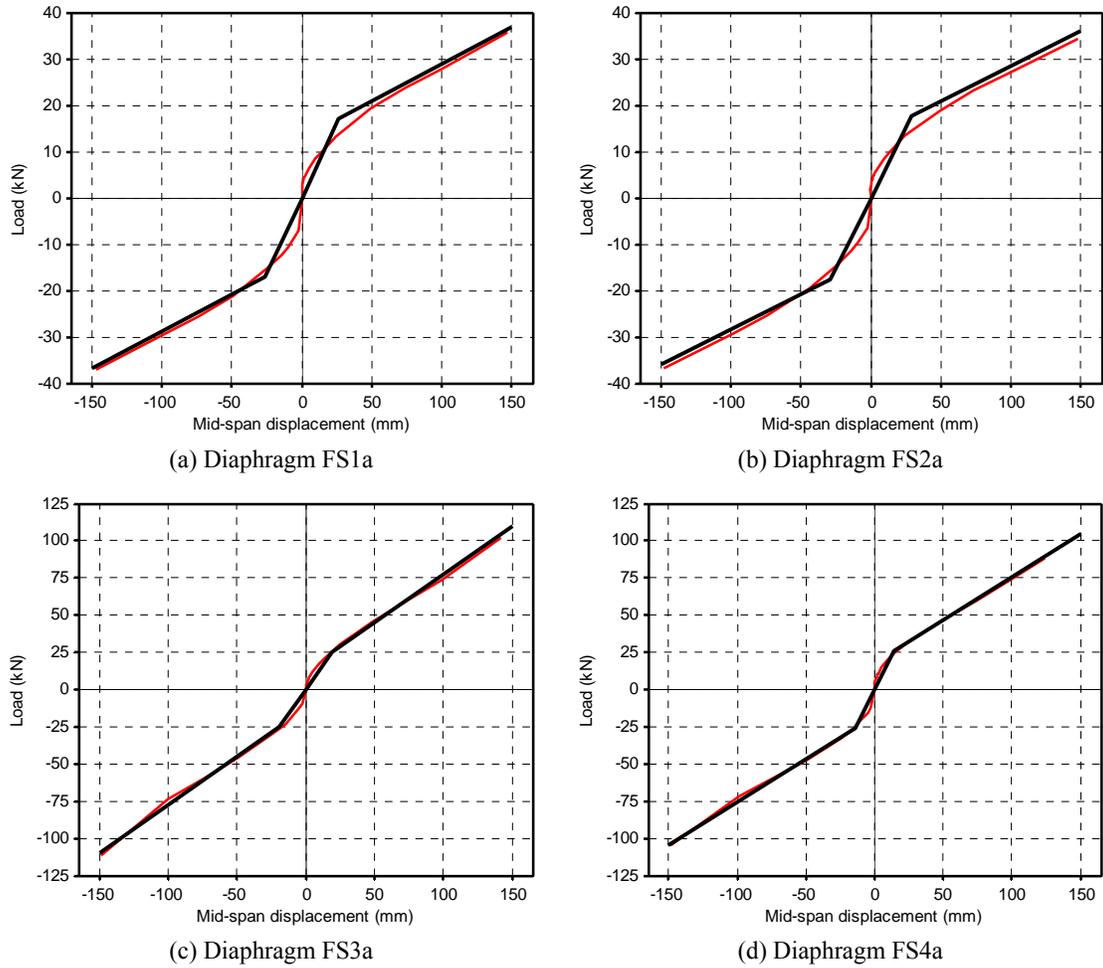
**Figure 5** – Bilinear curves for tested as-built diaphragms

Figure 5 shows the bilinear curves produced for diaphragm tests FS1a to FS4a. The bilinear curves defined the yield force ( $F_y$ ), yield displacement ( $\Delta_y$ ), maximum force at  $\Delta = 150$  mm ( $F_{max}$ ), and initial and secondary stiffness ( $K_1$  and  $K_2$ ) values presented in Table 2 that were used to calculate the desired

diaphragm performance parameters. Diaphragm stiffness  $K_d$  was defined as initial stiffness  $K_I$  while shear strength  $R_n$  was calculated by simply dividing yield force by two times the diaphragm depth. Ductility was determined using the conventional assumption of elastic-perfectly plastic response and calculating the ratio between maximum displacement and yield displacement. These values are presented in Table 1 for comparison.
