Statistical Assessment of Damage to Churches Affected by the 2010-2011 Canterbury (New Zealand) Earthquake Sequence

The Canterbury Region of New Zealand experienced an extensive earthquake sequence during 2010-2011, with two particularly severe events being on 4 September 2010 and 22 February 2011. The presented work entails a statistical analysis of the data collected for 112 church buildings located in the affected region, including details of the *in situ* damage observed by the authors and the structural assessment classification assigned by the local authorities. The seismic performance of these churches is discussed and compared with both the structural classifications used in Italy, where a specific survey form for churches is used, and with the building damage classifications assigned by the local authorities.

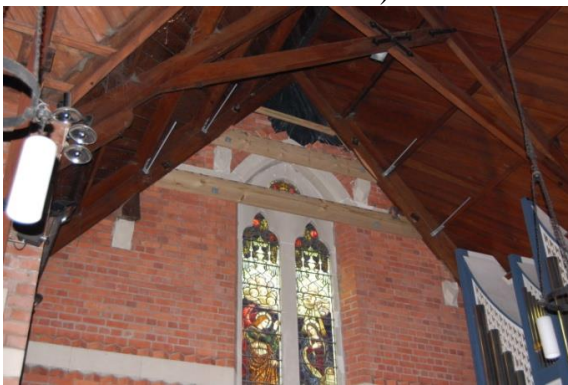
(c) interior inspection (stone church of St Peter's, stone and clay brick, Upper Riccarton)

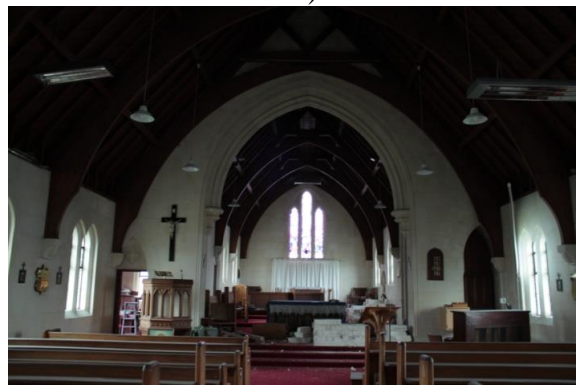
(d) interior inspection (St. Faith's, stone, New Brighton)

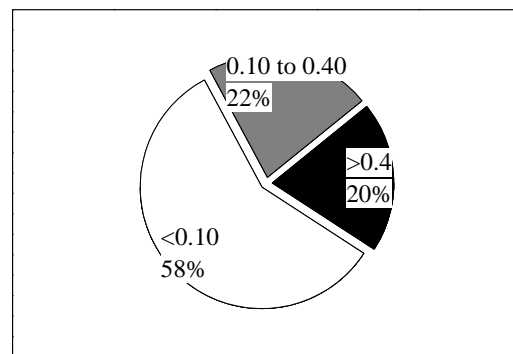
(d) damage index i_d (Italian survey form)

The i_d parameter was computed and taken into consideration in Figure 11 (d), although the seismic behaviour of the timber churches poorly fits the *macroelement* concept, which is based on the division of a church into a given number of elements that have a nearly independent seismic response as is typical of masonry churches [Doglioni et al., 1994; Giuffrè, 1999]. This disparity does not indicate that the architectural elements are absent as the church can still be divided into the same *macroelements*, but instead that the structural components are less likely to be activated individually as in masonry churches, because of the required localization of deformation.

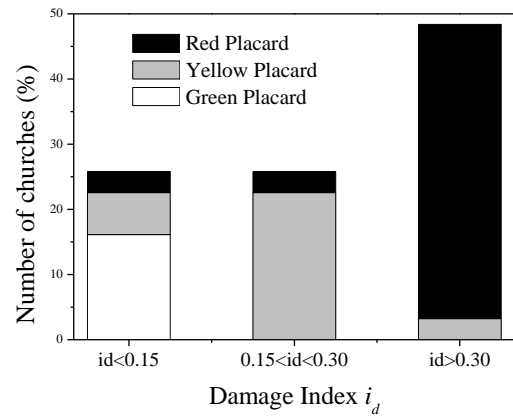
(b) correlation between the damage index i_d and placard classification

The division of the damage index i_d into three intervals in order to define a value for each colour placard for stone churches was undertaken in a slightly different manner to the procedure adopted for the complete dataset accounting for all typologies (see Figure 16 (b)). The interval for the *green* placards was assigned an elevated upper limit (0.15 instead of 0.10) and the interval for the *red* placards was assigned a decreased lower limit (0.30 instead of 0.40). The absence of clear demarcation between the three placard designations is readily identifiable, particularly when the i_d value is related to the FFU, as show in Figure 16 (c). As the percentage of Safe classifications is

higher than the percentage of *green* placards, the middle interval ($0.15 < i_d < 0.30$) has a small percentage of Safe classifications, as opposed to the information presented in Figure 16 (b), where no green placards are found in the middle interval. It is also shown in Figure 16 (c) that the percentage of *red* placards in the first interval is due to external causes, and therefore the i_d of these churches can be quite low.

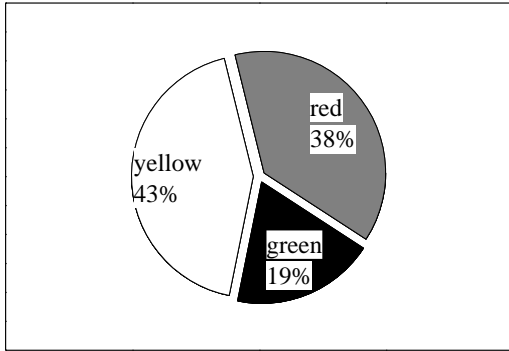
(a) placard classification

The brick churches were less damaged than the stone churches, but also exhibited poor performance during the earthquakes. Figure 17 (a) shows that a *red* placard was assigned to 38% of the churches, while a *yellow* placard was assigned to 43% of the churches. The percentage of *red* placards assigned for this typology was smaller than the percentage assigned for the stone churches, but the sum of *red* and *yellow* placards was similar for both masonry typologies and exceeded 80%.

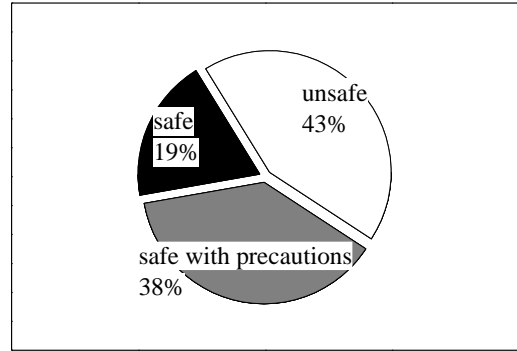
(b) FFU classification (Italian survey form [Civil Protection Department, 2006])

The FFU classification (see Figure 17 (b)) gave good agreement with the placard classification (Figure 18 (a)) with the same percentage of *green* placards and Safe classifications assigned to the same churches. The percentage of *red* placards was 5% lower than was recorded for the Unsafe category, and therefore the percentage of *yellow* placards was 5% higher than recorded for the ‘Safe with Precautions’ category. Also, these classifications were not assigned to the same churches as the *red* placard percentage was lower than the percentage assigned as Unsafe and there was also 5% having a ‘Safe with Precautions’ classification in the *red* placard column (see Figure 18 (a)).

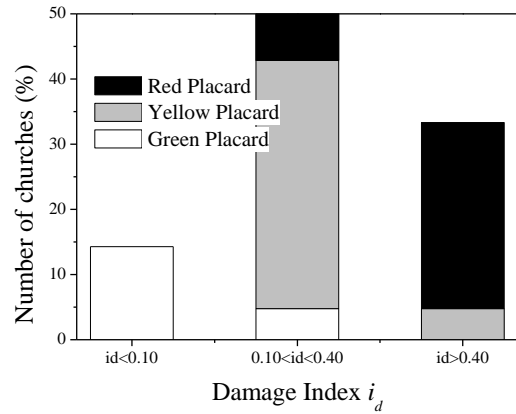
(b) correlation between the damage index i_d and placard classification

The three suggested intervals for the i_d (see Figure 18 (b)) are the same as those used for the entire dataset of churches, and therefore are slightly different from those used for the stone churches. It was established that in order to be assigned a *green*

placard the brick churches required a lower i_d value in comparison to the corresponding value for stone churches, as the interval for brick churches is $i_d < 0.10$. For the *red* placards the inverse occurs and the brick churches required a higher value of $i_d > 0.40$, instead of the 0.3 value used for stone churches. These modifications indicate that stone churches can withstand higher levels of damage than can brick churches in order to be assigned a *green* placard, but sustain lower levels of damage in order to be assigned a *red* placard. Similar results are presented in Figure 18 (c), although the correlation between the colour placards and the FFU classification is not exact.

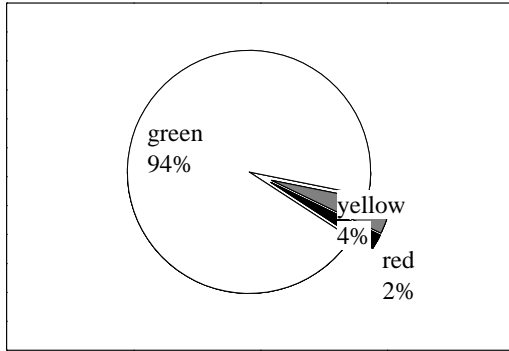
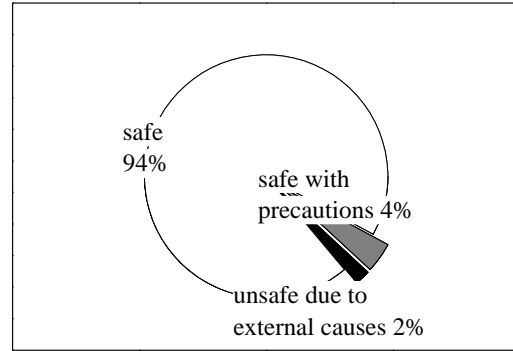
Figure 19 - Damage statistics for timber churches.

The timber churches had the best overall performance, with no structural damage and, as can be seen in Figure 19 (a) and (b), 94% of the churches were assigned a *green* placard or Safe classification. The single *red* placard assigned to a timber church was due to external causes, such that there were no Unsafe classifications and only ‘Unsafe due to External Causes’. Finally, the *yellow* placard, with the same percentage as the ‘Safe with Precautions’ category was due to non-structural damage, being mainly cracking of the inside or outside plaster.

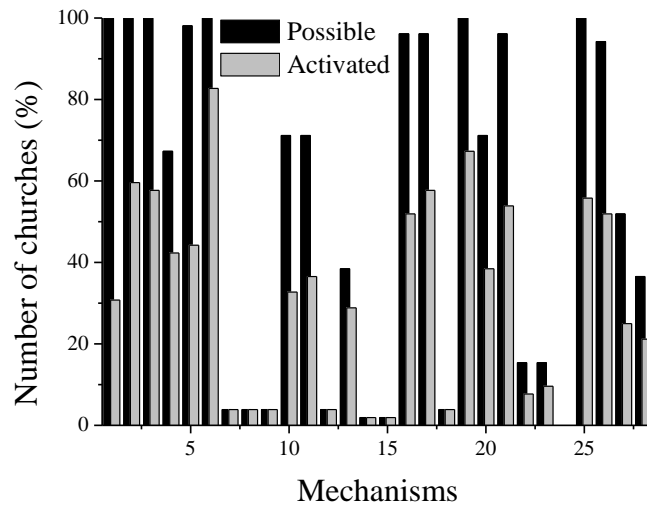
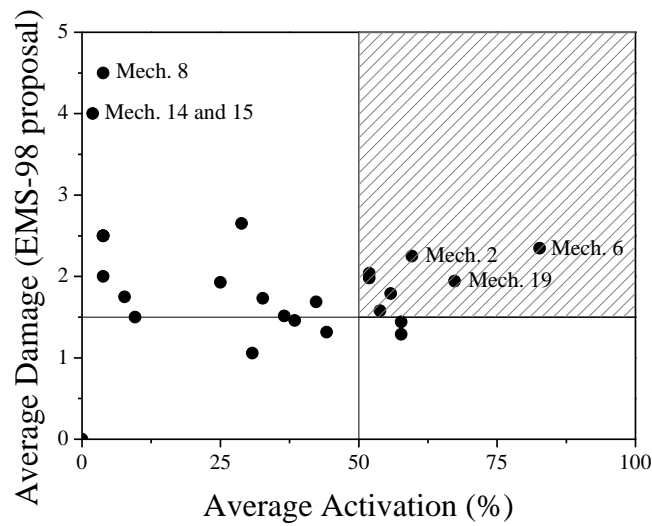
Figure 20 – Damage data for stone and clay brick churches.

The data on the timber churches are not included in the results presented in Figure 20 (a) and (b) regarding the failure mechanisms observed. A comparison between the Possible and Activated collapse mechanisms can provide valuable information. Certain *macroelements* represent basic architectural components of all churches and there is no surprise that mechanisms 1, 2 and 3, which are related to the church facade, can be activated in all stone and brick churches (see Figure 20 (a)). The same comment applies to mechanism 6, which is related to the lateral walls of the churches, to mechanism 19 which is related to the roofing elements, and to mechanism 25 which is related to irregularities in elevation.

the EMS-98 proposal [Grunthal et al., 1998], as well as the average activation value of that mechanism when it was available (see Figure 21 (b)). This last parameter is relevant when analysing the mechanisms with the highest average damage values, as mechanisms 8 (average value of 4.5), 15 (average value of 4.0) and 14 (average value of 4.0) are related to the vaults, dome and lantern, which are elements present only in the heavily damaged Cathedral of the Blessed Sacrament. Therefore, the most vulnerable mechanisms should be those that are activated in most churches and exhibit a considerable average damage value, and these mechanisms can be found in the shaded area of Figure 20 (b): seven mechanisms (2, 6, 16, 19, 21, 25, 26) are activated in more than 50% of the churches, with an average damage value greater than 1.5. Mechanism 6, which is shear in the longitudinal walls (see Figure 21 (a) and (b)) stands out as the most vulnerable mechanism (activated in 83% of the churches, with an average damage value of 2.34), followed by mechanism 19 (hammering of the roof, activated in 67% of the churches with an average damage value of 1.94, see Figure 21 (c) and (d)) and mechanism 2 (overturning of the top of the facade, activated in 60% of the churches with an average damage value of 2.25, see Figure 21 (e) and (f)).
