# Damage Inspection in Churches – The Canterbury Earthquake (New Zealand) Experience

João Leite<sup>1</sup>, Jason M. Ingham<sup>2</sup>, Paulo B. Lourenco<sup>3</sup>

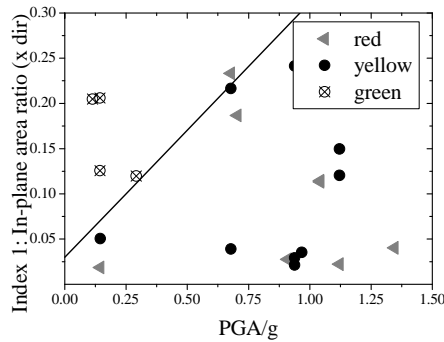
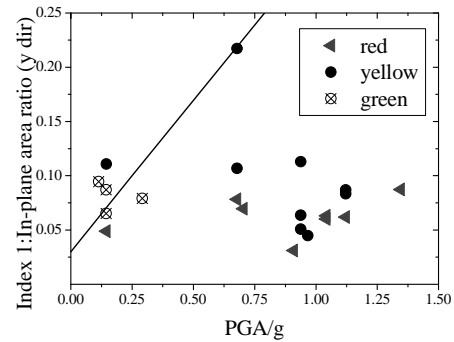
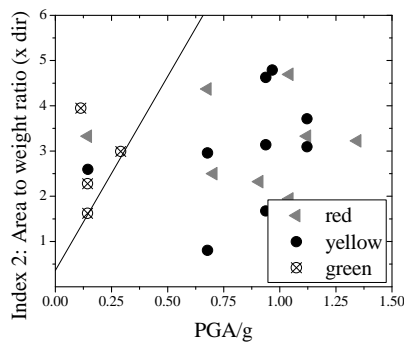
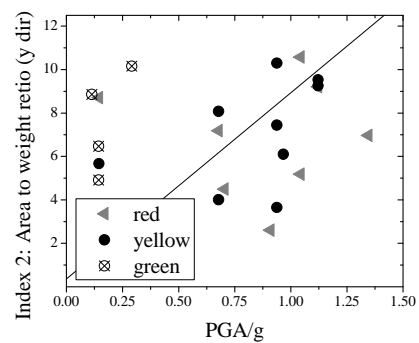
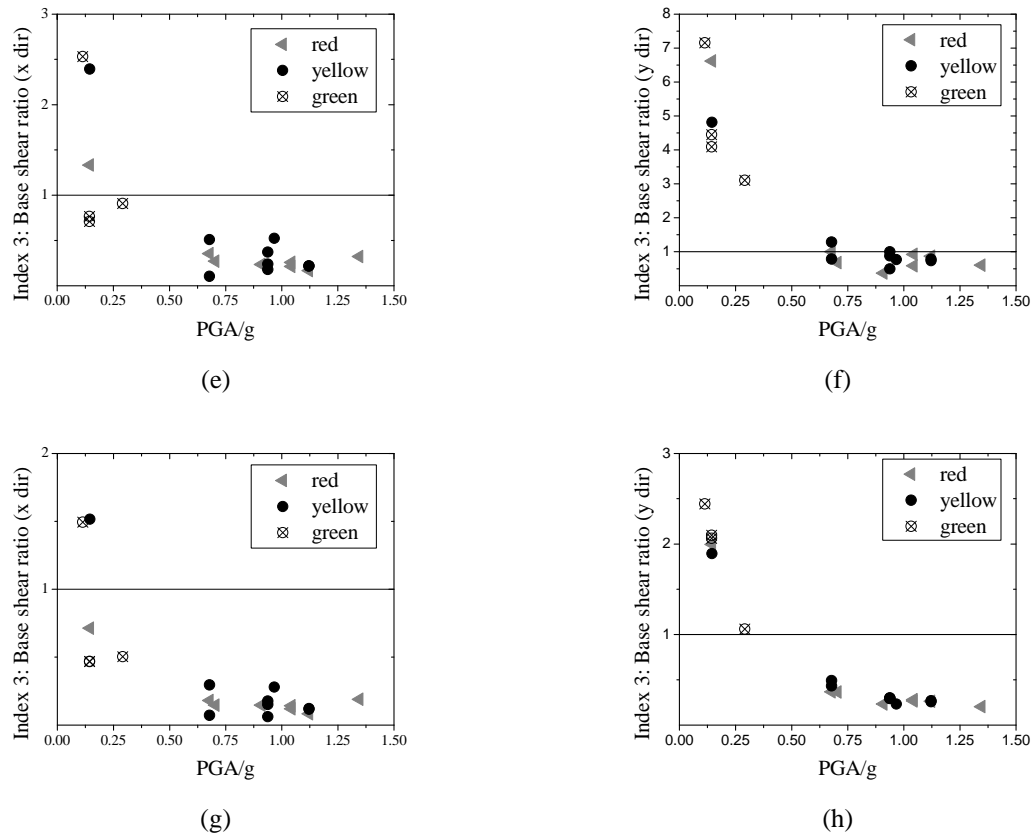
Figure 7 presents the scatter plots of each index and the recorded horizontal PGA of the 22 February 2011 event for clay brick churches, as well as the proposed thresholds from Figure 6. Direction X and Y correspond, respectively, to the transversal and longitudinal directions regarding the main nave. The threshold for the first index is excellent, with all the green tagged churches above or near the line and only one yellow and one red church incorrectly identified. The yellow tagged church had only minor cracking with the exception of a large shear crack on one longitudinal wall of the main nave. There were also unstable nonstructural elements inside that could collapse during a stronger aftershock, which led the structural inspector to classify the church as yellow. The red tagged church was also a particular case, as it had pinnacles overhanging from the transversal walls and therefore was unstable even for a low PGA. These elements were severely damaged or partially collapsed compromising the connection between the transversal and longitudinal walls. The thresholds for index 2 and 3 also have acceptable results. The X (or transverse) direction provides better results in all three indexes, and this is the critical direction. The indexes are consistent even if they are not directly correlated. Index 3 exhibits the worse performance if cohesion is taken into consideration, with better results obtained for a zero cohesion, see Figure 7 (e) (f) (g) (h).

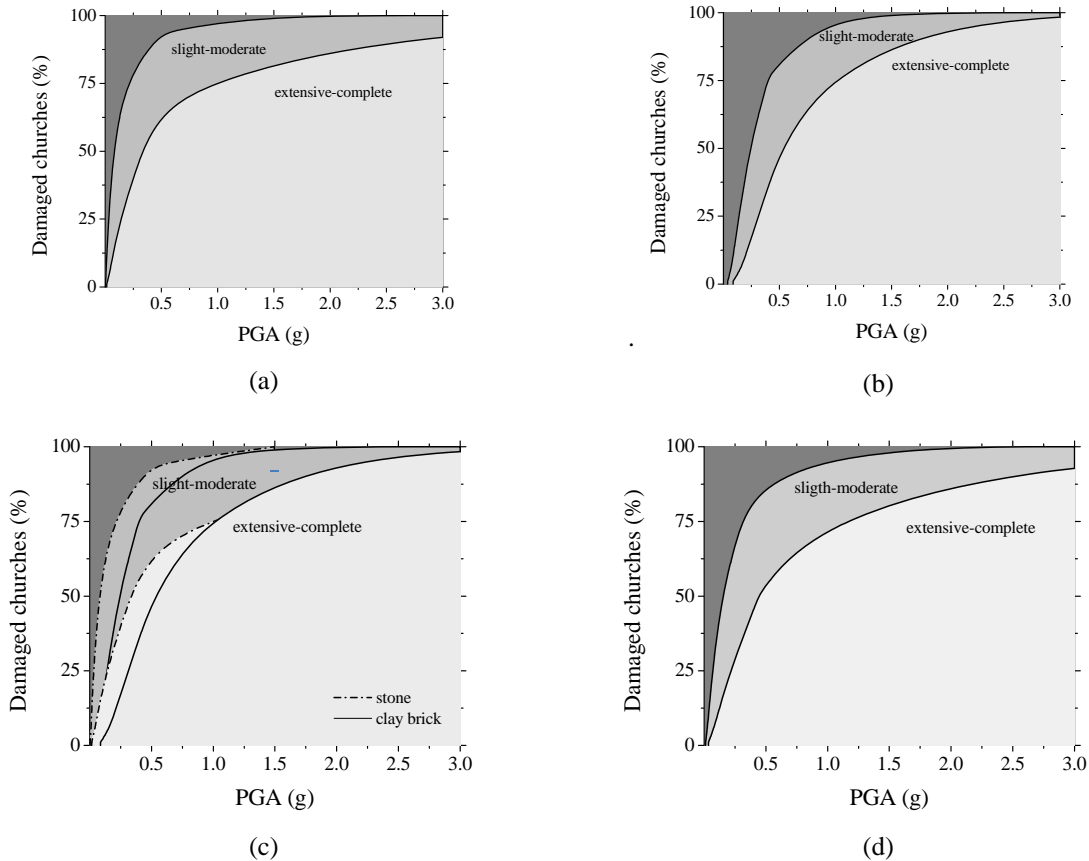
Figure 9. Fragility curves: (a) stone churches; (b) clay brick churches; (c) stone and brick; (d) all churches.

It is now assumed that the values of 5%, 50% and 95% quantiles are the lowest expected, the average, and the highest expected damage. For stone churches, it is expected that 50% receive a *yellow* tag for a PGA of 0.1g and a *red* tag for a PGA of 0.35g. For clay brick churches, it is expected that 50% receive a *yellow* tag for a PGA of 0.25g and a *red* tag for a PGA of 0.55g. For stone churches, it is expected that they all receive a *yellow* tag for a PGA of 0.65g and a *red* tag for a PGA of 3g. For clay brick churches, it is expected that they all receive a *yellow* tag for a PGA of 0.95g and a *red* tag for a PGA of 2.2g. Finally, for stone churches, it is expected that *yellow* tags appear for any seismic event and *red* tags appear for PGAs over 0.05g. For clay brick churches, it is expected that *yellow* tags appear for PGAs over 0.07g and *red* tags appear for PGAs over 0.15g.
