Damage Assessment of Unreinforced Stone Masonry Buildings After the 2010-2011 Canterbury Earthquakes

Ilaria Senaldi^a, Guido Magenes^b & Jason M. Ingham^c

DAMAGE ASSESSMENT OF UNREINFORCED STONE MASONRY BUILDINGS AFTER THE 2010- 2011 CANTERBURY EARTHQUAKES

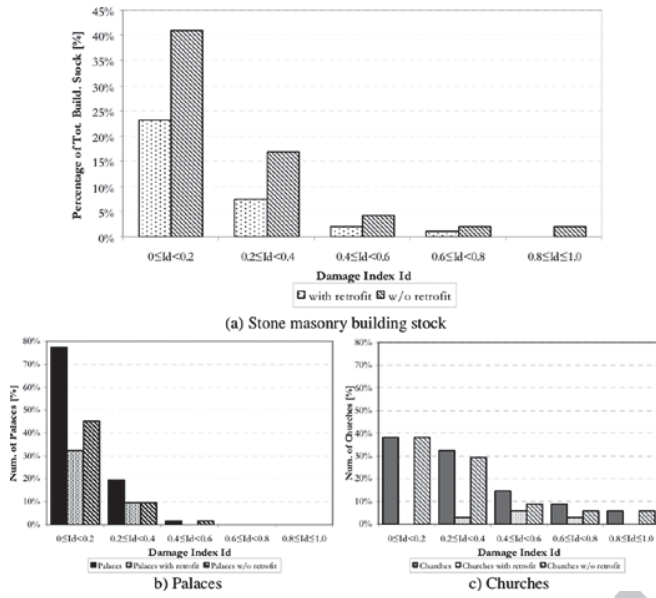
One of the objectives of the damage survey was to investigate the response of stone masonry buildings that had been seismically retrofitted or strengthened prior to the September 2010 earthquake (seismic improvements were identified in a total of 32 buildings, of which only four were churches). As previously illustrated, one of the most common factors that contributes to the vulnerability of unreinforced masonry structure is the lack of connection between walls and diaphragms. The Canterbury earthquakes have confirmed that properly designed securing systems at floor and roof level helped to reduce the likelihood of local failures due to out-of-plane collapse of walls and gables. As shown in Figure 19, buildings with applied seismic improvements have been subjected to a low level of damage, with approximately 23% of the total population having I_d values between 0 and 0.2, although three strengthened churches (i.e. Christchurch Anglican Cathedral, the Catholic Cathedral of the Blessed Sacrament and St. Luke's Church) were subjected to a moderate to high level of damage with corresponding damage indices from 0.44 up to 0.64.

Figure 19 Distribution of damage index Id, relatively to the effect of presence of strengthening interventions.

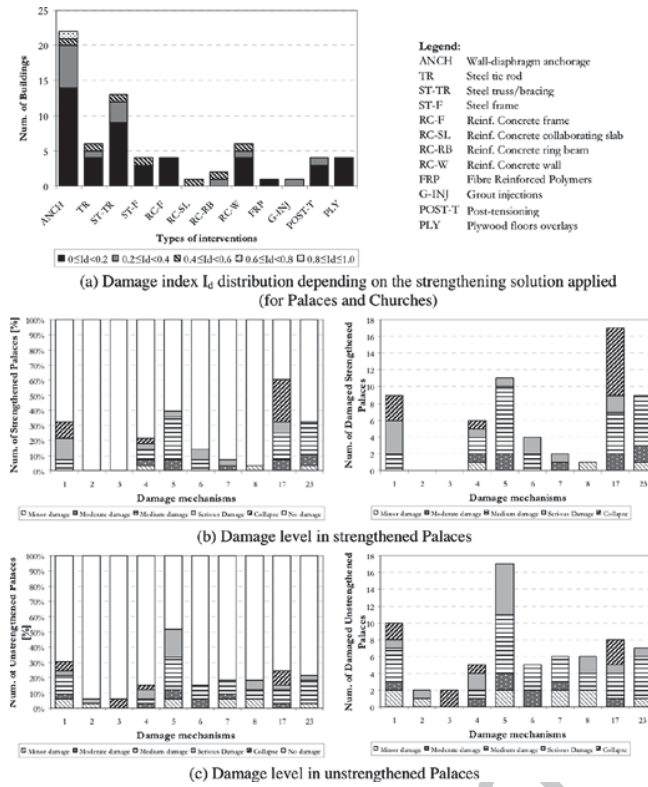
resistance of the original stone masonry structure, steel or concrete frames, additional shotcrete walls, post-tensioning or Fibre Reinforced Polymers were employed. Figure 20a shows the corresponding distribution of damage index values for each type of strengthening intervention. It is emphasised that in 13 cases only wall-to-diaphragm anchorages (sometimes connected to steel trusses or steel backing frames) were applied, while in the remaining 19 buildings more than one technique was applied to a single building, as is often the case in current practice.

In order to evaluate the actual effectiveness of the applied retrofit interventions, a comparison between the seismic performance of strengthened and unstrengthened buildings, in particular palaces, can be made. Figure 20b and Figure 20c represent the damage level reached in the mechanisms concerning the out-of-plane response of façades or of portions of walls (namely mechanisms from 1 to 4 and 17) and those describing the in-plane response of masonry structural elements (mechanisms from 5 to 8 and 23) for strengthened and unstrengthened palaces.

damage respectively because of flexural failure of spandrels or of shear cracks in piers in the perimeter façades (Figure 20b), a greater number of unstrengthened buildings (e.g. 65% more than the strengthened ones for mechanism 5) were damaged because of the activation of the same type of damage mechanism. The use of steel or reinforced concrete moment frames as a retrofit strategy proved to be efficient, as in the case of the former Lawrie and Wilson Auctioneers Building ($I_d=0.02$, Figure 22a) or in the former Malthouse building ($I_d=0.08$, Figure 22b). Considering the former Chemistry Department that is now part of the Christchurch Arts Centre complex, the insertion of vertical post-tensioned tendons in collaboration with buttresses and of horizontal tie rods in collaboration with floors improved the global response of the structure (Figure 22c). Nonetheless, the building was damaged because of the partial collapse of the tower that was not retrofitted.

Figure 20 Impact of strengthening interventions on damage index and damage level in selected mechanisms.
