DAMAGE TO CONCRETE STRUCTURES FROM THE 2010 DARFIELD (CANTERBURY, NZ) EARTHQUAKE

Jason Ingham^{*}, Liam Wotherspoon^{**}, Lucas Hogan^{***} and Bilel Ragueed^{***}

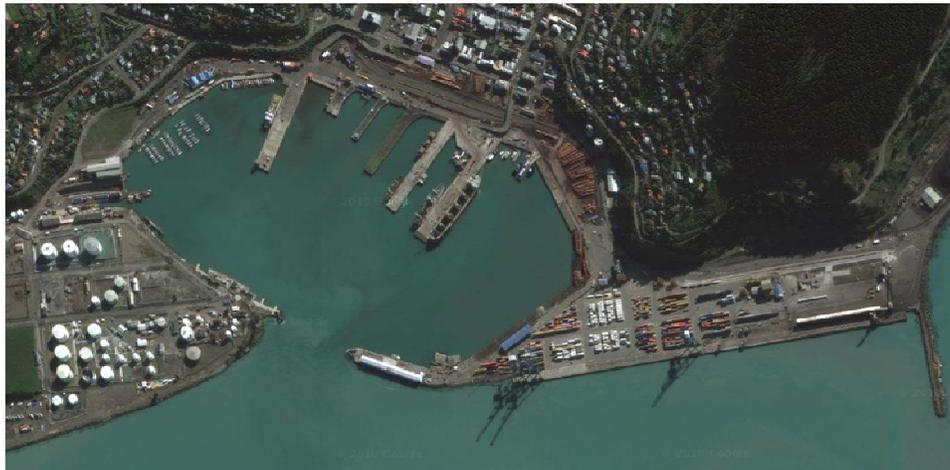
Figure 21. Layout Plan of LPC

The overall port structure sufficiently resisted the forces induced by the earthquake, resulting in no structural collapses. However, ground deformations induced by the earthquake did cause serviceability damage, which is consistent with what has been observed in similar sized earthquakes in other countries (Mahoney, Francis and Kennard, 2008). The primary lateral resistance mechanism is a series of tie backs running underneath the large yard behind the wharfs and anchored in large concrete 'dead men' installed adjacent to the cliff face, which prevented the wharfs from completely detaching into the sea. However, the reclaimed land underneath the yard displaced towards the sea, which caused cracking in the concrete pavement as evident in Figure 22.
