Implications of the 2010 Darfield (Christchurch, NZ) earthquake for Australia – are we ready?

Mike Griffith¹, Jason Ingham², Lisa Moon³

ABSTRACT

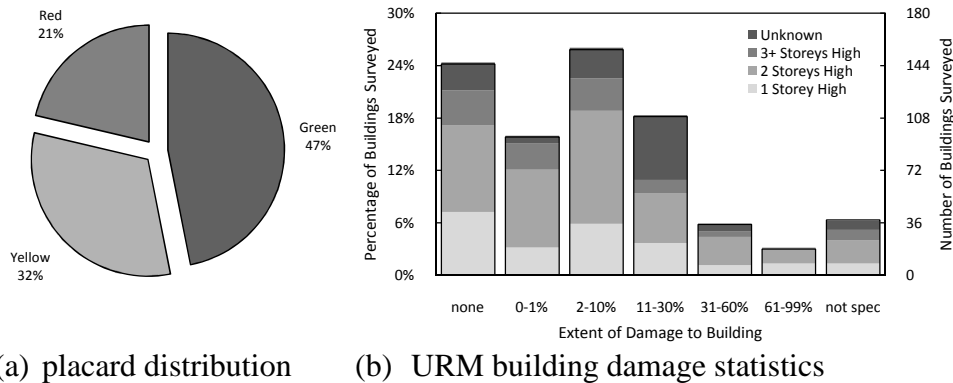
The results from the interrogation of damage assessment information are reported in Figure 3. Figure 3a reports the ‘useability’ assignment of the 595 URM buildings assessed. Figure 3b reports the level of damage for the same URM buildings. Despite the known vulnerability of URM buildings to earthquake loading, only 34% of the 595 assessed URM buildings were judged to have more than 10% damage.

Figure 3. Damage statistics.

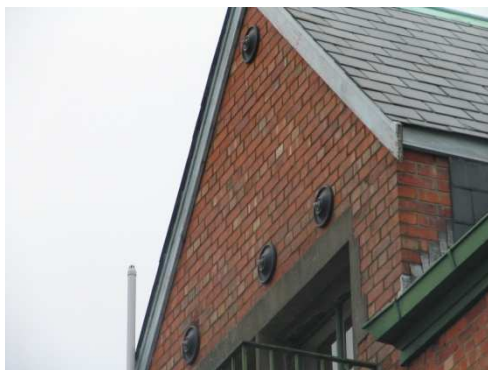
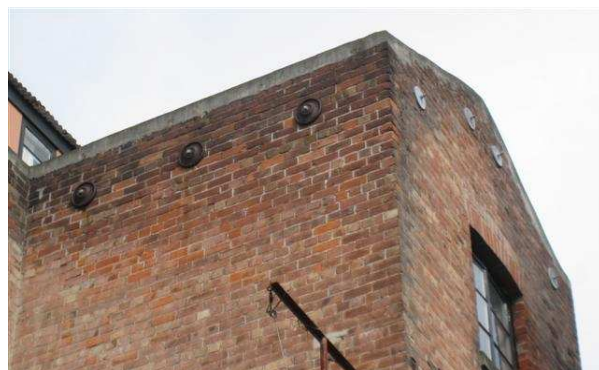
A significant feature of the earthquake was the number of occasions where wall-to-diaphragm (floor or roof) anchors performed well. Photographs showing this are presented in Figures 15-16. A typical wall-to-diaphragm anchor typically consists of a long 20 mm bolt with a large circular disk of about 150-200 mm diameter between the wall exterior and nut that clamped the disk to the wall.

Figure 15. Successful gable end wall and side wall anchorages.

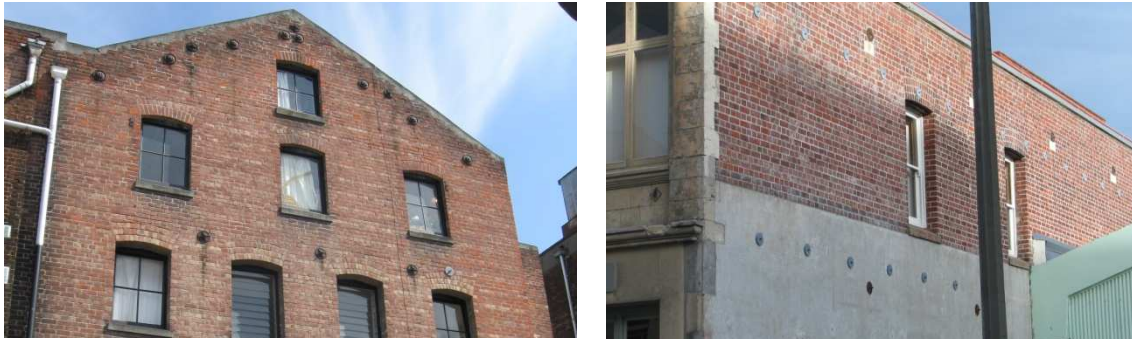
Figure 16. Successful wall-floor and wall-roof diaphragm anchorages.

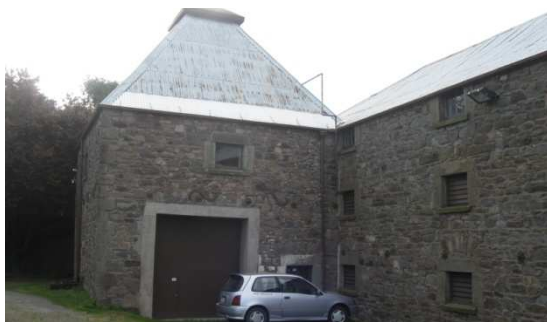
Diaphragm stiffness has a significant effect on the behaviour of a building during earthquakes, as observed at the Malthouse Theatre (Figure 18). Prior to the earthquake, the stone masonry building from 1867 underwent an extensive seismic retrofit involving stiffening of floor and roof diaphragms and connecting it to the external walls.

Figure 18 – Malthouse Theatre

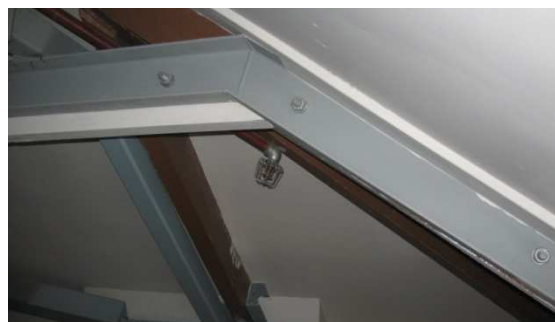
Figure 19 – Steel frame in roof

The roof diaphragm was stiffened through the addition of an internal steel frame (Figure 19). The frame was attached to the original timber roof trusses, and connected to the external walls. The floors were stiffened through the addition of blocking between joists (Figure 20a), and steel plates were added to connect some of the joists to the masonry walls (Figure 20b). Externally, diaphragm ties were visible on all sides at floor levels indicating that the floors had been anchored to the walls (Figure 20c).

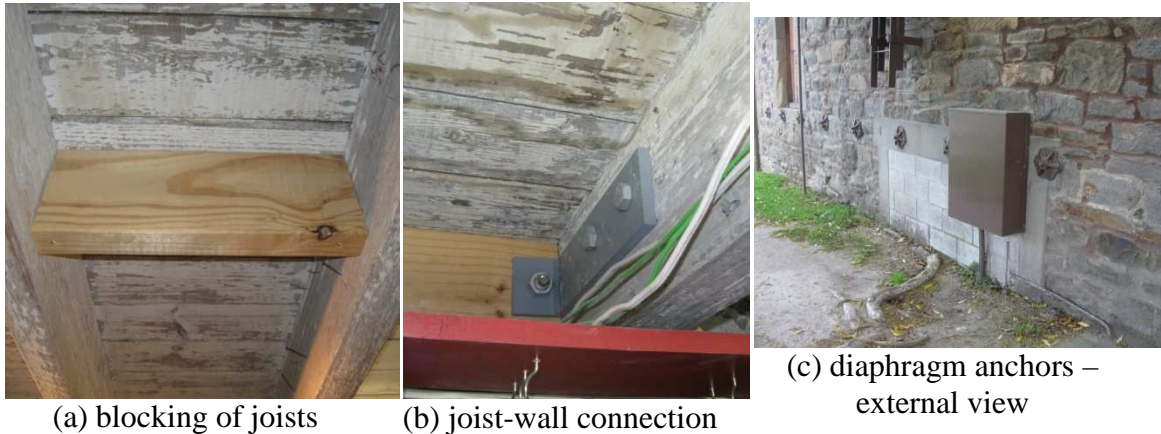
Figure 20 – strengthening of floor diaphragm and wall anchors

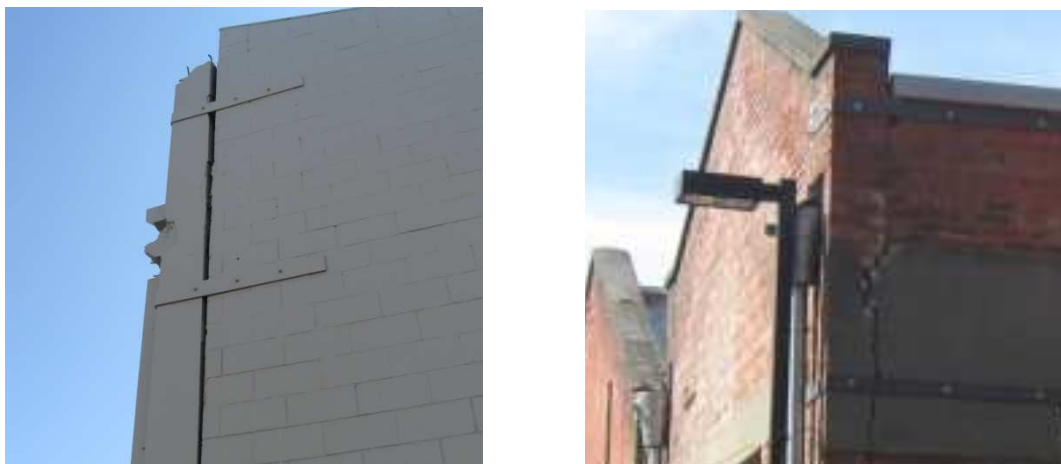
In some buildings steel plates were observed connecting the front and side walls. Such ties prevent building facades collapsing as well as increasing the in plane and out of plane capacity of both walls. While it is not clear whether the two examples shown in Figure 21 were installed before or after the recent earthquake, the technique has the potential to improve the seismic performance of the buildings by ensuring greater interaction between return walls.

Figure 21 – Examples of corner ties
