Interferometric Synthetic Aperture Radar (InSAR) and field-based observations of rainfall-triggered landslides from the November 2021 storm, Gisborne/Tairāwhiti, New Zealand

Matt Cook¹ | Martin Brook¹ | Murry Cave²

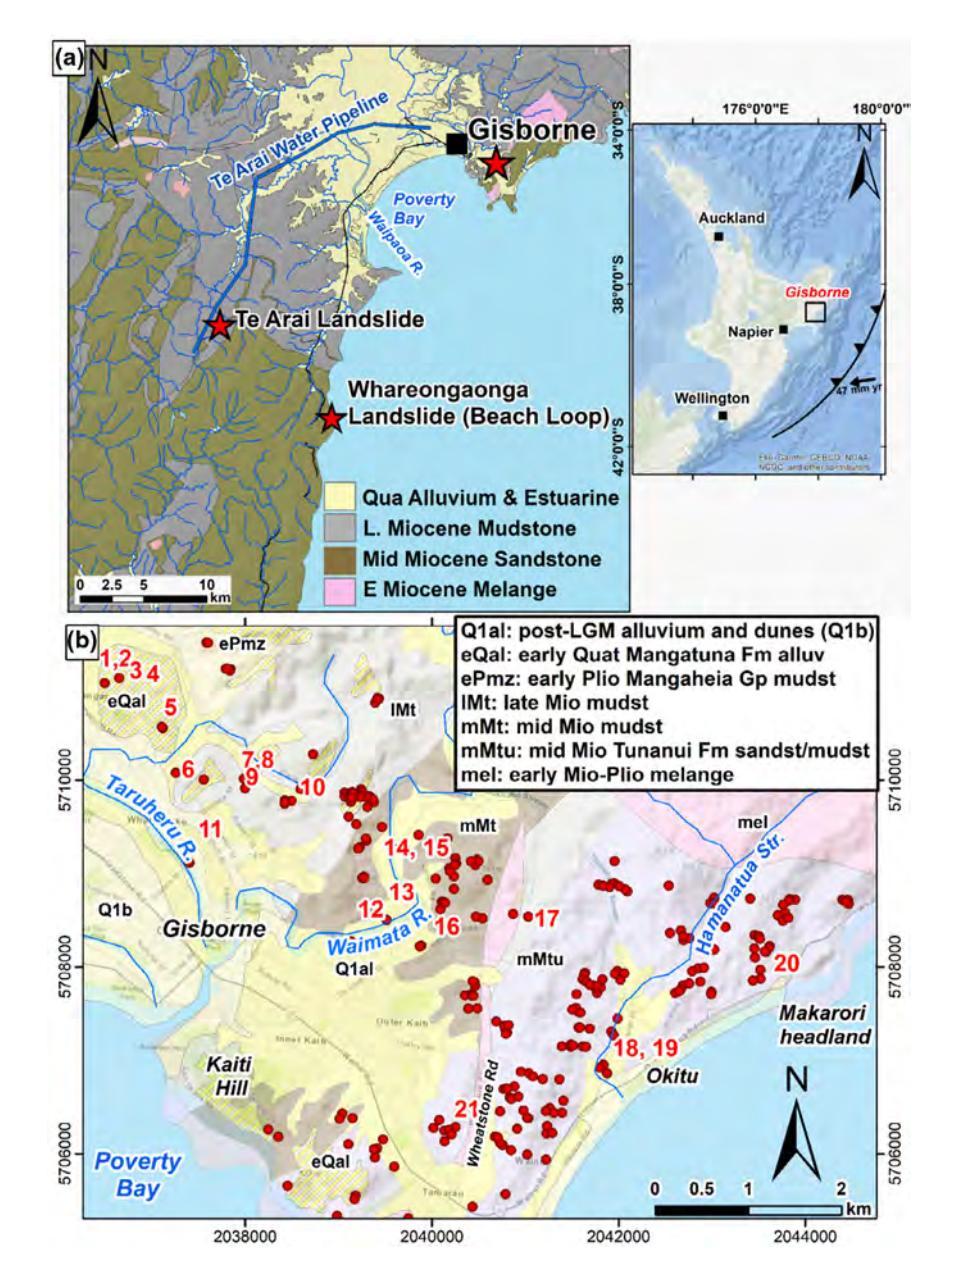
FIGURE 1 (a) Simplified geology of the Gisborne region with Te Arai and Whareongonga landslides also shown; (b) landslides (red circles) following the November 2021 storm in and around Gisborne city and suburbs (numbers are landslides visited and reported in Table 1), and geological abbreviations are from Mazengarb and Speden (2000).

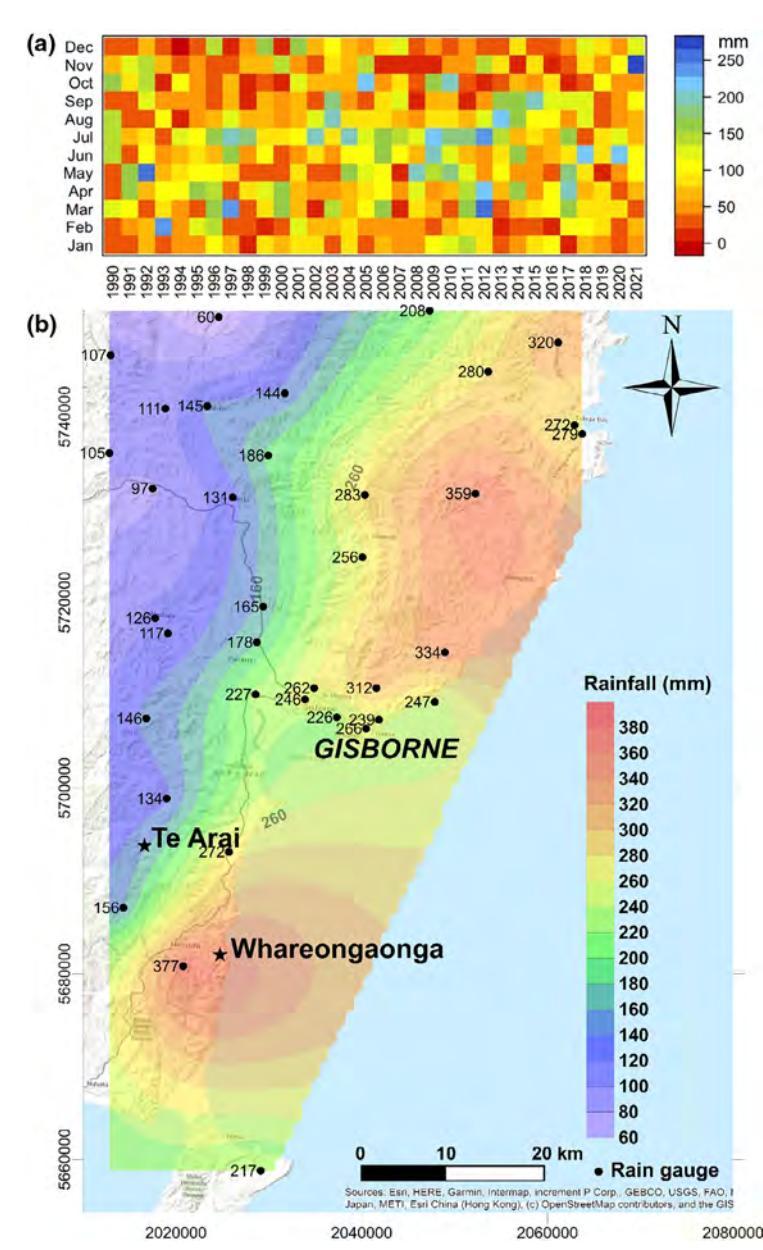
FIGURE 2 (a) Monthly rainfall totals for Gisborne airport automatic weather station 1990–2021, illustrating the magnitude of the 3–7 November 2021 event. Gisborne's 1990–2020 mean annual rainfall is 995 mm; 250.7 mm fell 3–7 November 2021; (b) Rainfall distribution for the November 3–7 2021 storm. Rainfall data provided by Gisborne District Council.

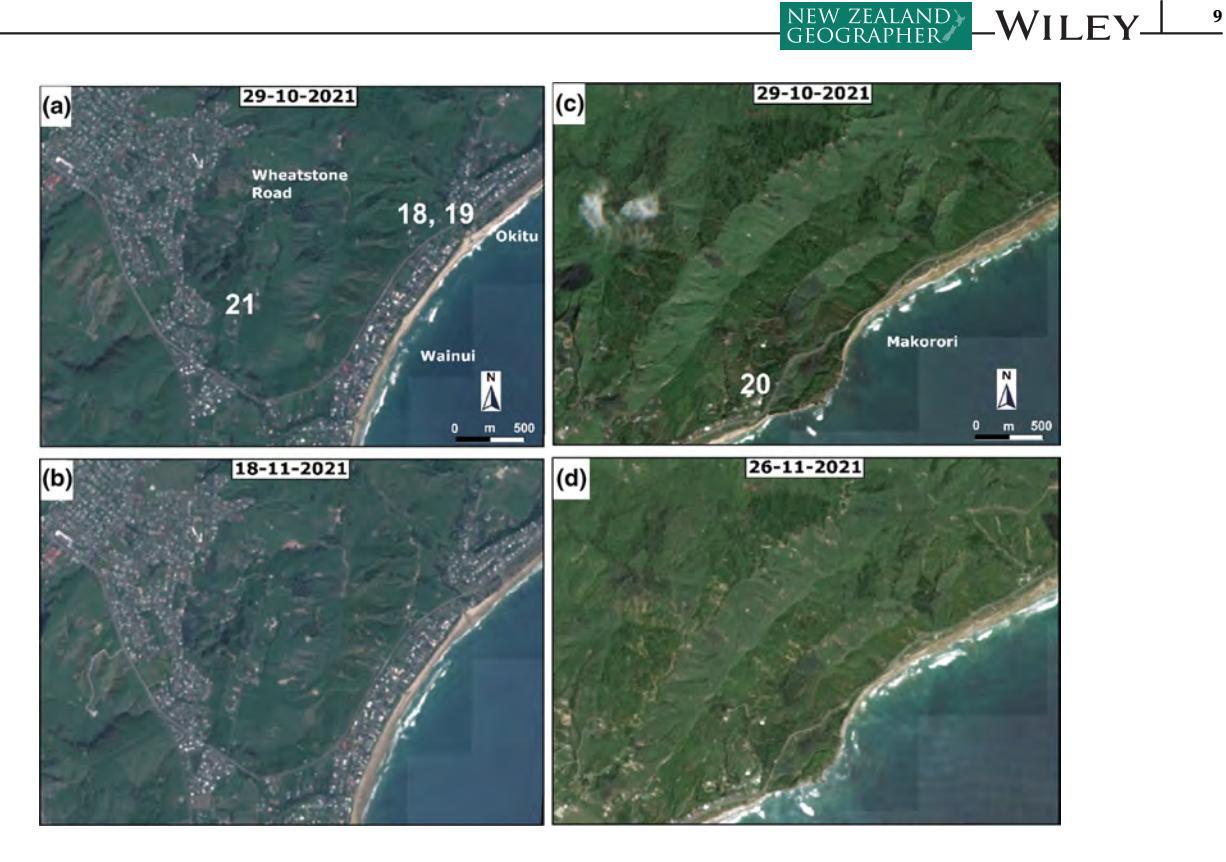
In addition to the information gleaned from the field reconnaissance, Sentinel-2 optical satellite imagery was useful for regional-scale overviews of landsliding in the Wheatstone Road area east of Gisborne (Figure 5a,b), and around the coastal township of Makarori (Figure 5c,d). Indeed, comparing the pre-storm (October 2021) and poststorm Sentinel-2 imagery, linear pale hues are visible on the hill pasture perpendicular to the axes of ridgelines in the post-storm imagery, representing shallow earthflows. Sentinel-1 InSAR results showing annual average slope velocity (2016–2021) is also shown in Figure 6. As can be seen from the Figure 6 plots, most of the points analysed indicate that slopes are deforming at \sim 15–30 mm/year. A more detailed example of InSAR velocity of slopes around Wheatstone Road (landslide #21) is shown in Figure 7. This landslide is a shallow rotational slump, which transitions downslope into an earthflow (Figure 7a), but is also extending upslope by headscarp retrogression, towards a house. Parts of this landslide exhibit velocities of \sim 30 mm/year. Figure 7b shows the timeseries of slope velocity of landslide #21 from 2016 to 2021, with the groundwater fluctuations from a piezometer at Cameron Road also shown on the plot (blue line), together with monthly rainfall (blue bars). The velocity pattern (black line) shows that the slope is following a generally consistent annual pattern of movement, with large inflections in the trend due to major rainstorms, causing a pulse of rotational slumping to occur.

FIGURE 5 Sentinel-2 optical satellite imagery before and after the November 2021 storm event for the Wheatstone Road area (a and b) and Makorori (c and d).

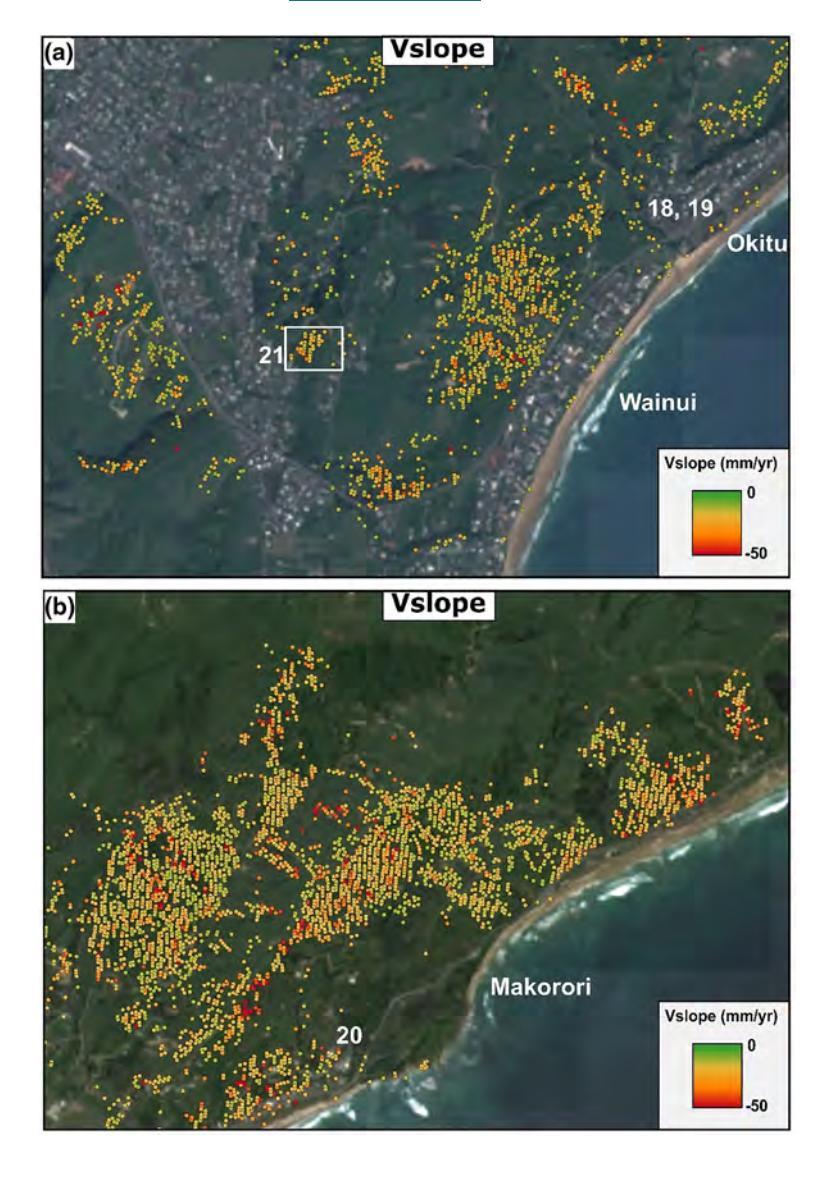
FIGURE 6 Sentinel-1 InSAR slope velocity (Vslope) data for January 2016 to December 2021 for the

data for January 2016 to December 2021 for the Wheatstone Road area (a) and Makorori (b). White box in (a) is the extent of the aerial image in Figure 7, including Landslide #21.
