PERFORMANCE OF MASONRY BUILDINGS DURING THE 2010 DARFIELD (NEW ZEALAND) EARTHQUAKE

Abstract

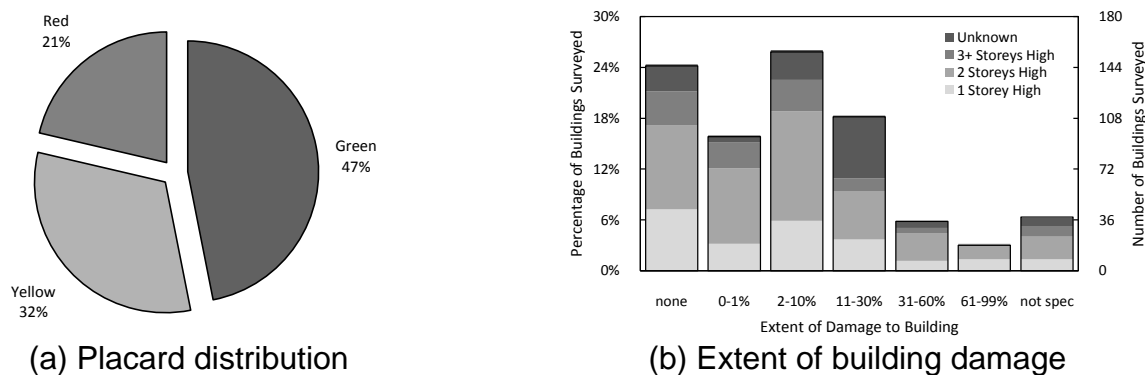
Figure 4: Building damage statistics derived from interrogation of the inspection database

In general, the observed damage to URM buildings in the 2010 Darfield earthquake was consistent with the expected seismic performance of this building form, and consistent with observed damage to URM buildings in past. Despite the known vulnerability of URM buildings to earthquake loading, 395 of the 595 buildings (66%) were rated as having 10% damage or less, with only 162 (34%) of the buildings assessed as having more than 10% damage (refer Figure 4). It was also possible to study the distribution of damage dependent on storey height, with the data indicating no definitive trend and a comparatively uniform level of damage assigned to buildings in each height category. The general observation from the debris of collapsed URM walls was that the kiln fired clay bricks were generally of sound condition, but that the mortar was in poor condition. In most cases the fallen debris had collapsed into individual bricks, rather than as larger chunks of masonry debris. However, it appears that superior mortar was often used in the ornate parapet above the centre of the wall facing the street, as this segment of the collapsed parapet often remained intact as it collapsed.

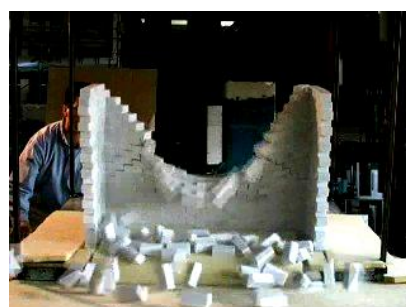
(f) Dry-stacked masonry test

Several examples of face load wall failure (see Figure 8(e)) closely resembled observed damage (see Figure 8(f)) in dry stack masonry experiments [Restrepo-Velez and Magenes 2009], providing further support to the supposition that many of the wall failures were partly attributable to poor mortar strength. Cavity wall construction is generally believed to be much less common in New Zealand than is solid multi-leaf (or multi-wythe) construction. However, cavity wall construction can be extremely vulnerable to out-of-plane failure in earthquakes, particularly in situations where the cavity ties were poorly installed, or more commonly have corroded over time, as the wall is then comparatively slender and less stable than for solid construction. Figures 9(a) and (b) show examples of cavity wall buildings that suffered out-of-plane wall failures. Figure 9(c) shows that cavity ties were present but were insufficient to prevent the outer leaf from failing.
