Rehabilitation of earthquake damaged external RC beam-column joints

J. Shafaei, A. Hosseini & M. S. Marefat

2014 NZSEE
Conference

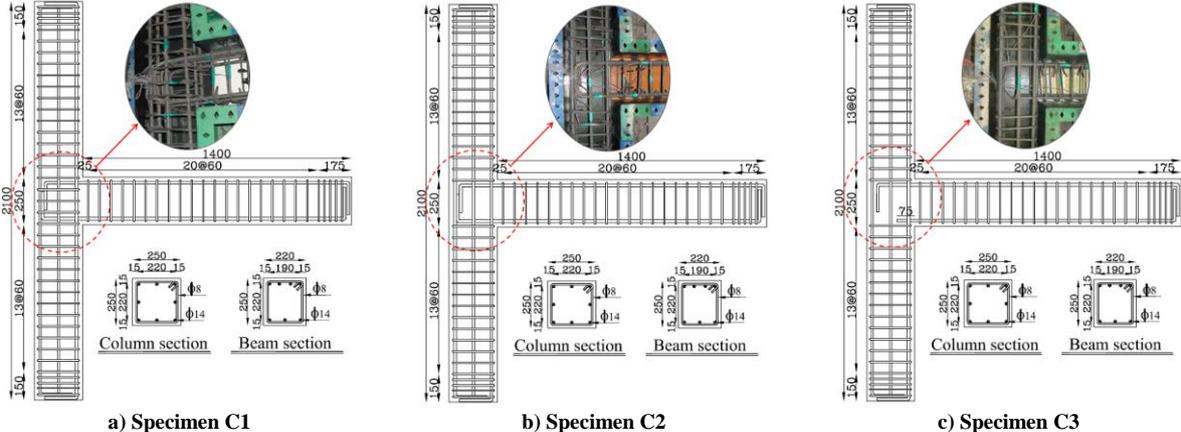
Figure 1. Dimensions and reinforcement details of control specimens (dimensions in millimetres).

The experimental program consisted of three half scale external RC beam-column joints with seismic and non-seismic reinforcement details and identical dimensions, which were tested before and after rehabilitation by applying lateral cyclic loading of increasing amplitudes. Tested specimens were comprised of one unit having seismic reinforcement detailing and two units having non-seismic reinforcement detailing. Two defects were considered for the non-seismic units, being the absence of transverse steel hoops and insufficient bond capacity of beam bottom steel reinforcing bars in the joint region. The damaged specimens were rehabilitated by injecting epoxy grout into existing cracks and installing stiffened steel angles at the re-entrant corners of the beam-column joint, both above and below the beam, which were mounted and held in place using prestressed high tensile strength bars. Specimen C1 represented a seismic beam-column joint designed to satisfy ACI Committee 318M-11 (2011) requirements as a benchmark specimen, whereas specimens C2 and C3 had inadequate reinforcement detailing in the joint region and represented RC structural sub-assemblies having deficient detailing. Specimens RC1, RC2 and RC3 represented rehabilitated external beam-column joint specimens. The dimensions and reinforcement details of the control specimens are shown in **Figure 1**.

Dimensions and reinforcement details of all control specimens were identical except for the reinforcement details in the joint region as shown in **Figure 1**. The column height and beam length represented the distance to the points of contraflexure for seismic bending moments. The column height was 2100 mm with cross section dimensions of 250×250 mm and the beam length was 1400 mm from the face of the column to its free end, with a cross section of 220×250 mm. The longitudinal reinforcement used in the column was 8φ14 deformed bars, corresponding to a 2% reinforcement ratio and the transverse reinforcement in the column was φ8 deformed bars with 135° end hooks that were spaced at 60 mm inside and outside the joint panel zone. The top and bottom longitudinal reinforcement of the beam were 4φ14 and 3φ14 deformed bars, corresponding to a 1.22%

and 0.91% reinforcement ratio respectively, and the transverse reinforcement of the beam was $\phi 8$ rectangular ties starting at 25 mm from the face of the column that were spaced at 60 mm for the beam length. The longitudinal and transverse reinforcement of all control specimens for the beam and column satisfied ACI 318M-11 seismic requirements (see **Figure 1**). Specimen C1 had sufficient shear reinforcement in the joint, while specimen C2 was designed as a shear-deficient specimen provided with no transverse shear reinforcement in the joint region and specimen C3 was designed as a shear-deficient and anchorage critical specimen with the bottom longitudinal reinforcement in the beam anchored 75 mm from the column face and with no transverse reinforcement installed in the joint region. The dimensions and joint reinforcement details of the control specimens C1, C2 and C3 are shown in **Figure 1**.

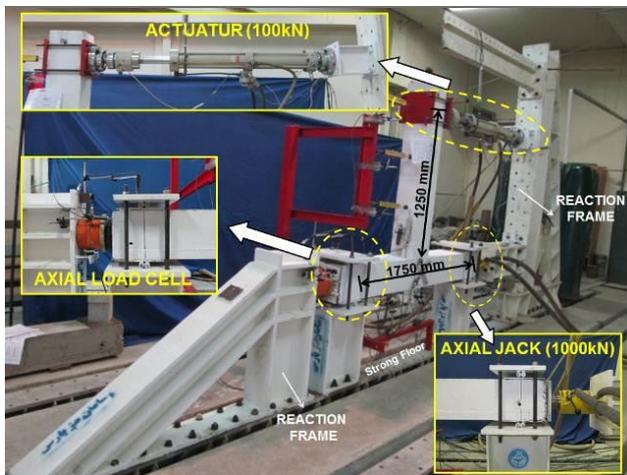
Figure 2. View of test setup.

The test setup with the specimen supports and other key components is illustrated in **Figure 2**. All specimens were tested with the column positioned horizontally and the beam standing vertically, thereby being rotated 90-degree from the true orientation. Roller supports were constructed and the top of the beam was linked to an actuator with a swivel connector to simulate the support condition at the top of the beam and both ends of the column. Thus the top of the beam and the left and right of the column were all pin-connected in the loading plane, to simulate the inflection points of a moment frame subjected to lateral earthquake loading.

Lateral cyclic loading with increasing amplitudes was statically applied to the top of the beam in two opposite directions, parallel to the longitudinal direction of the column, by a hydraulic actuator with a ± 100 kN loading capacity and a ± 200 mm displacement range, and a horizontal 1000 kN capacity hydraulic jack was used to apply constant axial load to the column to simulate gravity actions. The position of the hydraulic jack, axial jack and load cell are indicated in **Figure 2**. The two ends of the column were restrained against both vertical and horizontal deformations, whereas their rotations were allowed due to the hinged boundary conditions.

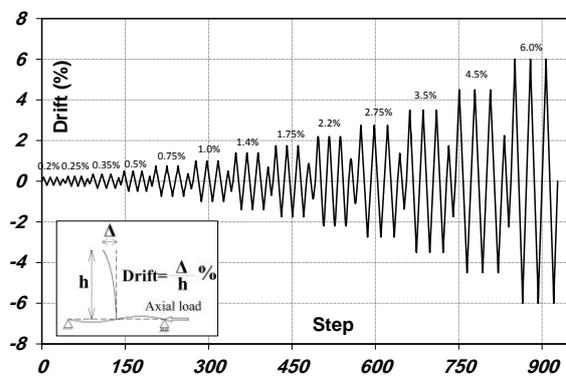
Figure 3. Lateral cyclic loading protocol.

throughout each test. After application of the 220 kN axial load to the end of the column, low rate lateral cyclic loading of increasing amplitudes was applied at the top of the beam in a displacement controlled mode to identify the cyclic behaviour of the beam-column joint. The loading procedure for all specimens was based on acceptance criteria specified in ACI Committee 374.1-05 (2005) utilizing displacement (drift) control to preliminary target drifts. **Figure 3** shows the lateral cyclic loading protocol according to ACI 374.1-05.

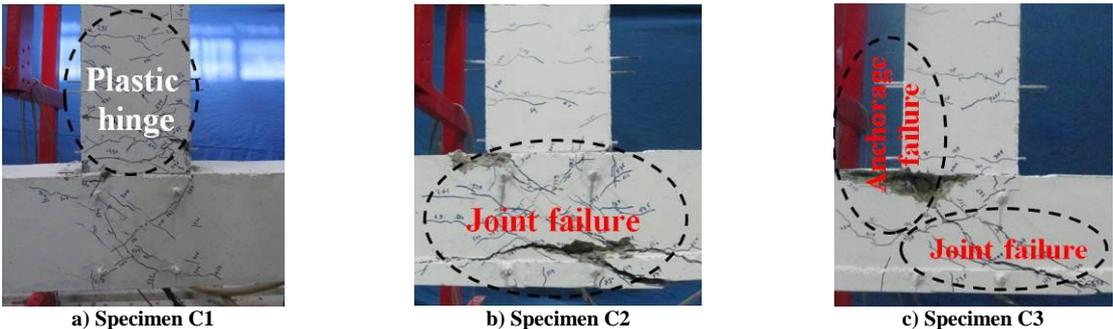
Figure 4. Damage pattern of control specimens C1, C2 and C3 at the end of testing.

The damage pattern of control specimens at the end of testing are shown in Figure 4, illustrating that specimen C1 was controlled by the flexural mechanism of the beam at the beam-column interface, whereas specimens C2 and C3 failed by concrete crushing in the joint region. The first flexural cracks of all control specimens appeared at the bottom of the beam at 0.25% drift, and for specimens C1 and C2 these cracks gradually propagated to a height of 750 mm whereas for specimen C3 these cracks propagated to a height of 300 mm for the pull direction, and to 650 mm for the push direction. Yield of longitudinal and transverse reinforcement was measured by strain gauges, with first yield of the beam longitudinal reinforcement occurring at a drift ratio of 1.1% for specimen C1, while yield of the beam longitudinal reinforcement was not recorded for specimens C2 and C3.

For specimen C1, spalling of concrete cover at the column surface commenced at a drift ratio of between 1.75 to 2.2%, and diagonal cracking in the joint zone began at a drift of 1.75% for the push direction. Additional cracking in the joint panel zone appeared thereafter as loading progressed, but crack widths remained fine throughout the test. At a drift ratio of 3.5% the beam became extensively cracked along a distance equal to its depth from the column face, and at a drift ratio of 4.5% wide cracks developed in the beam potential plastic hinge zone and spalling commenced, as shown in Figure 4a.

For Specimen C2, X-shape cracks in the joint panel zone commenced at a drift ratio of 0.75%, indicating imminent joint failure. The flexural and diagonal cracks grew in size and number as the drift ratio increased. Spalling of concrete cover appeared in the joint region at a drift ratio of between 1.4 to 2.0%, and from a drift of 2.0% the cracking was mainly concentrated in the joint region and formed a typical X-shaped pattern, as shown in Figure 4b. At a drift ratio of 3.5% the concrete in the joint panel zone spalled and crushed, exposing the column longitudinal reinforcement. Lateral cyclic loading was continued with substantial damage in the joint panel zone until 4.5% drift, as shown in Figure 4b.

For specimen C3 the vertical cracks in the joint panel formed at a drift ratio of 0.5%, due to bond-slip of the beam bottom reinforcement for the pull direction, and diagonal shear cracks in the joint zone developed at a drift ratio of 0.75% for the push direction. When the specimen was next loaded in the opposite direction the bond-slip cracks opened and the lateral load-carrying capacity deteriorated significantly, and then when reversed back the diagonal shear cracks in the joint panel zone opened, causing crushing of the concrete, deterioration of the bond condition of the beam bottom reinforcement, and degradation of the lateral load-carrying capacity. Specimen C3 reached a maximum load of 20.0 kN for the pull direction, and a maximum load of 35.0 kN for the push

direction, which was much less than the strength calculated for yielding of the beam longitudinal reinforcement of 32.0 kN and 41.5 kN for the pull and push direction respectively (see Figure 4c). The test was stopped at a displacement of 54 mm, corresponding to a drift of 4.5%, as the load-carrying capacity was greatly reduced.

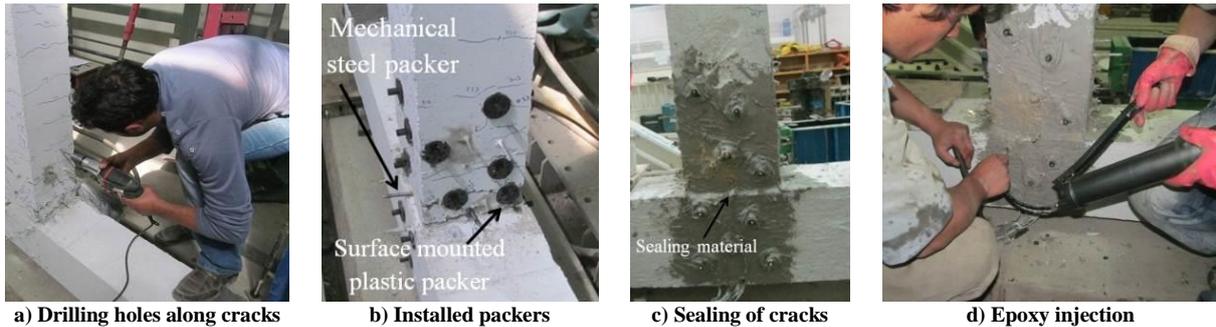
Figure 5. Step by step repair procedure#1 for specimen C1.

The control specimens damaged due to applying lateral cyclic loading were cleaned and made ready for the repair procedure. First, loose and damaged concrete pieces were removed from all parts of the damaged specimens using a hammer and chisel and concrete surfaces were cleaned using a blower to eliminate surface dust. According to FEMA 308 recommendation, in the current study two repair procedures were employed depending on the different levels of damage. The first procedure was referred to as repair procedure#1 and as shown in **Figure 5** entailed partial replacement of loose concrete on the damaged area by special mortar, followed by epoxy injection into the cracked zone. The second procedure was referred to as repair procedure#2 and as shown in **Figure 6** entailed complete replacement of crushed concrete in the damaged area by application of special mortar, followed by epoxy injection into the cracked zone. Repair procedure#1 was applied on specimen C1

where damage was typically confined to the cover concrete of the joint region as the core concrete was confined by adequate reinforcement inside the joint and was mostly intact, whereas repair procedure#2 was applied on specimens C2 and C3 where the concrete cover and core of the joint region were seriously fragmented and complete removal of concrete from the effected zone was necessary. **Figure 5** and **Figure 6** illustrate various steps of the repair operations for damaged control specimens for the repair procedure#1 and repair procedure#2 respectively.

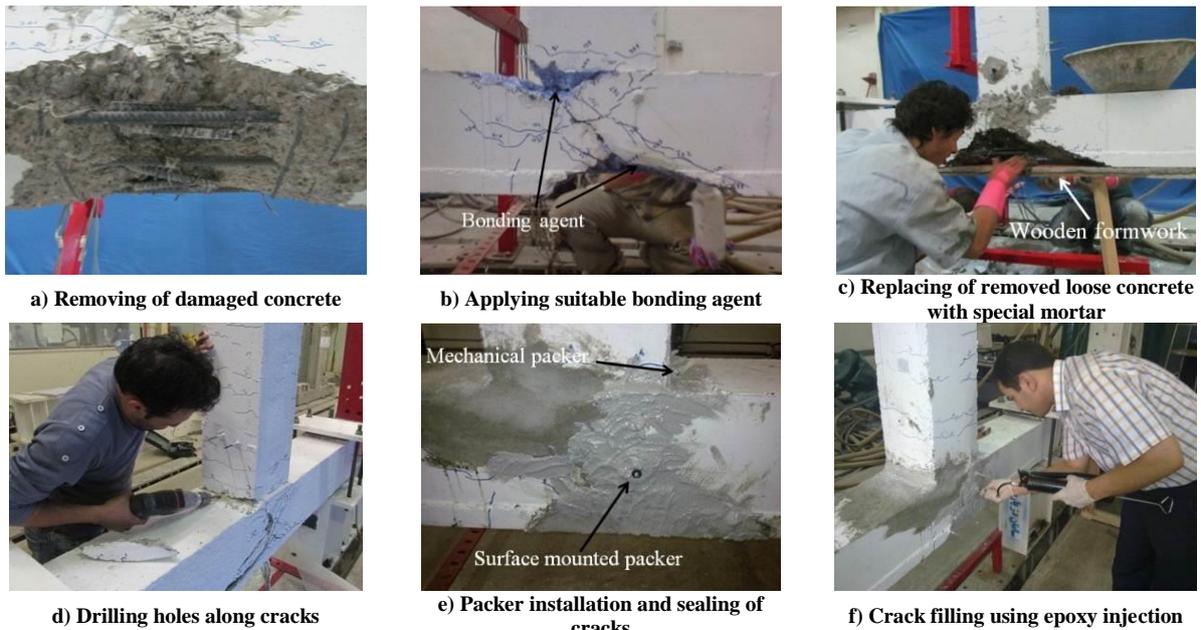
Figure 6. Step by step repair procedure#2 for specimens C2 and C3.

After the removal of loose material a bonding agent (SikaCem Concentrate) was applied on the cleaned surfaces to improve the bond between the fresh mortar and existing concrete and to increase surface hardness and significantly reduce the problem of surface dusting (see Figure 6b). A premixed, non-shrink, and self-compacting high strength mortar (Sika MonoTop-438 R) with 2.0 mm maximum aggregate size was used to replace the removed concrete and for the filling of cavities. Wooden formwork was placed on the bottom of specimens C2 and C3 where extensive repair and complete replacement of crushed concrete in the joint region was needed (see Figure 6c). Mortar was placed by hand and the surfaces of the repaired areas were made smooth by hand using a rubbing stone. The repaired areas were covered by plastic and cured for 3 days to maintain non-shrink characteristics of the new mortar. The formwork was removed after 1 week of curing.

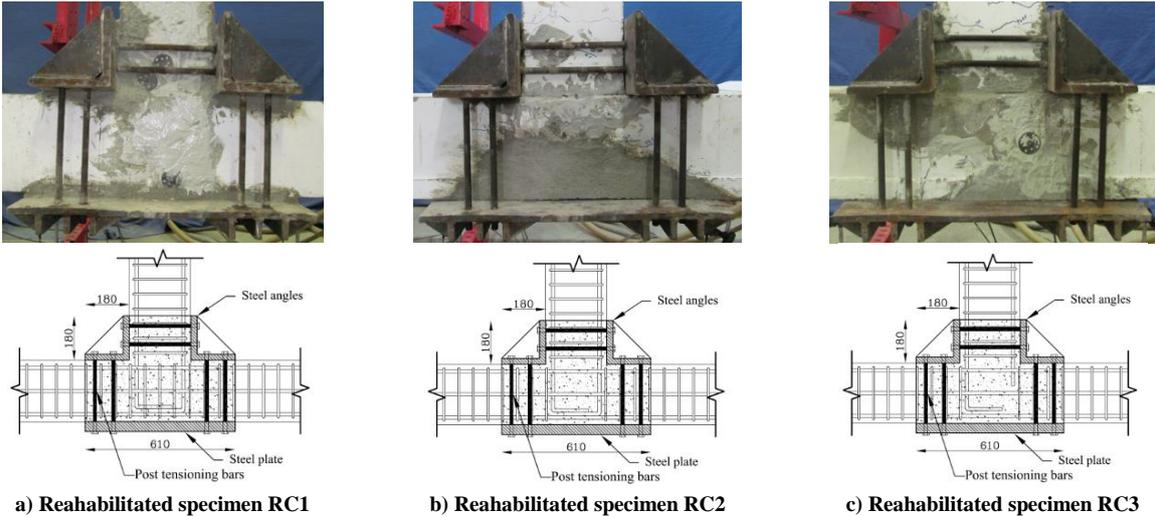
Figure 7. Details and view of specimens after improvement (dimensions in millimetres).

Details of the improvement procedure were the same for all repaired specimens, as shown in **Figure 7**. For all rehabilitated specimens, the total joint width including the steel angles and plates was 350 mm, which was greater than the width of the beam and column and allowed the prestressed bars to pass outside the beam and column without requiring holes to be drilled through the beam-column joint. The three steel elements that comprised the improvement intervention were held and fixed in place using high tensile strength M16 bars, washers and nuts and were prestressed until a tension force approximately equal to 70 percent of the minimum tensile strength ($0.7f_{pu}$) was produced in the bars. The length and specified ultimate tensile strength of the prestressed bars were 400 mm and 1000 MPa respectively. Tightening was achieved using a calibrated wrench and the tension in all bolts was checked by a repeat pass to ensure that all bolts were prestressed to the prescribed value. The improvement procedure adopted for repaired beam-column joints involving a steel angle size of 180 mm×180 mm×18 mm and a plate length of 610 mm. Views of the repaired control specimens RC1, RC2 and RC3 after the improvement procedure are shown in **Figure 7**.

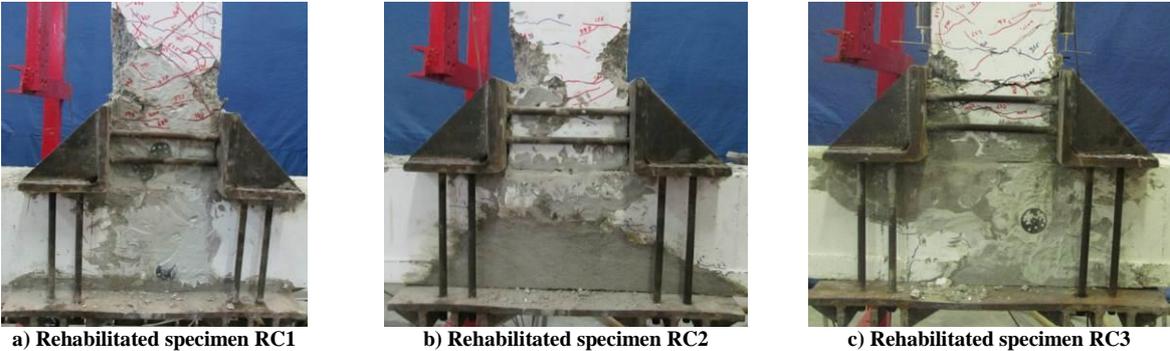
Figure 8. Damage pattern of rehabilitated specimens at the end of testing.

The damage pattern of rehabilitated specimens at the end of testing are shown in **Figure 8**, illustrating that an almost regular and consistent pattern of cracks was observed in all rehabilitated specimens, and that the flexural mechanism in the beam at the edge of the steel angles was the failure mode for all rehabilitated beam-column joints. In **Figure 8** the blue lines show cracking patterns of control specimens before rehabilitation and red lines show cracking patterns of rehabilitated specimens after the rehabilitation procedures. The first flexural cracks for all rehabilitated specimens were observed at the edge of the joint enlargement in the beam at a drift ratio of approximately 0.2% and gradually

extended to the whole length of the beam. From cyclic testing of the control specimens it was observed that all of the strain gauges on the stirrups and longitudinal bars in the column and beam had failed. Thus, first yield of the beam longitudinal reinforcement was not able to be recorded during cyclic testing of the rehabilitated specimens. As the applied drift increased, spalling of concrete cover at the corners of the beam section and at the edge of the steel angles commenced at a drift ratio of between 1.75% to 2.20% for all rehabilitated specimens. As testing continued, damage extended towards the middle of the beam section and penetrated into the concrete core. In specimen RC1, RC2 and RC3, despite the corresponding performance of the control specimens (C1, C2 and C3), no diagonal cracks formed in the joint panel zone up to the end of testing. The behaviour of all rehabilitated specimens was generally close to each other in terms of cracking development and failure mode.

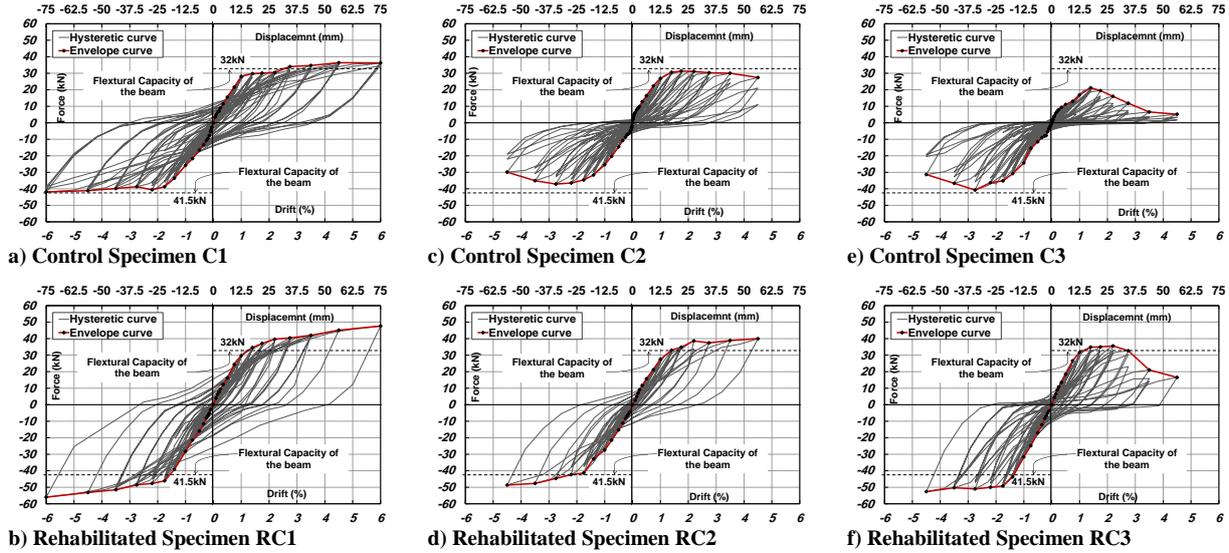
Figure 9. Load-displacement hysteretic response of control and rehabilitated specimens.

Load-displacement (and drift ratio) hysteretic response and their associated envelope curves for peak displacement points at first reversal of cycles (Elwood *et al.* 2007) are shown for the control and rehabilitated specimens in **Figure 9**. **Figure 9a** illustrates that the response of Specimen C1, the beam-column joint designed according to ACI 318M-11, exhibited ductile load-displacement hysteretic response with no notable pinching or strength drop at the end of testing. The hysteretic loops of the non-seismic specimens (C2 and C3) show considerable pinching and continuous stiffness and strength degradation with increasing displacement with respect to the seismic specimen (C1), which is

primarily attributed to the joint shear failure of specimen C2 (see **Figure 9c**) and joint shear failure and bond failure of beam bottom reinforcement of specimen C3 (see **Figure 9e**). Load-displacement hysteretic response of rehabilitated specimens RC1, RC2 and RC3 are shown in **Figure 9b**, **Figure 9d** and **Figure 9f** respectively. The hysteresis loops of the rehabilitated specimens are larger and remained stable without apparent strength deterioration and stiffness degradation with respect to their corresponding control specimens. The hysteretic response of the rehabilitated and control specimens show that the ultimate load and deformation capacity of the rehabilitated specimens was higher than their respective control specimens, for both the push and pull directions. Finally it can be concluded that the proposed rehabilitation method was effective in significantly improving the performance of the non-seismically detailed beam-column joints.

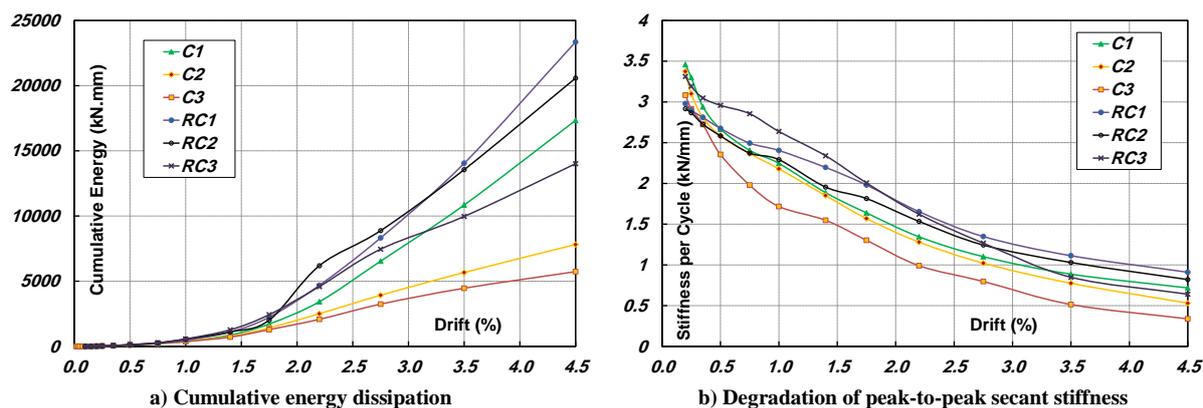
Figure 10. Comparison of cumulative energy dissipation and degradation of peak-to-peak secant stiffness.

The comparison of cumulative hysteresis energy dissipation and degradation of peak-to-peak secant stiffness for all specimens is shown in **Figure 10a** and **Figure 10b** respectively. The energy dissipated from the beginning of the test till $\pm 4.5\%$ drift ratio for the control specimens C1, C2 and C3 and rehabilitated specimens RC1, RC2 and RC3 was 17.3, 7.8, 5.7, 23.4, 20.6 and 14.1 kN.m, respectively. As shown in **Figure 10a**, the rehabilitated specimens dissipated more energy with respect to their corresponding control specimens up to 35%, 160% and 147% for the rehabilitated specimens RC1, RC2 and RC3 respectively. As shown in **Figure 10b**, the initial stiffness of the rehabilitated specimen are very consistent and had a lower rate of cyclic stiffness degradation with respect to their corresponding control specimens.
