**EMPIRICAL VULNERABILITY ASSESSMENT OF REINFORCED CONCRETE FRAME  
WITH MASONRY INFILL BUILDINGS IN THE CANTERBURY EARTHQUAKE  
SEQUENCE**

**ABSTRACT**

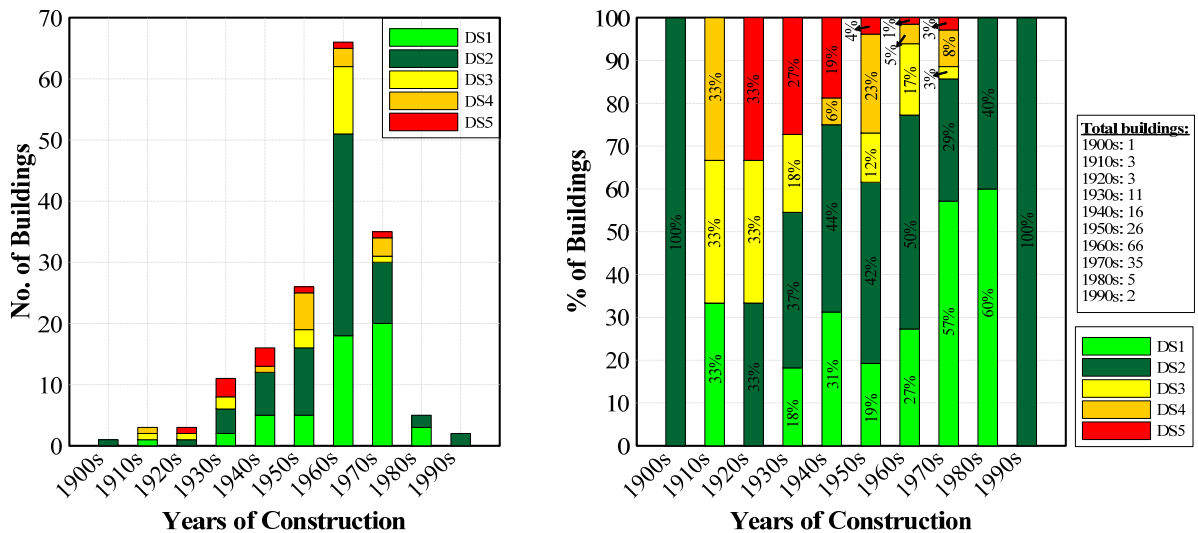
(a) Number of damaged buildings

(b) Damage state as a percentage

Figure 7: The influence of period of construction on damage

Figure 7 presents the recorded level of damage sustained by RCFMI buildings following the 2011 Lyttelton earthquake, correlated against period of construction. It was observed that RCFMI building constructed between the 1910s and the 1930s (more than 45% of the total number of surveyed buildings) had considerably more damage because these buildings were constructed before the introduction of the first New Zealand seismic code in 1935. It was documented that a large number of these buildings experienced moderate to major damage, and, as expected, the buildings constructed in that era were likely prone to earthquakes.

In contrast, RCFMI buildings constructed from the 1940s onwards exhibited better performance compared to the buildings constructed between the 1910s to the 1930s, as seismic requirements would have been incorporated into the design process (see Figure 7). It is considered that the New Zealand seismic code had a significant elevation in seismic criteria in 1976, which required seismic detailing and ductility [18]. As a result, it is unsurprising that RCFMI buildings constructed in the late 1970s onwards performed satisfactorily during the earthquakes.
