Renovation Effect of Flax FRP-Reinforced Cracked Concrete Slabs under Impact Loadings

Wenjie Wang ^{1,*}, Zonglai Mo ², Nawawi Chouw ³ and Krishnan Jayaraman ⁴

Citation: Wang, W.; Mo, Z.; Chouw, N.; Jayaraman, K. Renovation Effect of Flax FRP-Reinforced Cracked Concrete Slabs under Impact Loadings. *Materials* **2021**, *14*, 6212. <https://doi.org/10.3390/ma14206212>

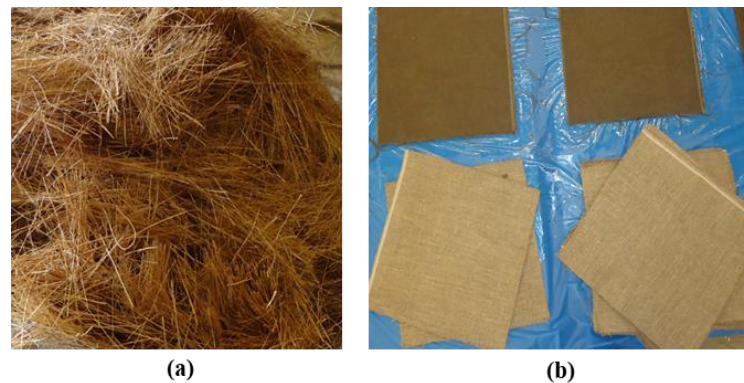
Figure 1. (a) Coconut fibre; (b) Flax fabric.

The coconut fibre was imported from Dewataru, Bali, Indonesia, the diameter and length of which are around 0.25 mm and 50 mm (Figure 1a), respectively, with a density

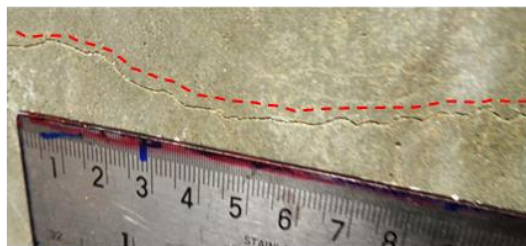
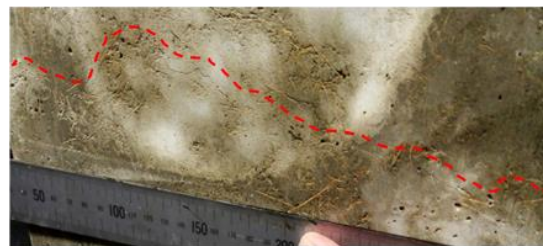
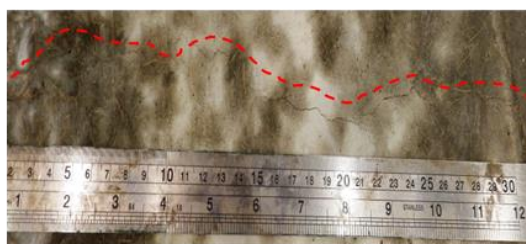
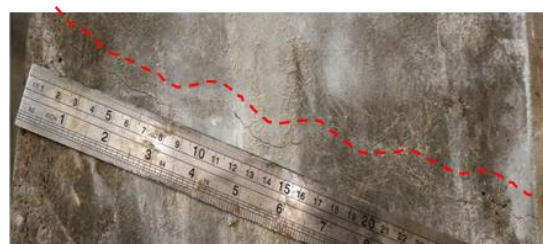
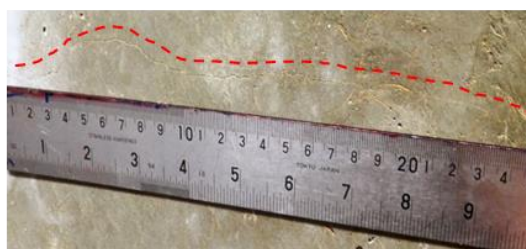
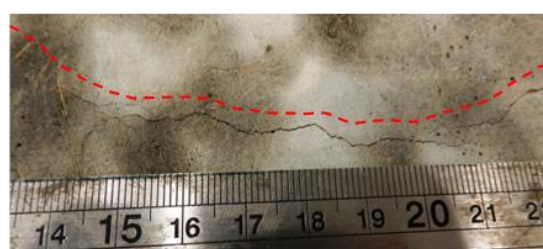
Figure 2. Crack damage of CFRC slabs under impact load.

All six specimens were cracked under the same drop weight and height, i.e., a drop weight of 40 kg and an impact height of 5 mm, to make sure all specimens had similar crack damage. The crack pattern of these six specimens was similar, as shown in Figure 2, indicating that similar damage was achieved. The crack occurred at the tensile side of the slab, located close to the specimen centre line, and the width was less than 0.5 mm.

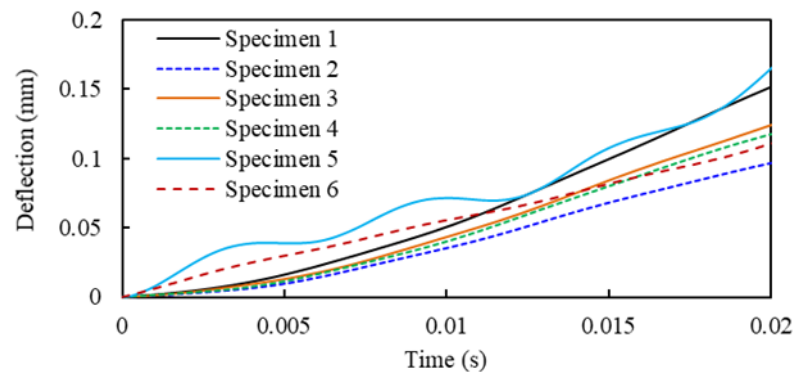
Figure 3. Deflection of CFRC slabs under an impact load.

The deflection histories of the specimens during the impact are displayed in Figure 3. It shows that specimens have a similar response under the same level of impact, but with slightly different values of deflection, which is due to the mixture effect of concrete where the fibre diffusion cannot be exactly controlled. The maximum deflection ranged from 0.89 mm to 1.65 mm.

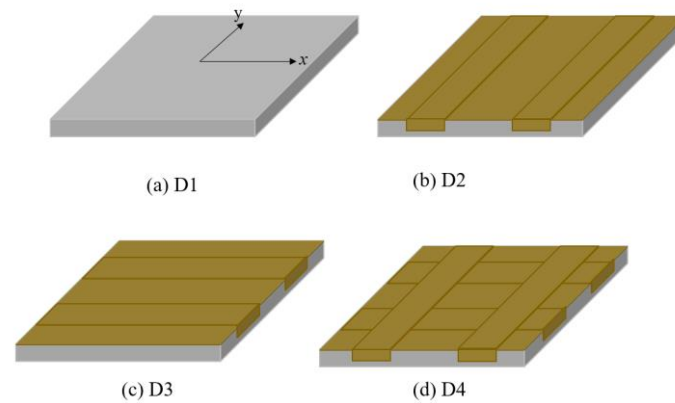
Figure 5. Sketches of renovated FFRP-CFRC square slabs.

The CFRC specimen casting procedure is the same as described in Section 2.2.1. After curing 28 days of CFRC, FFRP laminates with an area of 1.5 m² were prepared and adhered to the CFRC square slabs. The FFRP-CFRC configurations are shown in Figure 5. D1, D2, D3, and D4 are four different renovation approaches. D1 means the specimen of CFRC as reference. D2 means FFRP laminates were attached to the tensile side of the slabs and two strips were attached along the X-axis. D3 means FFRP laminates were attached

to the tensile side of cracked slabs and two strips were attached along the Y-axis. D3 means FFRP laminates were attached to the tensile side of the slabs and four FFRP strips were attached to both the X- and Y-axis.

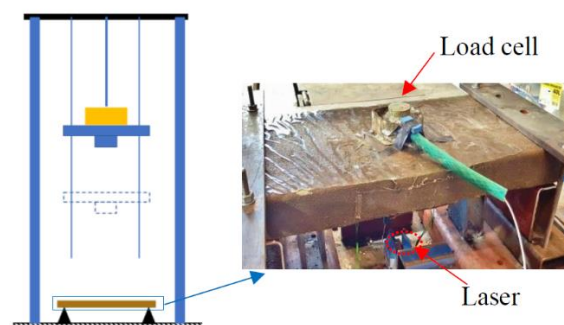
Figure 6. Sketch of impact machine and specimen set-up.

Impact tests were carried out using a drop weight test rig, with variable impact heights (maximum heights of 2600 mm). The impact mass can be set from 30 kg to 200 kg, with an increment of 10 kg. The PCB dynamic load cell was monitored to record the impact force. The accelerometer provided by PCB Company of USA was employed to record the acceleration of the specimens during impacts. The laser displacement sensor sourced from Panasonic, Ōsaka, Japan was installed beneath the slab centre to measure the net deflection of the slab, and its data acquisition was set to 50 kHz.

Repeat impact tests were carried out on G1 and G2 FFRP-CFRC slabs. The impact height was initially set to 10 mm, then increased to 30 mm, 50 mm, 70 mm, 100 mm, 150 mm, 200 mm, 250 mm for each subsequent strike until the specimen broke. The dynamic load cell and laser sensor were applied to measure the impact force and the deflection, respectively. Besides, strain gauges were attached to the centre of the slab tensile surface to measure the strain of FFRP laminates. A number of impact tests were conducted with increasing impact heights until a specimen was broken. The detail of the test set-up for the impact test is described in Figure 6. Table 3 lists the test matrix of the specimens.

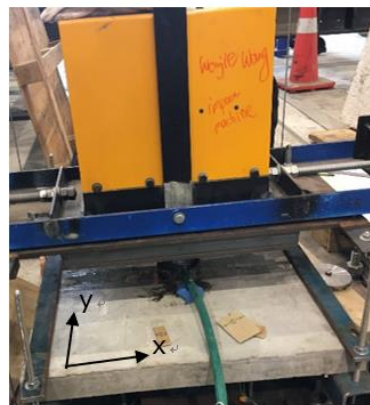
**Figure 7.** Test set-up for square specimen Group D.

Impact tests are similar as described above. Repeat impact tests were carried out on the FFRP-CFRC square specimens D1, D2, D3, and D4, respectively. The impact height was initially set to 10 mm, which then increased, then increased to 30 mm, 50 mm, 70 mm, 100 mm, 150 mm, 200 mm, 300 mm, 400 mm, 500 mm, 600 mm for each subsequent strike until the specimen broke. The test set-up for the impact test is described in Figure 7. In the test, the dynamic load cell was removed when the impact height was higher than 400 mm, as the specimen occurred a significant sag at the local central area. Hence, only the impact force within 400 mm of height was recorded. As for the strain, the record was continual until the final rupture of the specimen. The detailed test matrix can be seen in Table 3.

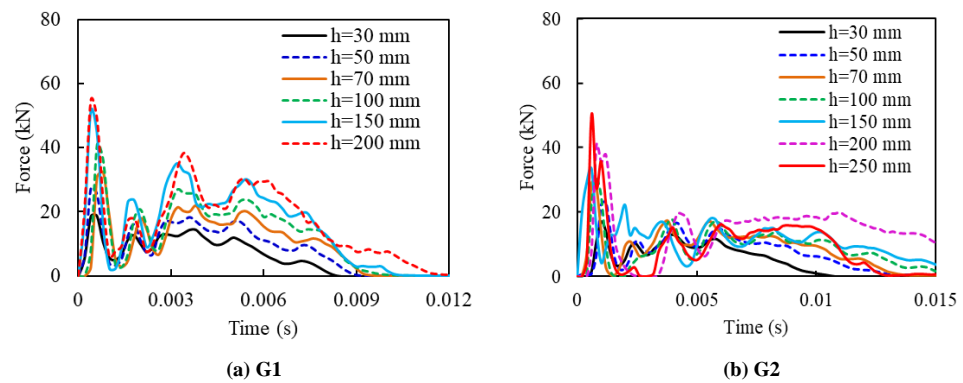
Figure 8. Impact force-time histories of G1 and G2.

Figure 8 displays the impact force histories of G1 and G2. The entire impact force-time period for slabs G1 and G2 are about 0.01 s and 0.015 s, respectively. The maximum impact force occurs at the very first stage of impact before 0.002 s. Multiple smaller force peaks were observed, which were called “secondary peaks” in the force history. This phenomenon can be explained by multiple contacts between the specimen surface and the impactor during the impact.

With regard to the total number of impacts required for failure, slab G1 suffered 6 blows of impact and slab G2 was fractured at the 7th impact at 250 mm of drop height. The maximum impact force increased with impact height. The maximum impact forces of G1 and G2 slabs were found to be about 54.79 kN and 50.26 kN, respectively. The results of series G1 and G2 were compared with the result of bare CFRC slabs to demonstrate the effectiveness of FFRP renovation in this study. The force-time history, deflection-time history and damage pattern of bare CFRC slabs can be found in the previous study [18]. The CFRC slab had a maximum impact force of about 6 kN, and the peak impact force occurred before 0.005 s. Two strikes took place for damaging the CFRC specimen with a failure height of 20 mm. It can be clearly found that flax fibre can greatly reinforce the impact resistance of pre-cracked CFRC, with the maximum impact force changed from 6 kN to over 50 kN.

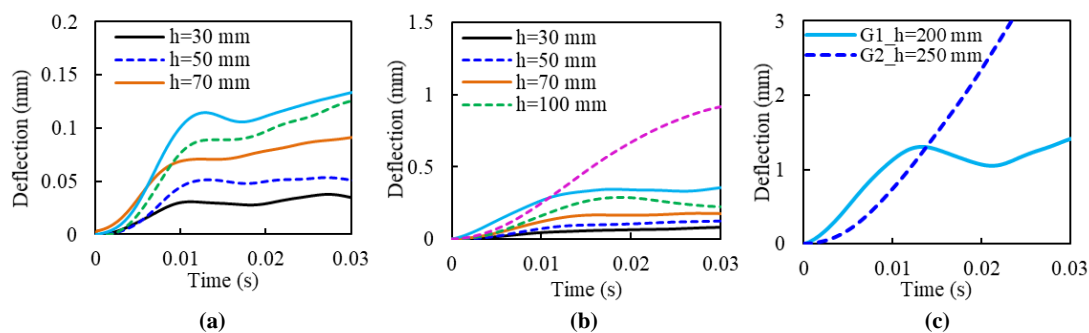
Figure 9. Deflection-time histories of G1 and G2 specimens under impact: (a) G1 with the impact height from 30 mm to 150 mm; (b) G2 with the impact height from 30 mm to 150 mm; (c) Deflection of G1 and G2 at failure.

Figure 9 displays the deflection of G1 and G2 during the impact, of which Figure 9a,b shows the undamaged situations, and Figure 9c provides the damage case (at the final impact with specimen fracture). The maximum deflection increased with the drop height. For slab G1, the maximum value increased from about 0.03 mm (30 mm of impact height) to 0.13 mm (150 mm of impact height). The deflection increases significantly at the last impact (200 mm of impact height), with a maximum value of about 1.5 mm. Slab G2 had a similar development of maximum deflection, while the values were larger than that of slab G1. For the same impact-loading situation, the maximum deflection of slab G2 increases from 0.07 mm to 0.35 mm, and the fracture deflection was about 3 mm, with a drop height of 250 mm.

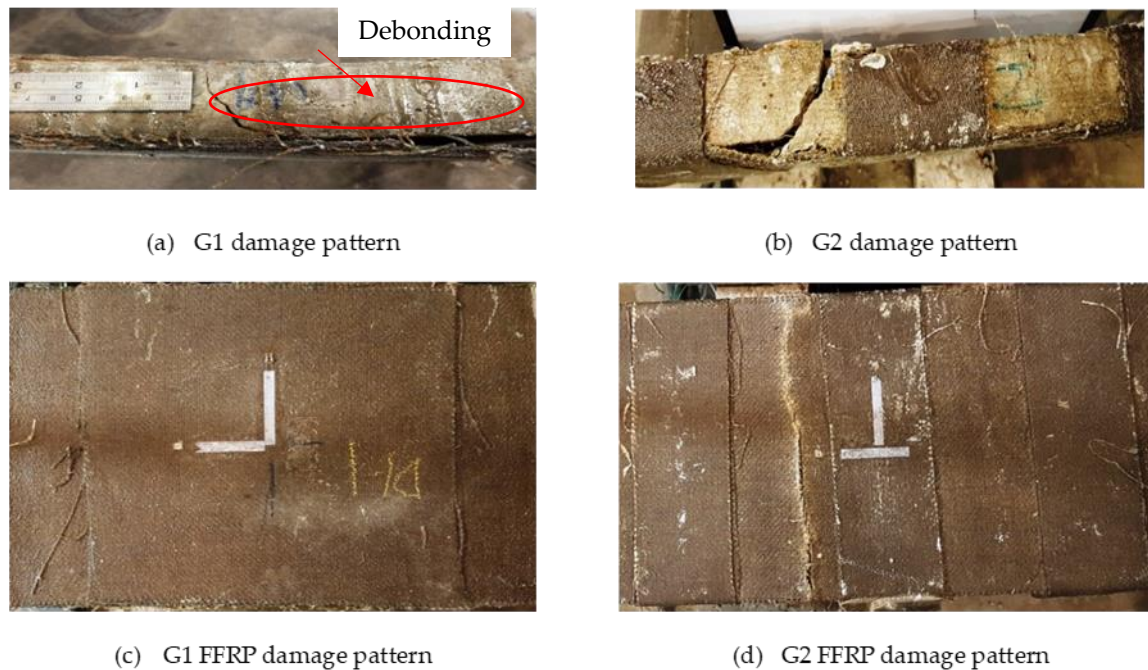
Figure 10. Damage patterns: (a) side view of G1 slab; (b) side view of G2 slab; (c) top view of G1 slab, and (d) top view of G2 slab.

The deflection difference between G1 and G2 could be due to their difference in damage patterns. Figure 10 shows their damage patterns. It is found that G1 occurred debonding failure when the drop height was 200 mm, as shown in Figure 10a, hence the test was stopped after this event. Whereas, slab G2 lasted until the fracture of FFRP laminates occurred, as shown in Figure 10d. This phenomenon can also be observed through the strain changes of FFRP laminates, shown in Figure 11. The strain in the case of G1 decreased suddenly to $2500 \mu\epsilon$ at the 200 mm height impact, due to the FFRP laminates being debonded from the concrete core. On the other hand, FFRP strain in slab G2 increased gradually with the increment of drop height until the damage occurred.

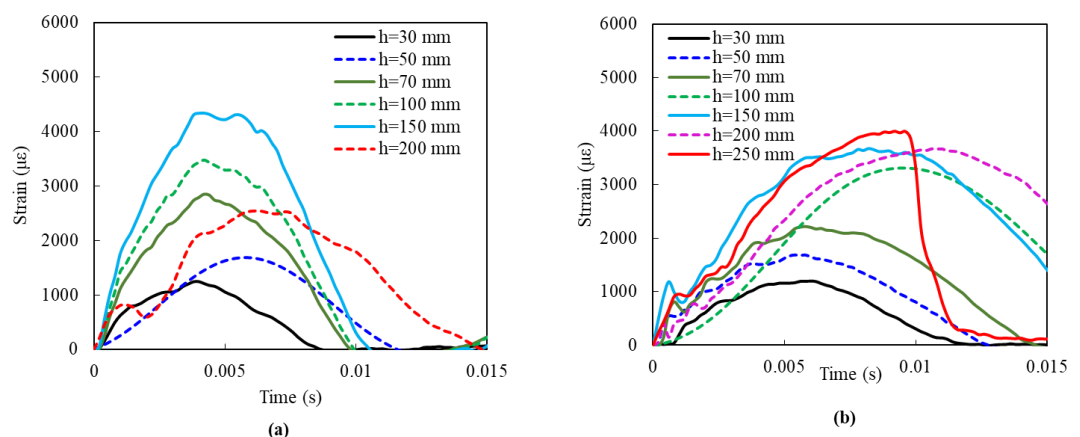
Figure 11. FFRP strain of (a) G1 and (b) G2 slabs.

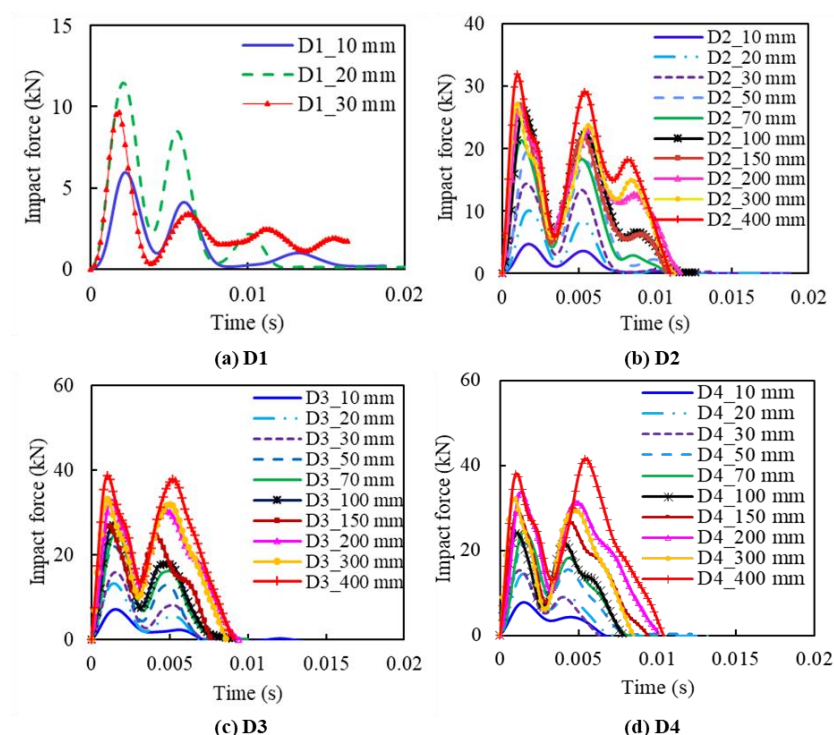
Figure 12. Impact force histories under different impact height for Group D: (a) specimen D1; (b) specimen D2; (c) specimen D3; (d) specimen D4.

Figure 12 shows the impact force histories of slabs D1, D2, D3, and D4. As a reference, the peak impact force of slab D1 was around 6 kN, 12 kN, and 10 kN, with impact heights of 10 mm, 20 mm, and 30 mm, respectively (shown in Figure 12a). The decrease of impact force at the last impact is due to the sudden rupture of the specimen, resulting in a loss of load-bearing capacity.

From Figure 12, a similar phenomenon, “secondary peaks”, as described, can also be observed, while the first two peaks had a very close value for the specimen series D2, D3, and D4, except for bare CFRC specimen D1. This could be due to the increase of stiffness of D2, D3, and D4 by FRP reinforcement. The FRP reinforcement greatly increases the elasticity of the specimen, resulting in an obvious rebounding phenomenon during impact. The results of slabs D2 show that the amplitude can go up to over 30 kN as the impact height increases to 400 mm, as shown in Figure 12b, while the slabs of D3 and D4, with a similar impact height of D2, tend to achieve higher impact forces. For example, slabs D3 and D4, with an impact height of 400 mm (Figure 12c,d), have a peak force of about 40 kN, which is 10 kN, outnumbering that of slabs D2. It is also notable that the response time length of slabs shows little connection with slab thicknesses, around 0.01 s for all slabs, with two main amplitude peaks appearing at around 0.002 s and 0.0054 s, respectively. Reinforced by FRP laminate, the CFRC specimen can sustain higher capacity under repeat impact loadings. Among the four configurations of D1, D2, D3, and D4, the specimens D3 and D4 have the best impact resistance.

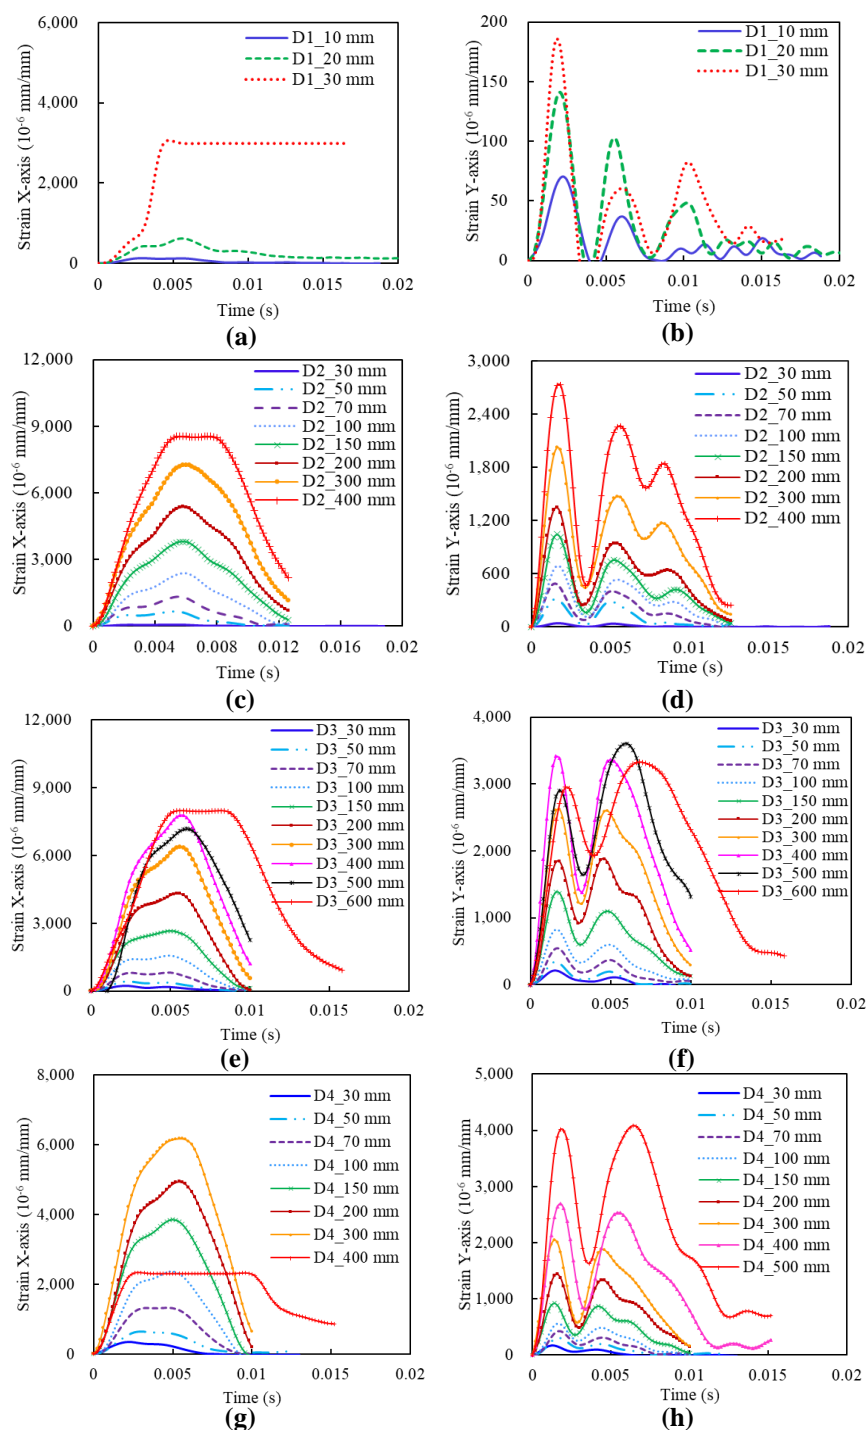
Figure 13. Strain time histories under different impact height for Group D: (a) X-axis strain of specimen D1; (b) Y-axis strain of specimen D1; (c) X-axis strain of specimen D2; (d) Y-axis strain of specimen D2; (e) X-axis strain of specimen D3; (f) Y-axis strain of specimen D3; (g) X-axis strain of specimen D4; (h) Y-axis strain of specimen D4.

Figure 13 shows the strain time histories of slabs D1, D2, D3, and D4 along the X- and Y-axis. A clear tendency is observed that, for the same type of slab, strain increases with the impact height, and the strain along the X-axis is more stable, with a higher value than that along the Y-axis. For different types of the slab, slabs D2 tend to achieve higher strain along the X-axis, while slabs D3 are higher in strain along the Y-axis. In addition, the time to the peak strain along the Y-axis shows an agreement with that of peak values of impact force in Figure 12, and the peak value along the X-axis is around 0.005 s. However, the strain along the X-axis performs different from the Y-axis, with only one fluctuation within 0.02 s, instead of two to three fluctuations along the Y-axis, which could be explained by the following reason. The specimen is fixed on the two edges at the two ends of the X-axis, leading to the constraining of the fluctuations at the X-axis during the impact. On the other hand, the fluctuations at the Y-axis are free to be generated as no constraints are applied.

For slabs D1, the strain along the Y-axis is nearly linear with thickness change, while the strain of D1_30 mm along the X-axis is way larger than those with other impact heights, as shown in Figure 13a. This is because the specimen occurred brittle fracture at the second impact with a height of 30 mm and the strain gauge along the X-axis was broken. In addition, it is notable that, after increasing to 300 mm of impact height for slabs D3, the increase of impact height leads to strain decrease, as shown in Figure 13e,f. A similar phenomenon is observed in slabs D4 in Figure 13g, where the strain of D4_400 mm

shows a significant drop, from 6175×10^{-6} mm/mm of D4_300 mm to 2331×10^{-6} mm/mm of D4_400 mm. It means that the slab occurred a sudden fracture, giving rise to a rapid drawdown of the strain with the strain gauge was workable.

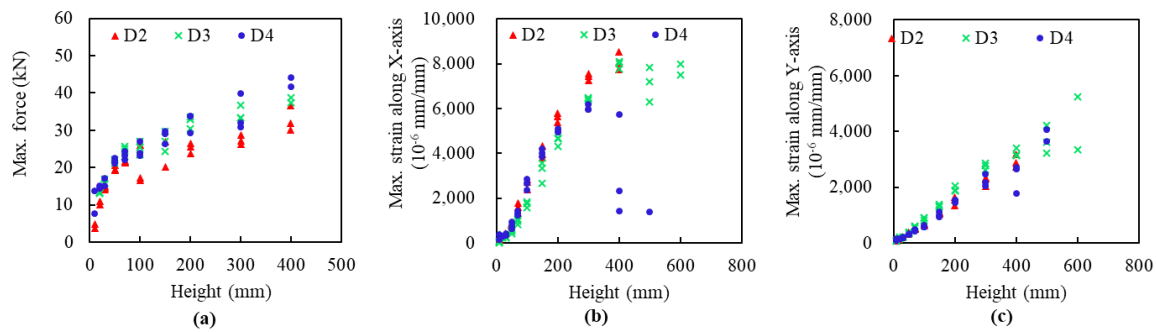
Figure 14. Comparison among D1, D2, and D3 for peak values under different impact heights: (a) Maximum forces, (b) Maximum strain along X-axis, (c) Maximum strain along Y-axis.

The detailed maximum values are compared from Figure 14. The slabs D4 have larger impact forces under the same impact height, while slabs D2 and slabs D3 have a slightly bigger strain along the X-axis and Y-axis, respectively. Comparing D2, D3, and D4, specimen D4 fractured at the height of 600 mm, followed by D3 with the height of 500 mm and D2 with 400 mm. This demonstrates that slab type D3 has the highest impact-resistant performance, indicating the best of the D3 FFRP configuration.

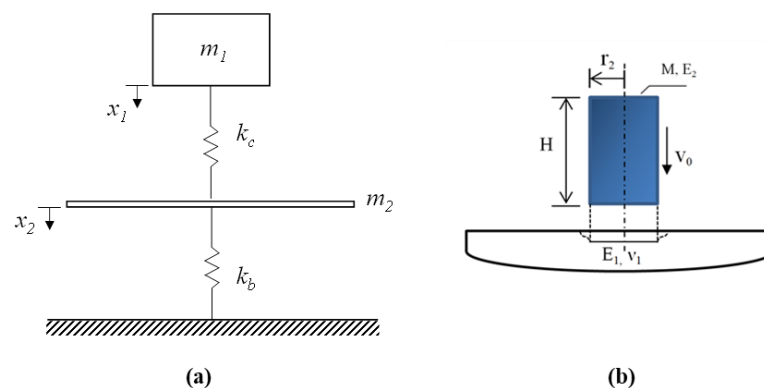
Figure 15. (a) Spring-mass model and (b) cylindrical striker impacting an elastic surface.

The studied impact results from the collision of two bodies, one with initial speed hitting another being at rest. This problem could be reduced to a two-degree-freedom of spring-mass system [21,22], which is composed of striking masse m_1 and square slab mass m_2 , a contact spring with a stiffness k_c , and another spring with a stiffness k_b . The idealization of the spring-mass system is given in Figure 15a.

In this system, the striker and the square slab are connected by a spring representing Hertzian contact stiffness. The shear and the membrane stiffness are neglected in the present study. The combination of the springs reduces to a single spring representing the bending stiffness of the concrete slab. The contact stiffness for a slab impacted by a cylindrical impactor is given by the following expression [23,24]:

where ν_1 is the Poisson ratio of the slab, E_1 is the Young modulus of the slab, H and r_2 are the dimension of the striker, as shown in Figure 15b

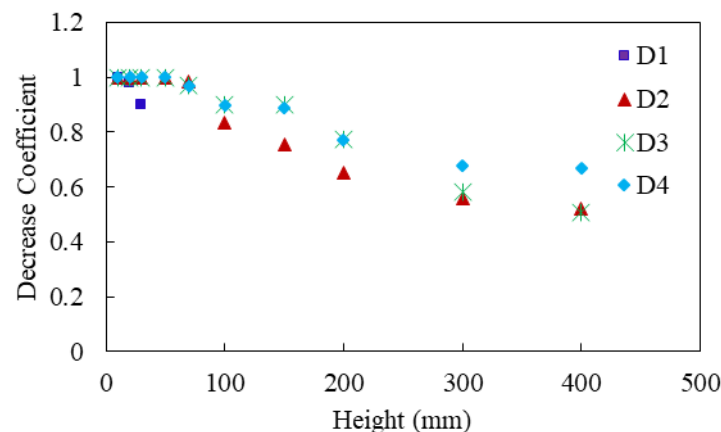
Figure 16. Estimated decrease coefficients of D1, D2, D3, and D4 slabs.

For the repeated impact, the specimen stiffness decreases due to the increase of the impact. To estimate the decrease of the stiffness in each impact, a similar method was applied as in the authors' previous work [21], where the way of obtaining the decreasing coefficient was described in detail. Figure 16 displays the estimated decrease coefficients of D1, D2, D3, and D4 slabs.

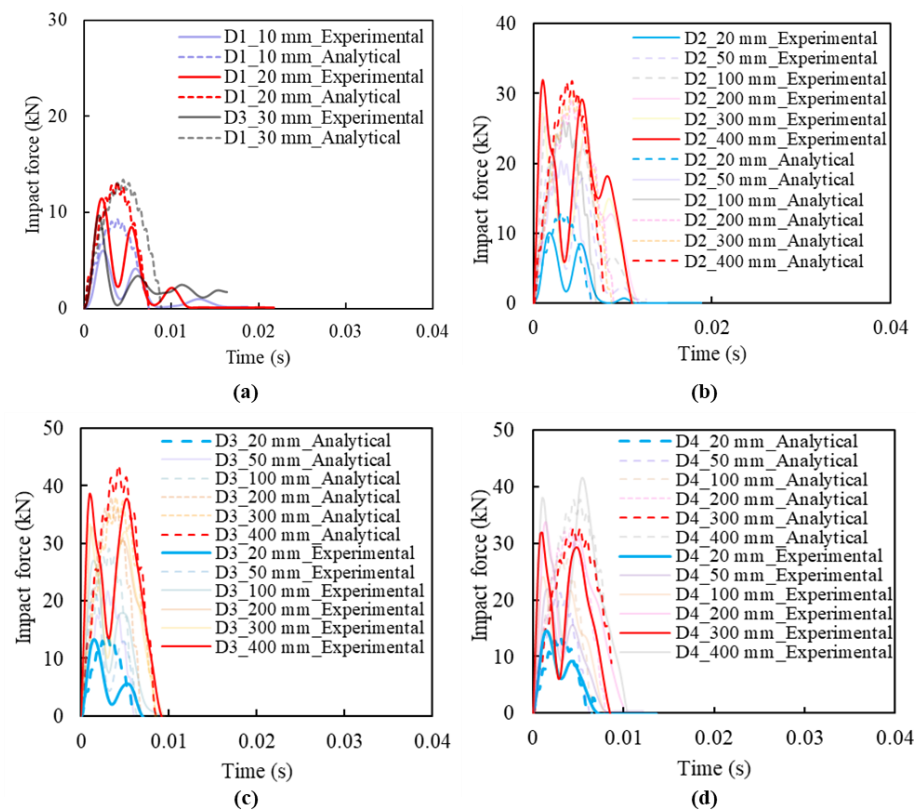
Figure 17. Impact force comparison of slabs between analytical results and experimental results: (a) Slab D1; (b) Slab D2; (c) Slab D3; (d) Slab D4

The analytical results of impact force histories based on the spring-mass model are compared with experimental results in Figure 17 for verification. The results reveal the magnitude of the peak impact force, but with a time shift due to the assumptions made during the analytical modelling. This also indicates that the decrease coefficients or specimen stiffness should be accounted for when the repeated impact tests are carried out.
